MILESTONE INSPECTION – PHASE I

SEAFARER CONDOMINIUMS
16401 PERDIDO KEY DRIVE
PENSACOLA, FLORIDA 32507

PREPARED BY: STEVEN W. RAY, P.E., R.S.
CARTER NELSON, E.I.T., R.S.

MAY 2024

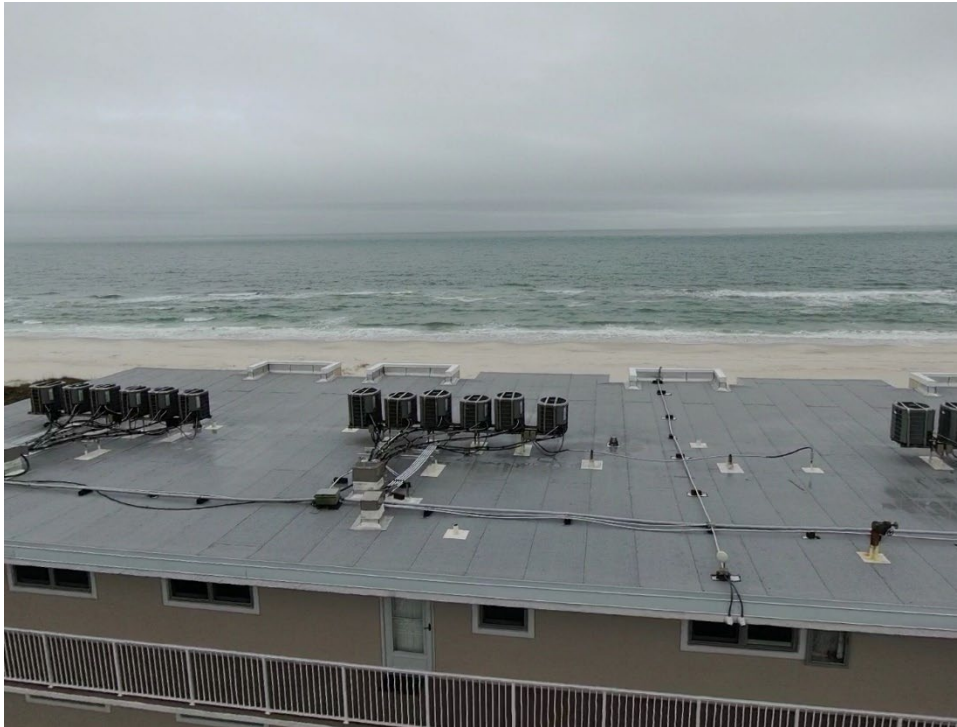
The roof system of the buildings is primarily modified bitumen membrane with TPO along the parapet wall features (reference photograph 2). The roof structure is consistent with a post-tension slab. During the inspection, we observed that the joints along the parapet walls are deteriorated and possibly failing in some locations (reference photograph 3). In addition, we noted a localized divot in the flat roof of the equipment penthouse, which appears to be sealed but should be monitored.

2. View of the typical roof system.

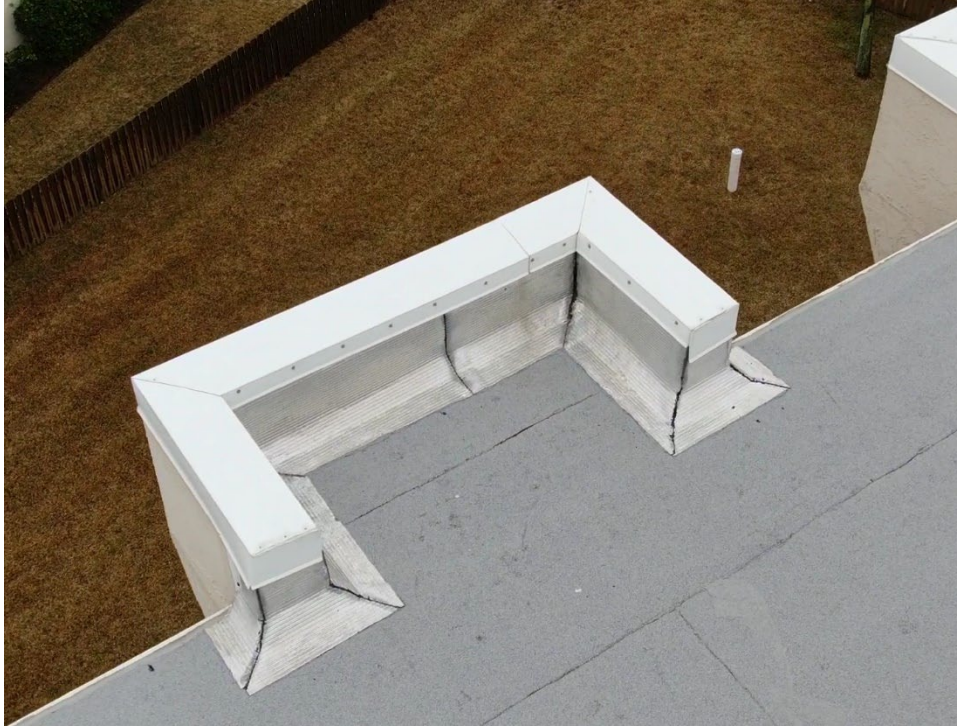
3. An example of joints in the TPO parapet wall building envelope failing.

- *The joints along the TPO membrane at the parapet walls should be sealed if any areas are opened.*
- *We recommend annual inspections as well as inspections directly after large storm events to ensure the roofing is intact.*

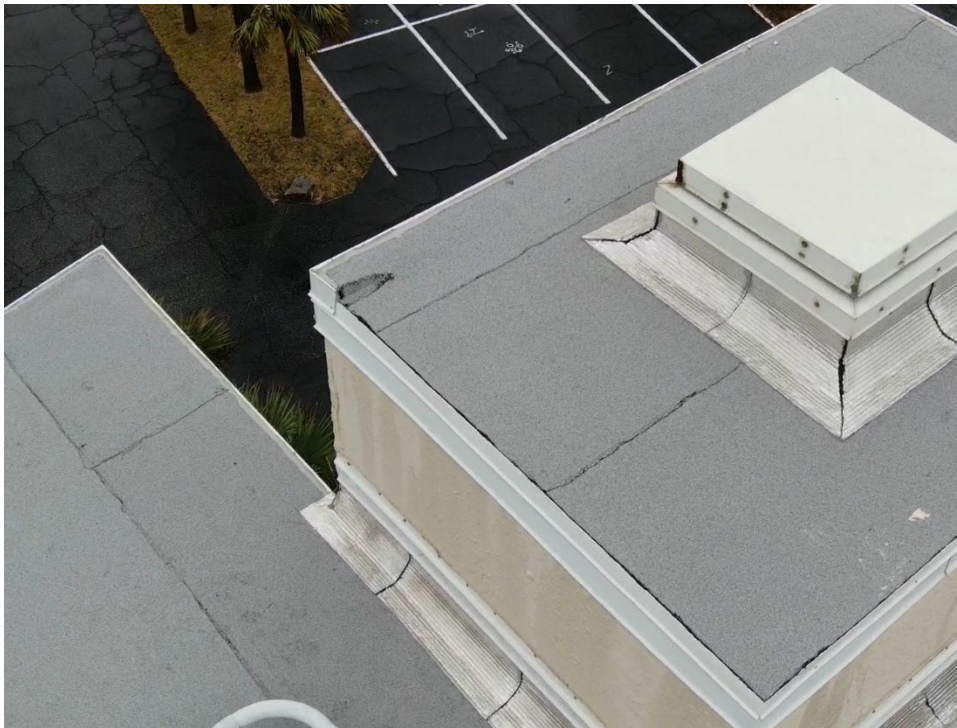
4. We noted an isolated divot in the flat roof section of the equipment penthouse.

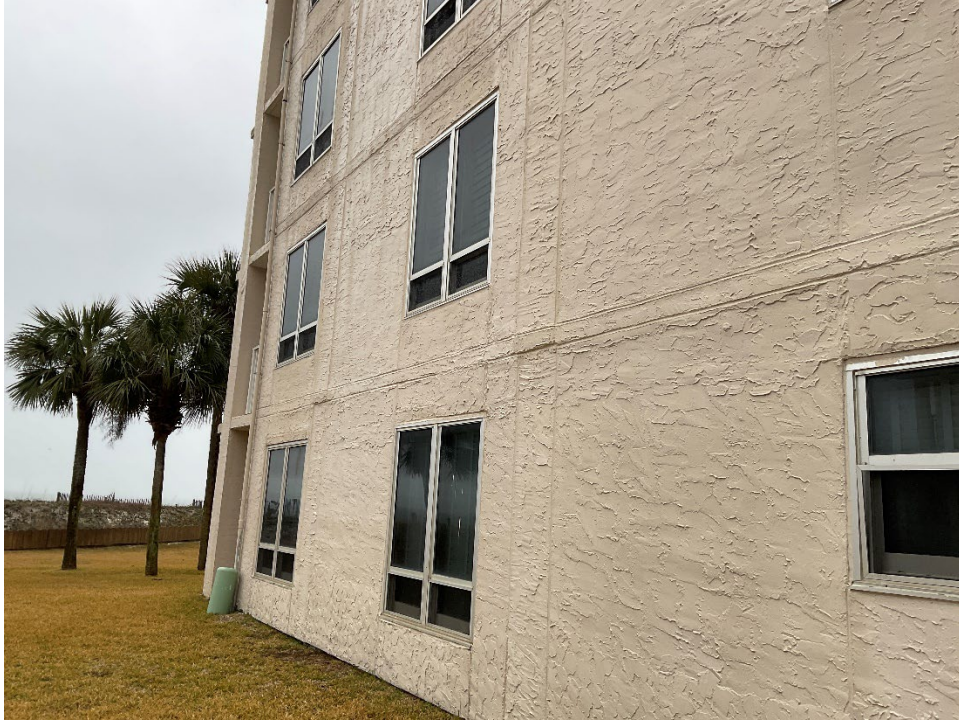
The exterior of the building is clad with stucco and cement plaster coating, which appears to be nearing the end of its useful service life (reference photograph 5). During the review, we observed delamination of the stucco and bubbling in multiple areas, which indicates the weaker areas have failed and will continue (reference photographs 6 & 7). Due to the multiple instances of these issues at both buildings, there is sufficient evidence that the coating is at the end of its useful service life and should be coated based on the SIRS schedule.

5. View of typical cladding on the building.

- *For the stucco issues, we recommend immediately repairing any cracks and delamination with the appropriate repair material for the stucco substrate to prevent water from severely delaminating the stucco in these areas.*
- *All open gaps should be caulked with NP100 immediately to prevent further water infiltration.*

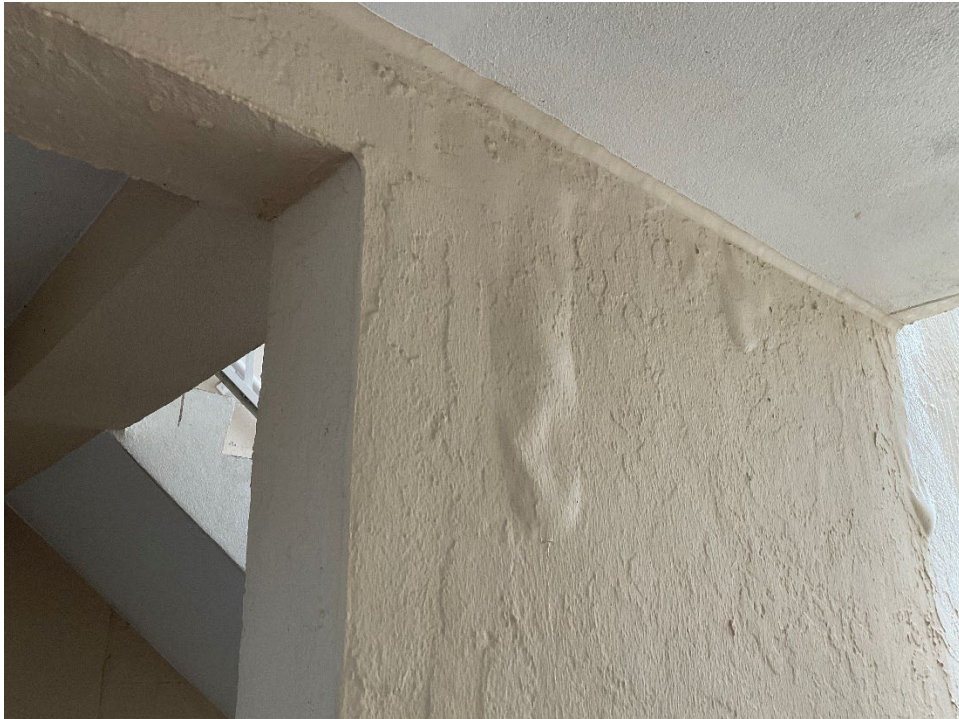
6. Bubbles were observed in the cladding of the exterior near stair towers.

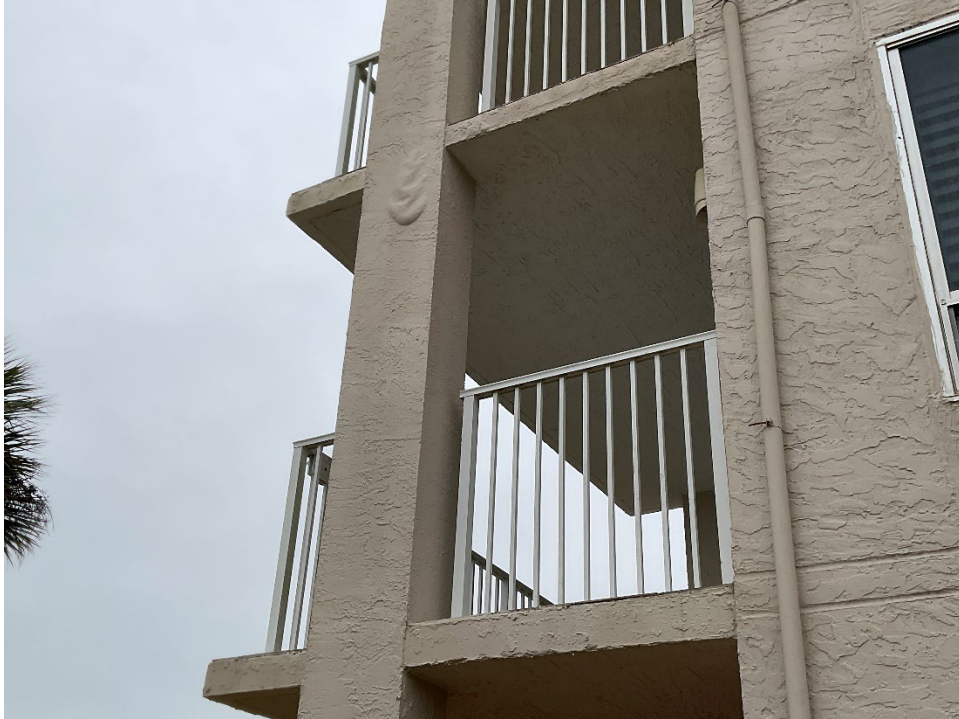
7. Additional bubbles were observed in the exterior cladding.

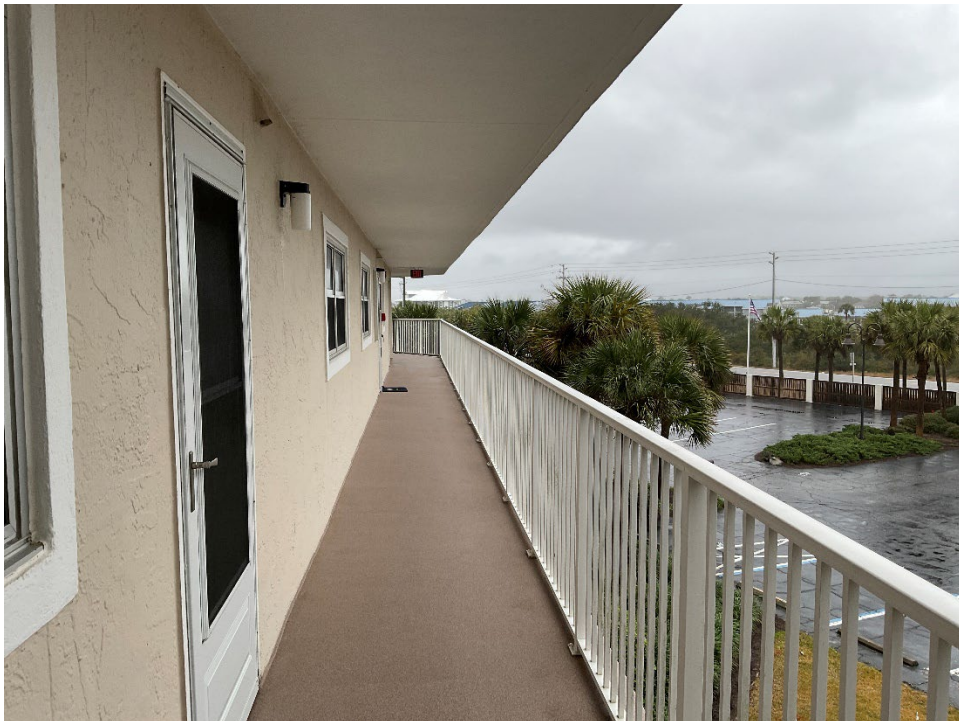
The corridors at this building have multiple instances of large cracks, which appear to be the result of expansion or contraction as well as failed expansion joints due to age (reference photographs 8-10). In addition, we observed poor drainage in multiple areas, which is due to a lack of scupper to allow for stormwater to run off the corridors. The coating appears to be in generally good condition, with only the expansion joints showing signs of delamination and cracks.

8. View of the typical corridor.

- *We recommend that all expansion joints be replaced with a new engineer designed system to extend the service life of the coating system.*
- *During the replacement of the coating, all joists should be routed and sealed with NP100. The new system should be a trafficable pedestrian system that will have a life cycle of 15-20 years.*

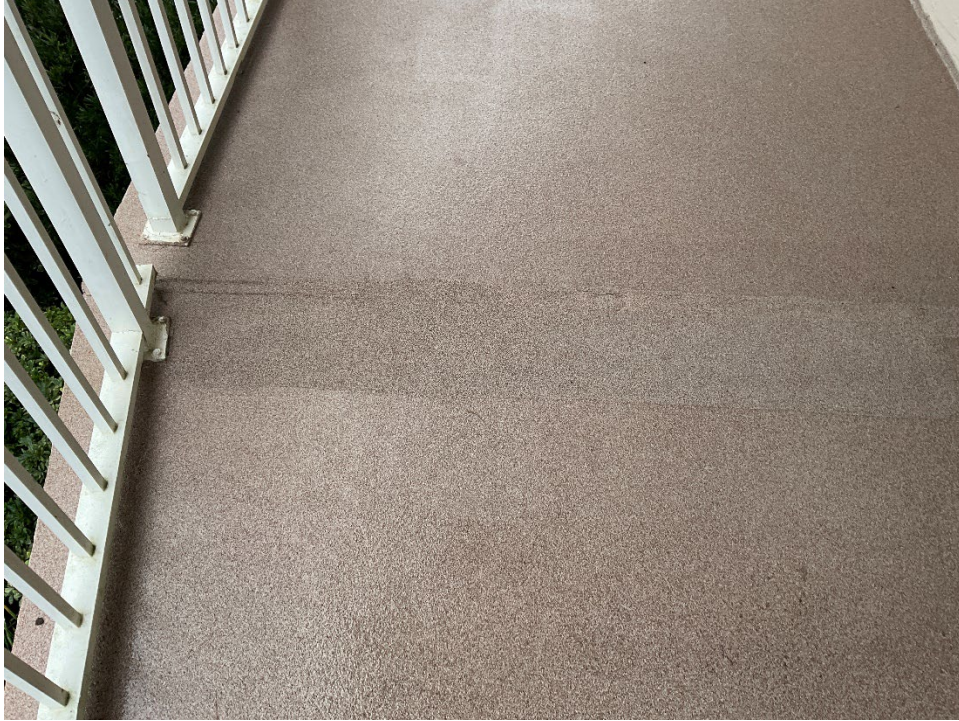
9. View of cracks at an expansion joint in the corridors.

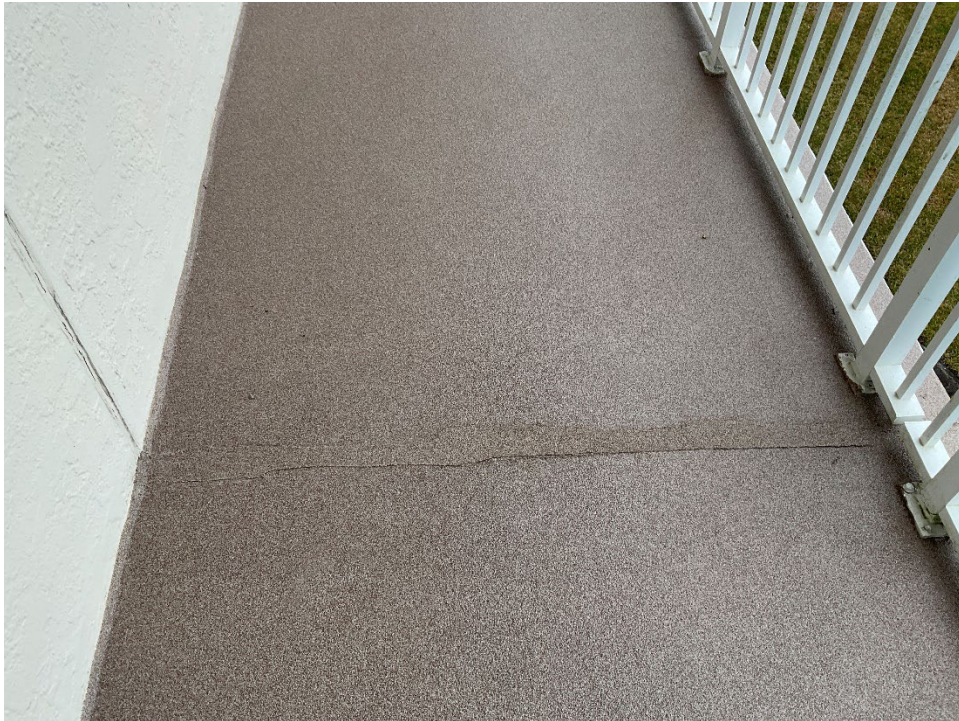
10. View of cracks at an expansion joint in the corridors.

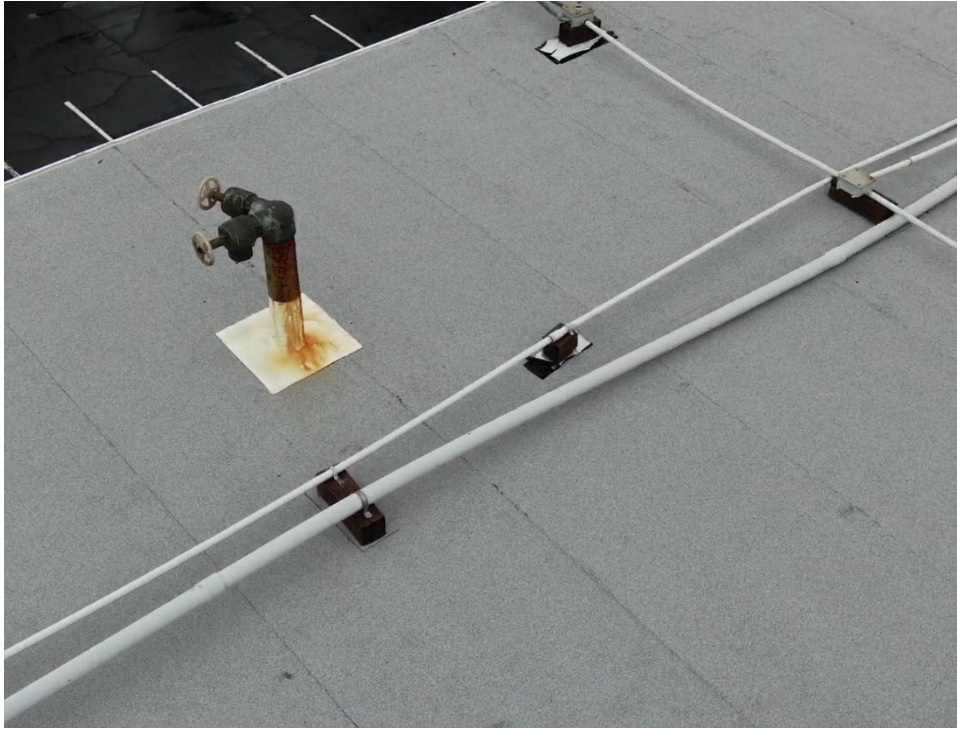
The building's fire safety systems consist of only the fire control panel safety system, as the property is grandfathered in. During the inspection, the equipment looked dated; however, it was in working condition and did not require any testing at this time. We did not find that the exposed standpipes on the rooftop show signs of excessive corrosion, indicating they are nearing the end of their useful service life.

11. Significant corrosion is present on all of the exposed standpipes on the rooftops.

We recommend that during the annual testing of the systems, the board make the contractor aware of any corrosion issues on equipment.
