**Los Angeles County
Metropolitan Transportation Authority
Office of the Inspector General**

**Review of the Expo/Blue Line
Junction**

Case No. 2011-0040

December 18, 2012

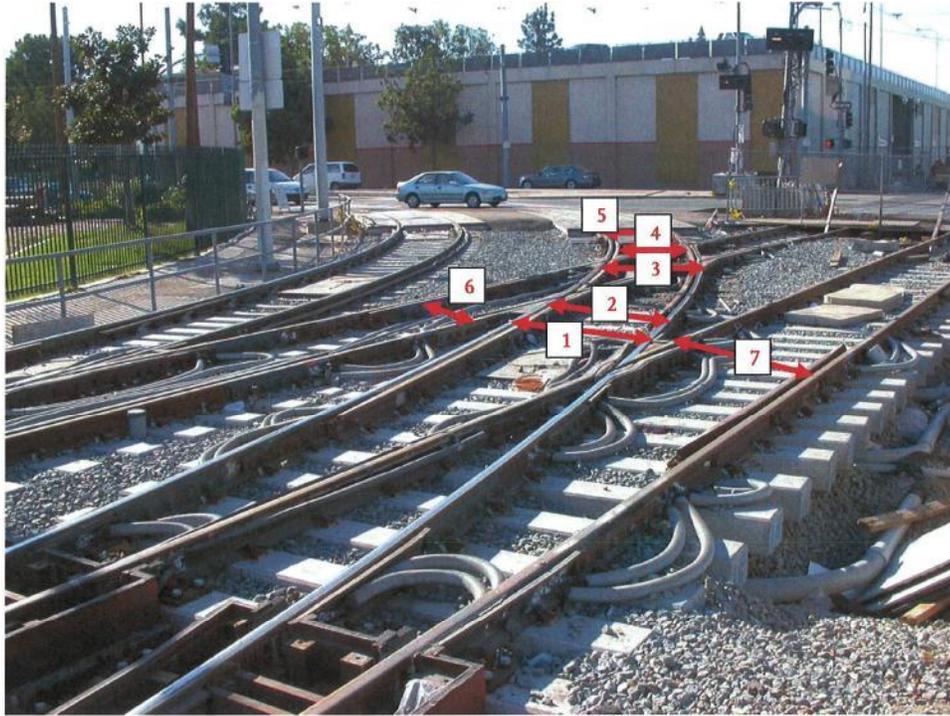
Different Track Gauge Measurements

| Measuring Point | Location Description | Track Gauge Measurement |
|---|---|---|
| 1 | Heel of 190' Radius Turnout Frog Track 2 | $56 \frac{1}{8}'' = 4' - 8 \frac{1}{8}''$ |
| 7 | Heel of 190' Radius Turnout Frog Track 2 | $56 \frac{3}{8}'' = 4' - 8 \frac{3}{8}''$ |

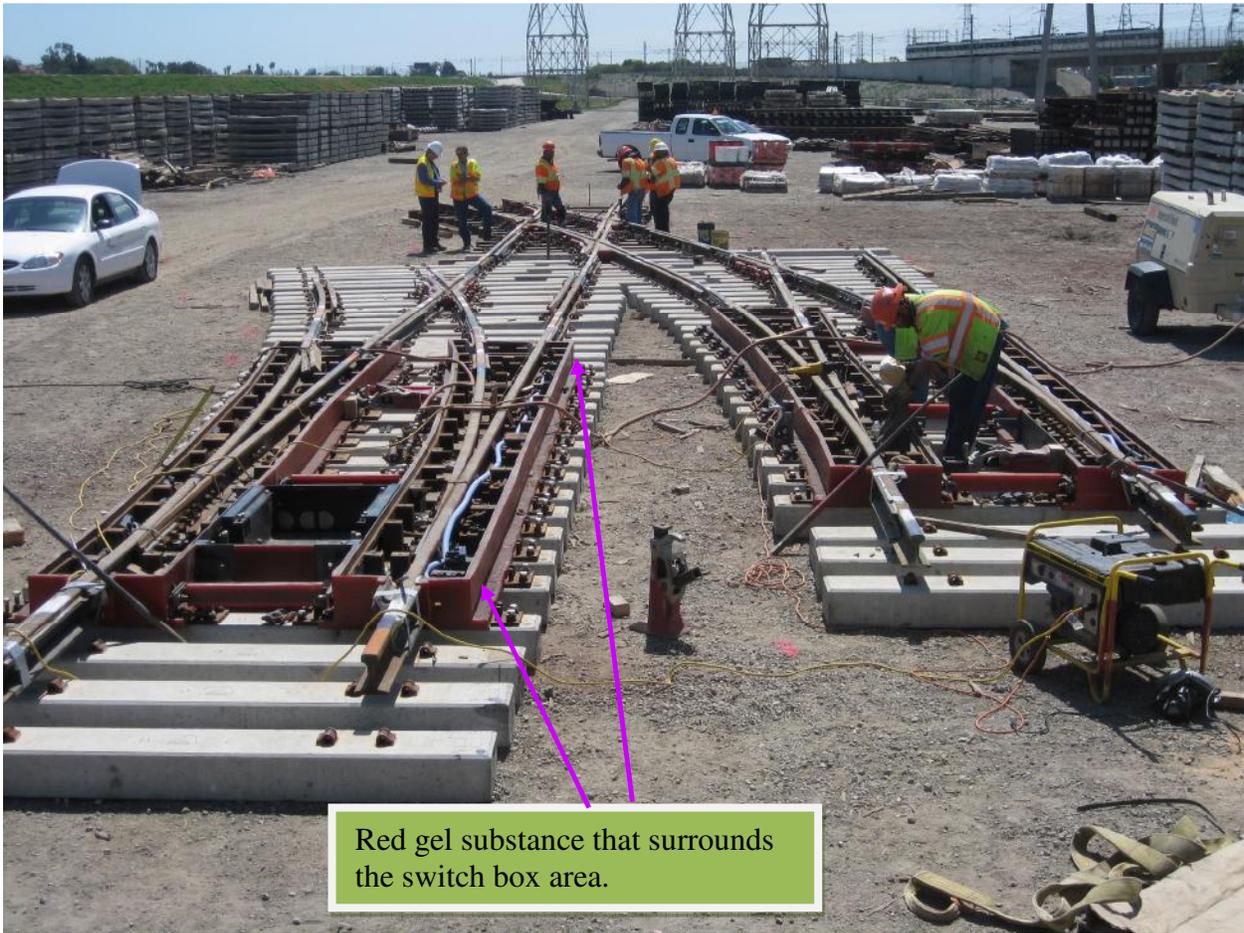
Picture of Diamond Switch Box Area

Red gel substance that surrounds the switch box area.

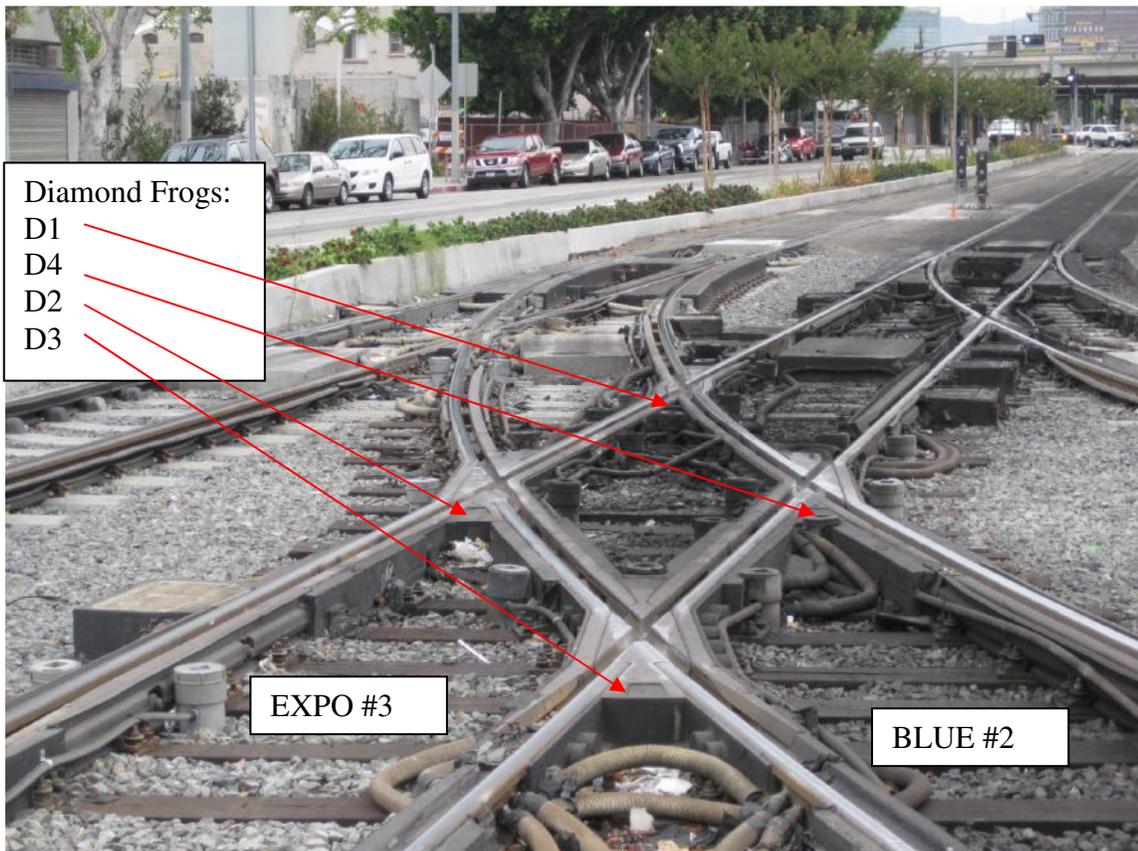
Figure 1: Junction with all four Diamond Frogs (D1-D4)

As noted in the introduction, the severe wear that was experienced at the D4 frog was addressed through the introduction of a welded “blip” near the D2 frog and associated approach “ramp” north of the “blip” in the southbound direction. This “blip” had the effect of forcing over the train wheels to protect the D4 frog in an effort to minimize wear at the frog. (see Figure 1). Note, however that no approach ramp was added in the northbound direction since this was not the primary direction of travel.

While the “blip” did provide protection for the D4 frog and did appear to reduce the batter at the frog point, significant concern was raised about the magnitude of the lateral forces generated by the blip and associated safety and integrity issues. To address these issues, ENSCO Incorporated was brought in to instrument a service vehicle and measure the level of impact loading and acceleration at the frog in question.

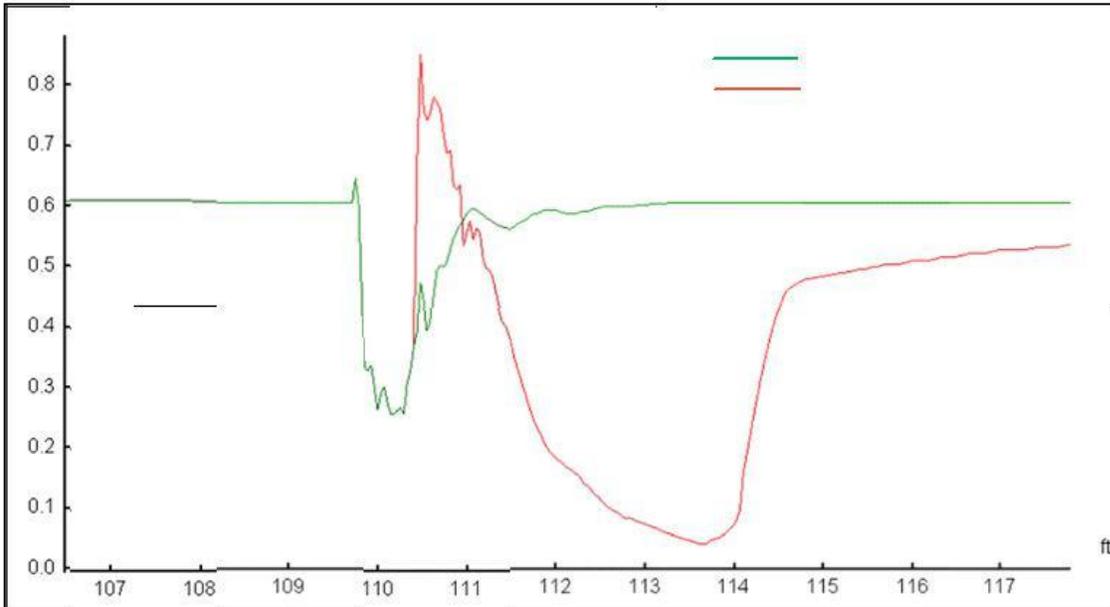
Figure 3. Comparison of L/V Ratio on the Lead Right Wheel through a Standard Frog (Green) and Expo Frog (Red)

As can be seen from this Figure 3, the Expo frog movement showed an L/V ratio of 0.8, as opposed to the standard movement of 0.6. While 0.8 is sometimes regarded as the “minimum” L/V threshold, ZETA-TECH performed a more detailed analysis of the L/V ratio threshold as a function of the actual wheel flange angle and coefficients of friction using the Nadal wheel climb analysis methodology. The results of the analysis showed that for the new wheel flange angle of 75 degrees (the same as was used by ENSCO in the modeling run) and for a range of coefficient of friction of 0.3 to 0.5, the actual L/V derailment threshold is 1.13, well above the model calculated L/V ratio through the Expo frog (of 0.8). This indicates that there is no risk of wheel climb, since the L/V ratio was less than the Nadal calculated derailment threshold.

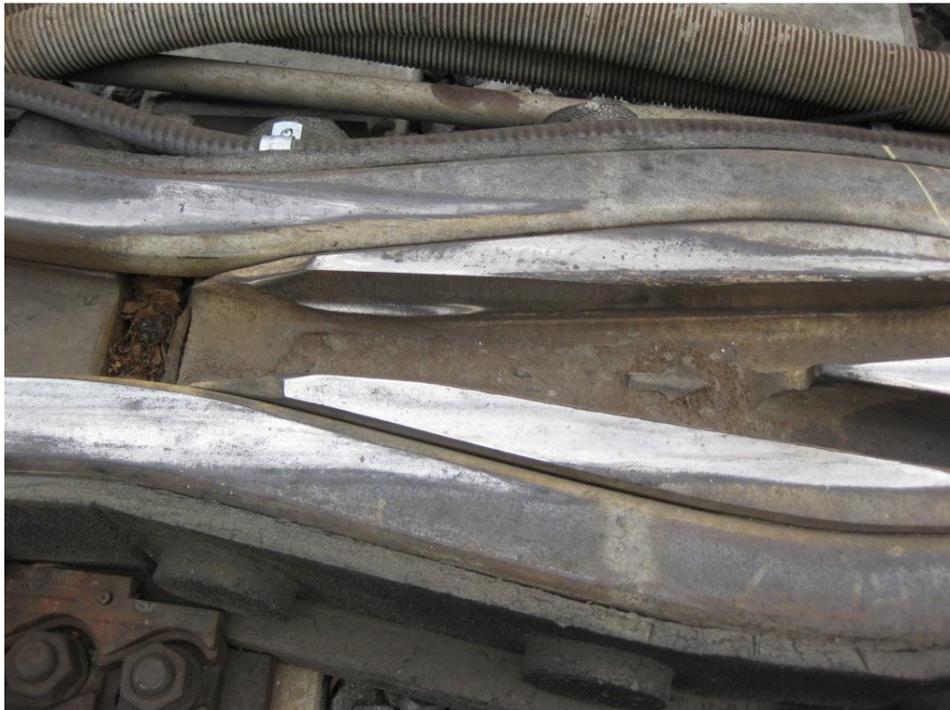
Figure 7: Observed Wing Rail Wear

Observation of the frogs elements of the diamond indicates that the flangeways in the diamond on track Blue#2 (both outer and inner rails) are being abraded by the back of flange of passing wheels. In addition, the wing rail of the frog in the turnout on EXPO #3 is being worn by the back of flange of passing wheels. (see Figure 7)

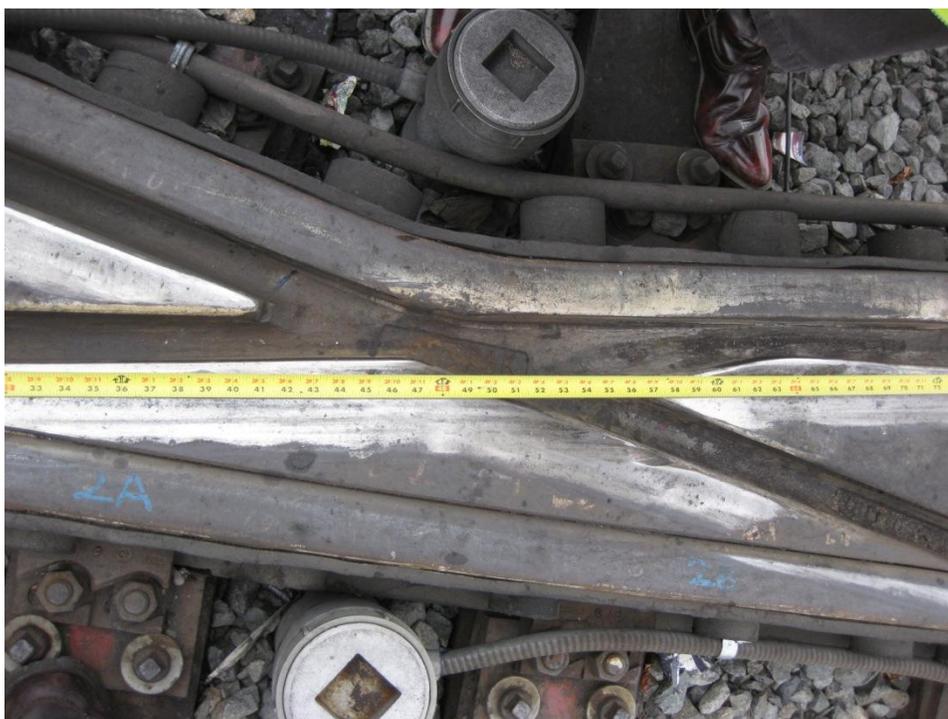
Figure 8: “Blip” and Ramp on D2

As noted previously, there is a transition ramp welded onto the center frog of the diamond just ahead of the “Blip” that aids in moving the wheel flange onto the Blip without causing a large impact (see Figures 8 and 9). However, this is for Southbound movement of trains, there is no ramp for trains operating in the reverse (northbound) direction.

Also, as can be seen in Figure 8, there is a small section of the flangeway opposite the “Blip” that has been either ground off or worn away that allows the wheel flange to move over when making contact with the “Blip”. Observation of train movements through the junction showed very little impact noise generated at the blip when trains are operating at speeds less than 10 mph.

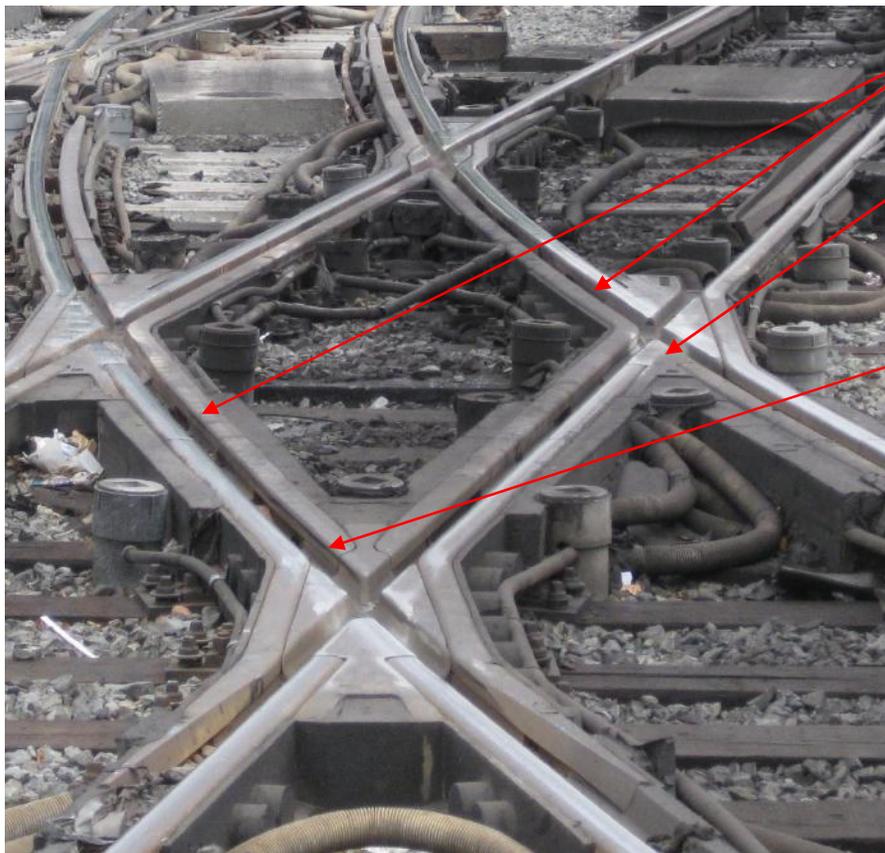
Figure 10: Movement through D4 Frog

The cause of the initial problem (flange strikes on D4 frog), appears to be the result of wide gauge through the diamond. With the maximum guard face gauge being 53.125 inches and the minimum wheel back-to-back being 53.094 inches, the back of the wheels are contacting both flangeway guard rails simultaneously. As a wheel approaches the D4 frog, it is aimed directly at the ½ inch point (see Figure 10).

It was noted that from observations and measurements taken in the field, that the existing diamond was manufactured in accordance with design specifications. In addition, the diamond was installed correctly for alignment, surface and crosslevel and does not appear to have been modified during installation. All problems associated with the D4 Frog being damaged by passing wheels are the direct result of an inappropriate diamond design that was not in compliance with AREMA Specifications.

NOTE: With wheels pinching both flangeway guard rails, frog D4 must be struck by passing wheel sets. By observation, both flangeway guard rails are being worn by passing back of flanges.
