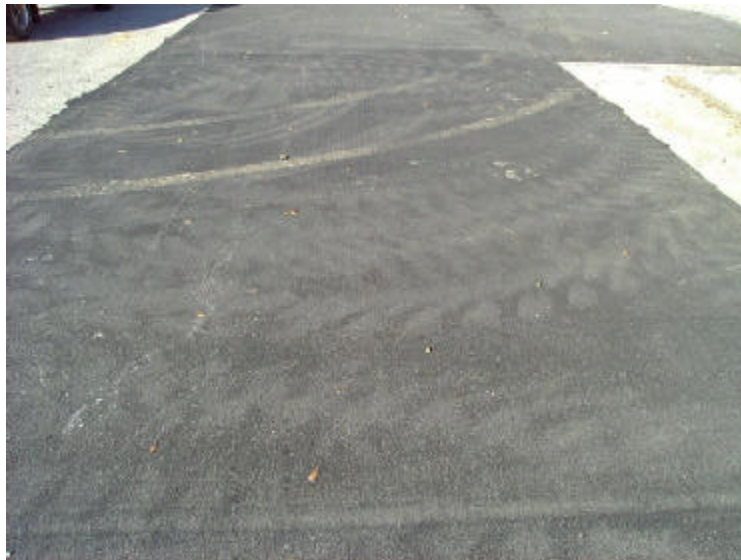
Figure 3. PCMO surface in October 2012. Some scuffing of the surface from the tank testing in August 2008 is apparent.

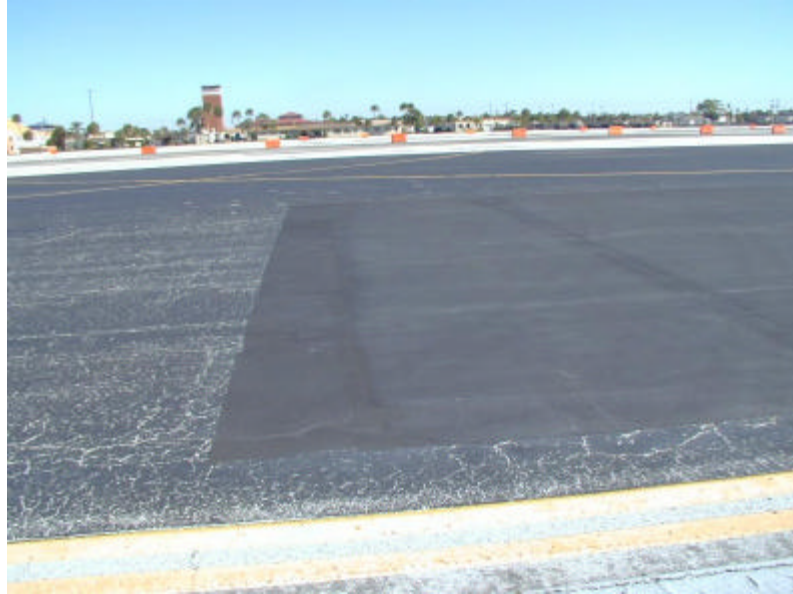
Figure 4. PCMO surface in October 2012 at MacDill AFB. The adjacent pavement is coal tar that is approximately 14 years old and is severely deteriorated.

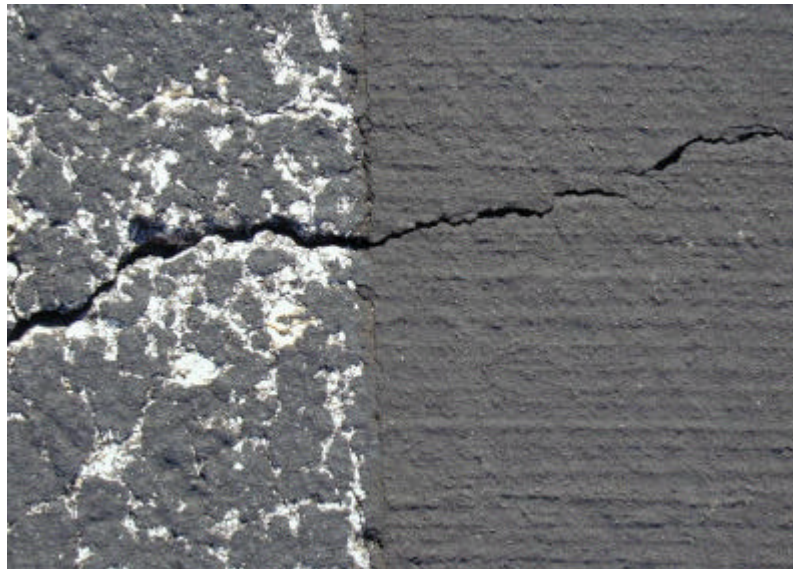
Figure 5. PCMO section at MacDill AFB showing reflective cracking. Note that the crack has not widened or displayed any raveling from the crack face.

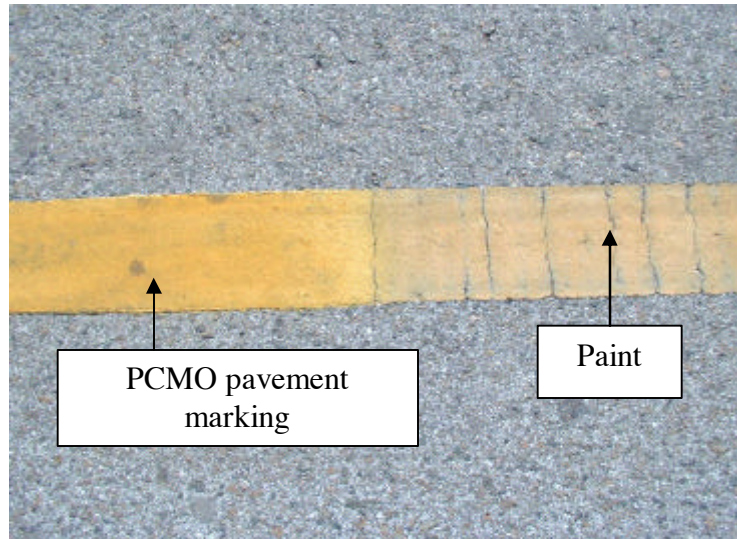
Figure 6. PCMO pavement marking line at MacDill AFB in October 2012 after 4 full years in service. Note the transverse cracking in the conventional airfield pavement marking paint. The marking paint is approximately 3 years old in this picture.

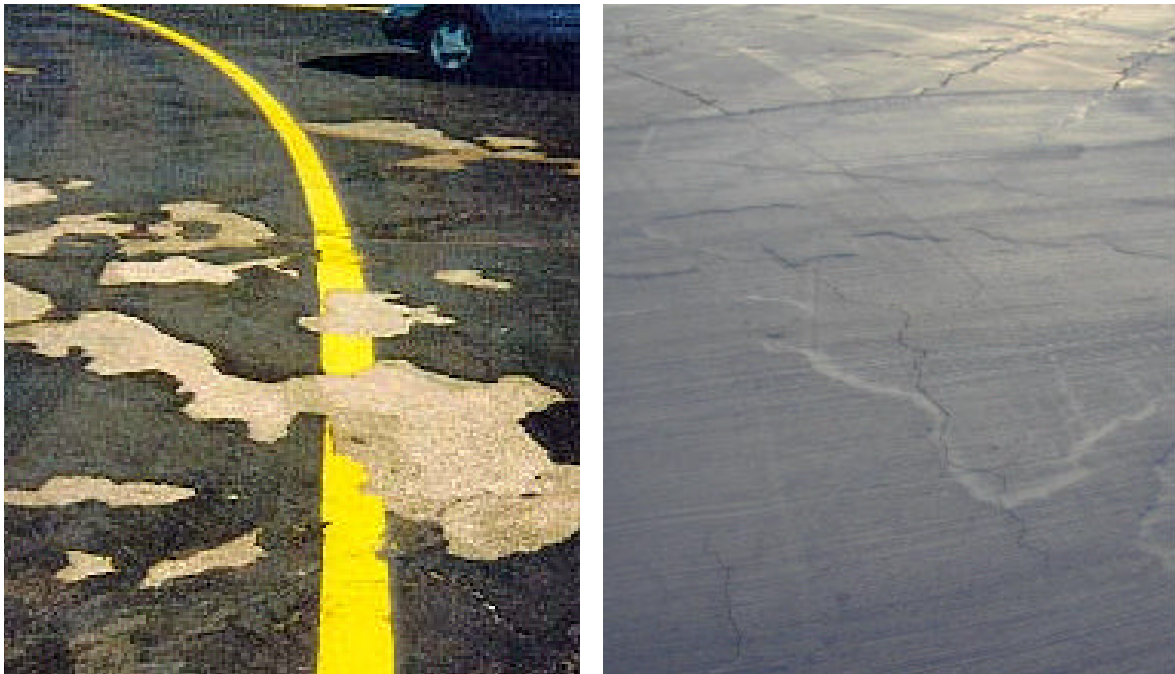
Section 2 was a small area placed over severely delaminating coal tar. The purpose was to determine if the PCMO was able to encapsulate the existing coal tar. It appears to have accomplished this by preventing further adhesion loss of the coal tar from the asphalt (Figure 7).

Figure 7. “Delaminated coal tar area before (2008) and after sealing with PCMO (2012) at Forbes Field, Topeka, KS.
