Roberts Hi-Tech Home Inspections, PLLC

Confidential Home Inspection Report - New Build Construction - SAMPLE REPORT

Spring Branch , TX, 78070

Date: November 15, 2018

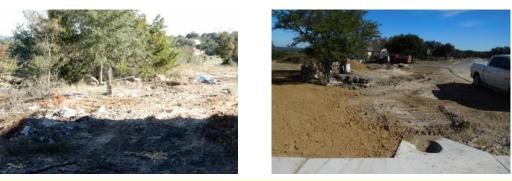
☑ All areas of yard appear to have positive drainage at this time which allows water to drain toward street.

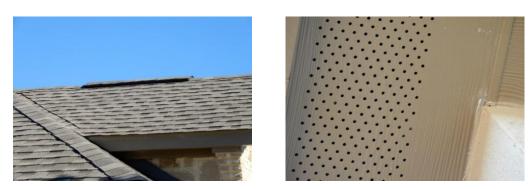
☑ Attic ventilation appears to be in satisfactory condition and functioning as intended. No deficiencies observed at this time.

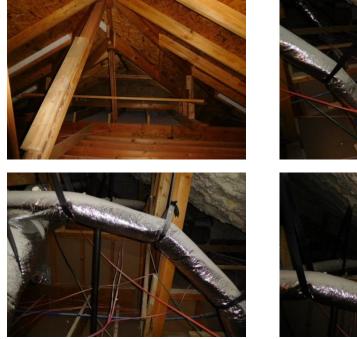
Attic structure appears to be in good overall condition and functioning as intended. No deficiencies observed at this time.

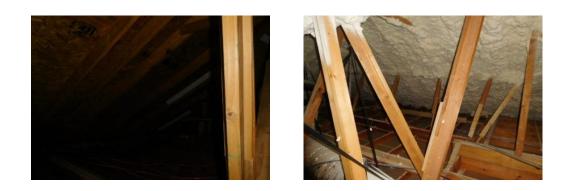
Attic Work Area

☑ Attic work area consists of plywood completely around HVAC system, Very adequate and in satisfactory condition. No deficiencies observed at this time. Work area and HVAC system located behind door in attic.

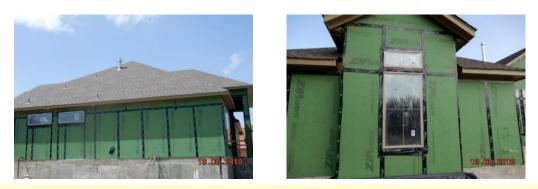
Exterior cladding (stone, EIFS, concrete fiber board, etc.) completely installed, in good overall condition and functioning as intended. No deficiencies observed at this time. Exceptions noted below. Patio column has a hole in EIFS. Should be repaired.

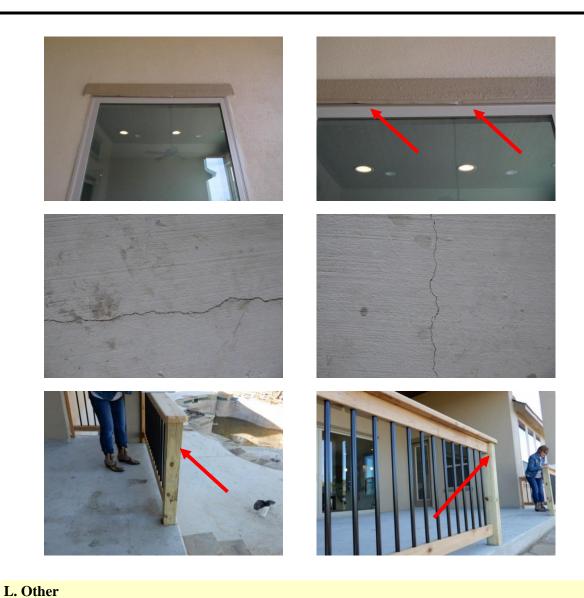
- Flashing / drip edge over window on back patio window bent. Repair or replacement needed. Builder aware and committed to resolving issue.
- Hairline cracks observed in cement flooring of back patio. Monitor and if cracks expand, fill in and seal as needed.
- Railing on back patio not secured. Repairs needed. Builder aware and $\overline{}$ indicated he was waiting on pool company to install their railings before he could secure patio railings.

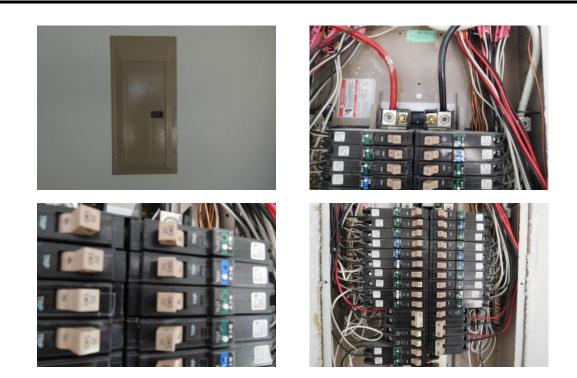
Grounding system properly grounded and bonded to gas pipe on east side of exterior. Appears to be in satisfactory condition. No deficiencies observed at this time.

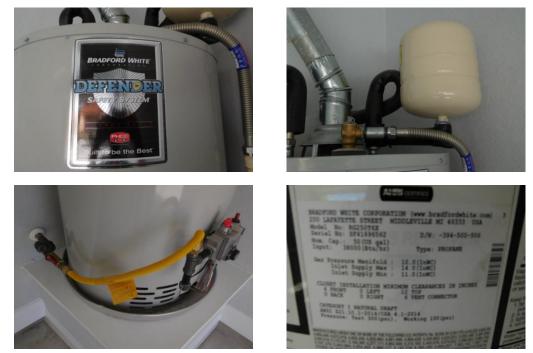
Water heater is located in garage. Is properly installed, elevated, with water pan, and properly vented to exterior of garage. Expansion tank present. TPR Valve present on water heater but not tested for safety reasons. In good overall condition. No deficiencies observed at this time.
