CLEARWATER HYDROLOGY

Dec. 18, 2021

RE: Technical memorandum on hydrologic and engineering assessment and CEQA documentation review- Head Royce School Planned Unit Development Permit Project, Oakland CA

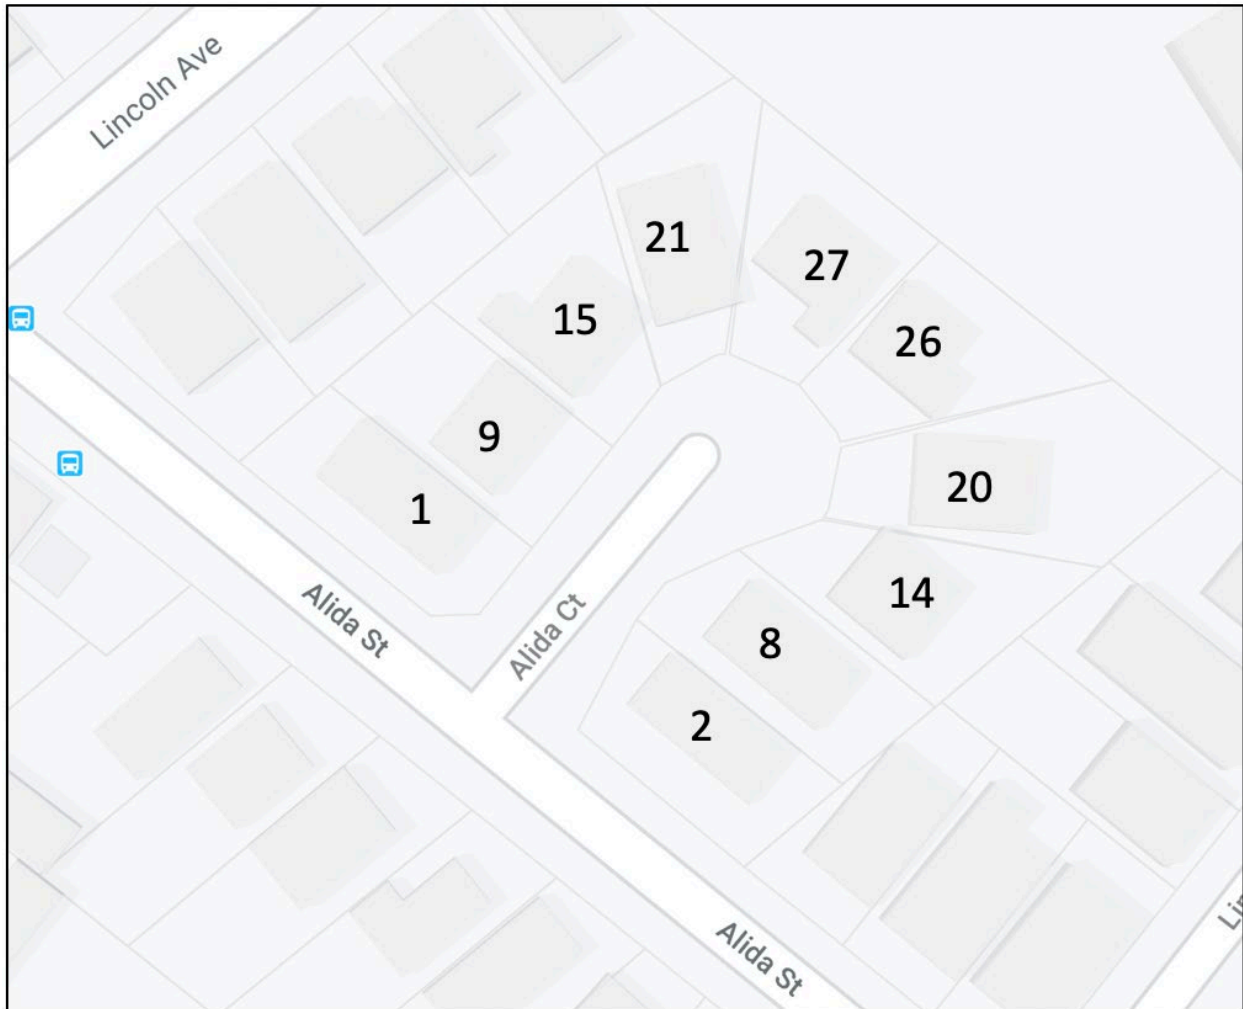
Alida Court Map and Summary of Water Issues from Uphill

Randy & Lori Morris 1 Alida Court
Think they installed drainage a long time ago and have no active issues – checking with homeowner.

Marie Coronfly 9 Alida Court
Installed sump pump in last few years, checking with homeowner for details.

Steve Lewis & Christine Palmer 15 Alida Court
Think previous owner installed drainage a long time ago and have no active issues – checking with homeowner.

Anne Purcell 21 Alida Court

History of minor basement water intrusion during rainy season that we soak up with towels daily. Installed drainage in yard behind basement to mitigate. Continued to have minor problem through last winter and have been contemplating sump pump. No leaking this year so far. (We've only gotten about 6 of average 21 inches of rain so far this season, but since we bought house in 2012, there has been some leaking after the first series of storms until this winter.)

Veronica Riedel 27 Alida Court

History of similar runoff from campus as 26 Alida Court issues (see below). Believe no active issues. House is not owner occupied – checking with owner to confirm status.

Judy Sigars 26 Alida Court

History of significant water runoff from campus behind house, that sluices down toward house and front of property. Initially, communications with Lincoln Child Center were initiated prior to July, 2013 following an incidence of a broken water pipe on the LLC property causing damage to recent landscaping on my property. The gravel and sandbags that were installed to remediate the problem proved insufficient during the heavy rains the following year. Large piles of gravel were pushed through my fence and deposited in my yard causing destruction to plants. Eventually, under HRS ownership and management, a “channel” and fence were built on the HRS property to divert the water with no further incidence.

Gayle Miller 20 Alida Court

History of significant water runoff from campus behind house, believe no current issues. Confirming details.

Kathy Simon 14 Alida Court

Current owner has not had any issues.

Nina Floro & Roger Walker (8 Alida Ct.)

We rarely have any water intrusion in our home. On the rare occasion that it does happen, it occurs in our sub-area during usual, sustained, extremely heavy rains. I believe the water that comes into the subarea is excess storm water that runs from our eastern side yard (the side where Kathy's house is) into a drainpipe that leads to a sump pump system that was installed in our subarea by the previous owners. The sump pump then diverts the little amount of water there is to our back yard. We also took precautions to put sandbags around the sump pump in case the system should ever fail for any reason (power, malfunction, etc.). We have not had any drainage issues or problems with water entering from the subarea of home; our subarea tends to remain relatively dry, despite heavy rains.
