Lower Waterford Congregational Church Adaptive Re-Use Study

September 22, 2020

Structural Conditions Assessment- Lower Waterford Church
September 1, 2020

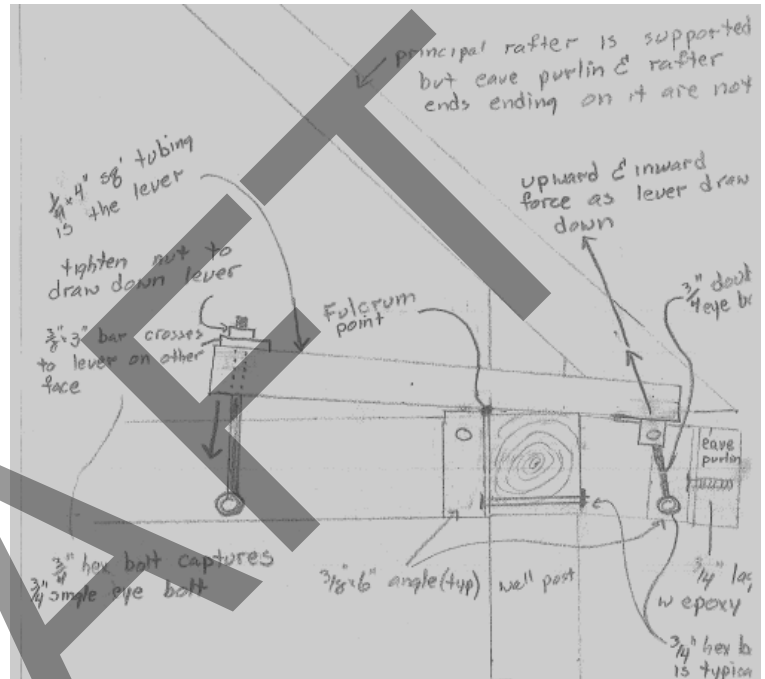
SECTION AT EAVE- SOUTHGATE CONSTRUCTION

There is an eave purlin that spans between trusses that is 1 to 2 feet outside of the exterior wall. This purlin supports the low end of the rafters. In about 2010, a major repair of the eave purlin to truss connection was made. The truss had apparently broken at the cantilevered section. A steel brace detail was designed and installed by Southgate Steeple Jacks. The contractor's sketch appears to generally match what was installed and appears to have functioned adequately (at right).

The remainder of the roof framing and trusses appear in very good condition without substantial deflection or deterioration. The 2010 renovations included adding a diagonal to the truss under the purlin- this substantially stabilizes the trusses. Access was made difficult by the limited walkways. Rafters and purlins appear to meet the requirements for reduced snow load due to sliding, although the main, interior purlins are marginally adequate.

- Monitor 2010 repairs at the eaves

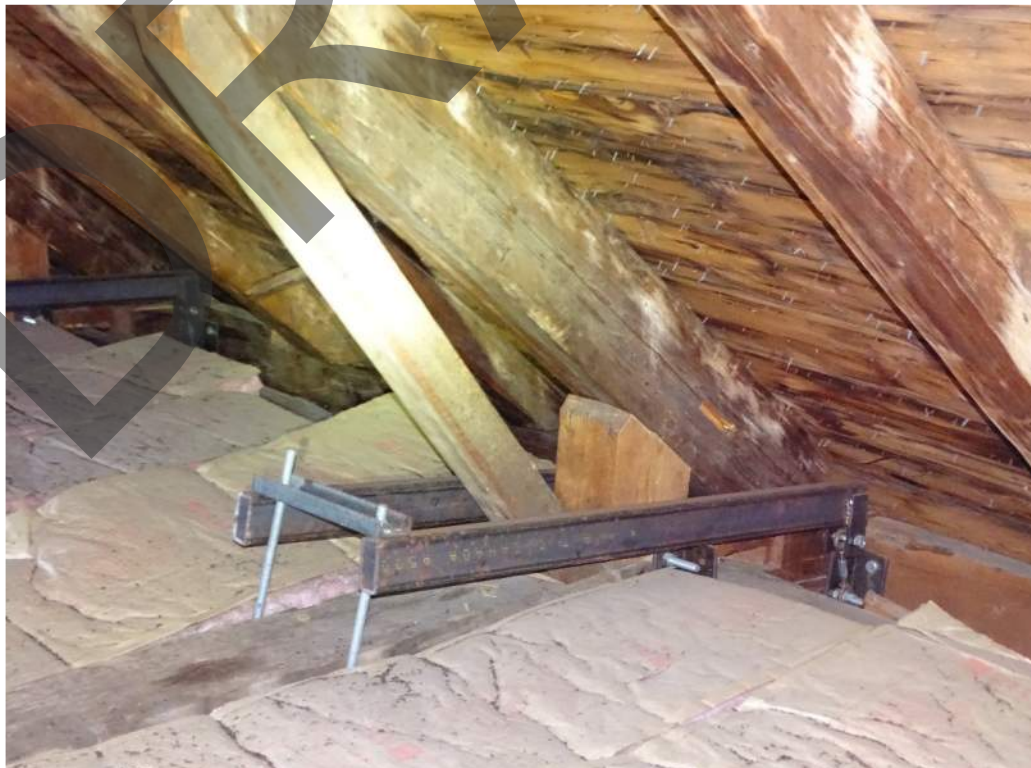
2010 EAVE REPAIR AT TRUSSES

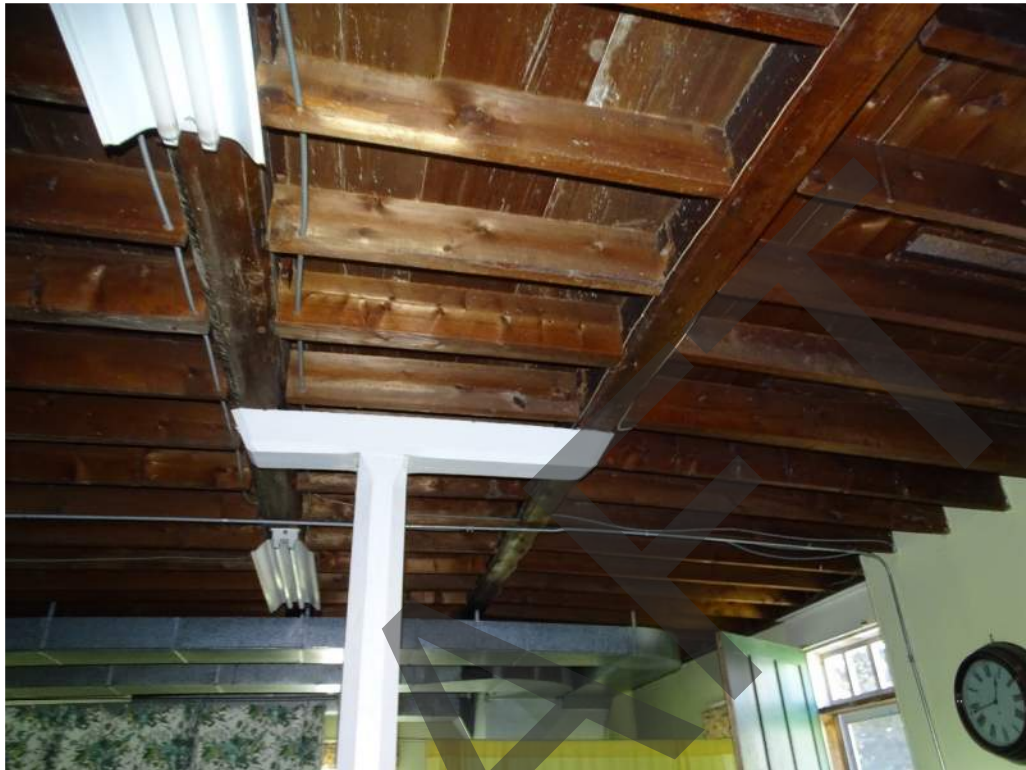
SANCTUARY FLOOR FRAMING

- The floor joists are generally adequate for 50 psf live load. Shorter spans (less than 8 feet) would be suitable for 100 psf live load.
- The joists are notched at their ends and should be reinforced to obtain capacities noted above.
- The beams range in capacity from about 35 psf to over 100 psf.
- There is a unique condition where a pair of beams is supported on one column with a short beam to connect the two. The short support beams should be reinforced.
- The wood columns to the north are smaller than the others and should be reinforced.

- Improve sanctuary floor framing to the 50 psf level as noted on the attached sketches.
- Further evaluate roof framing and likely improve connections and reinforce interior purlin. This would be required if insulation is to be added to the roof.

- Reinforce or replace substandard columns.
- Reinforce notched joists at sanctuary floor.

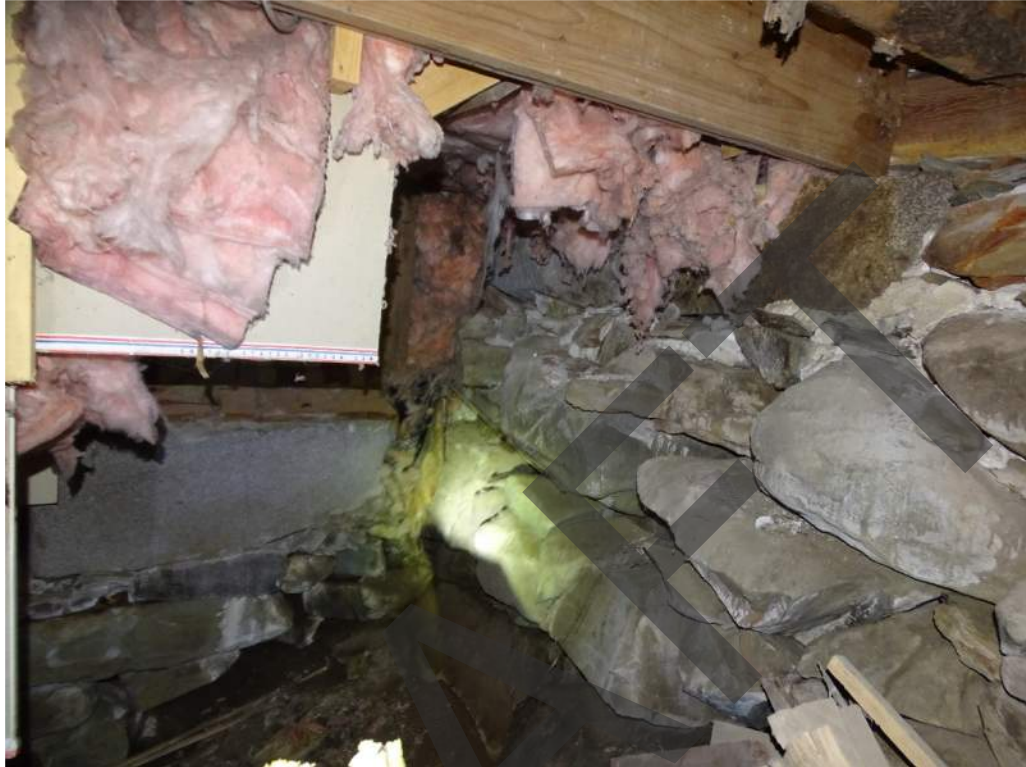
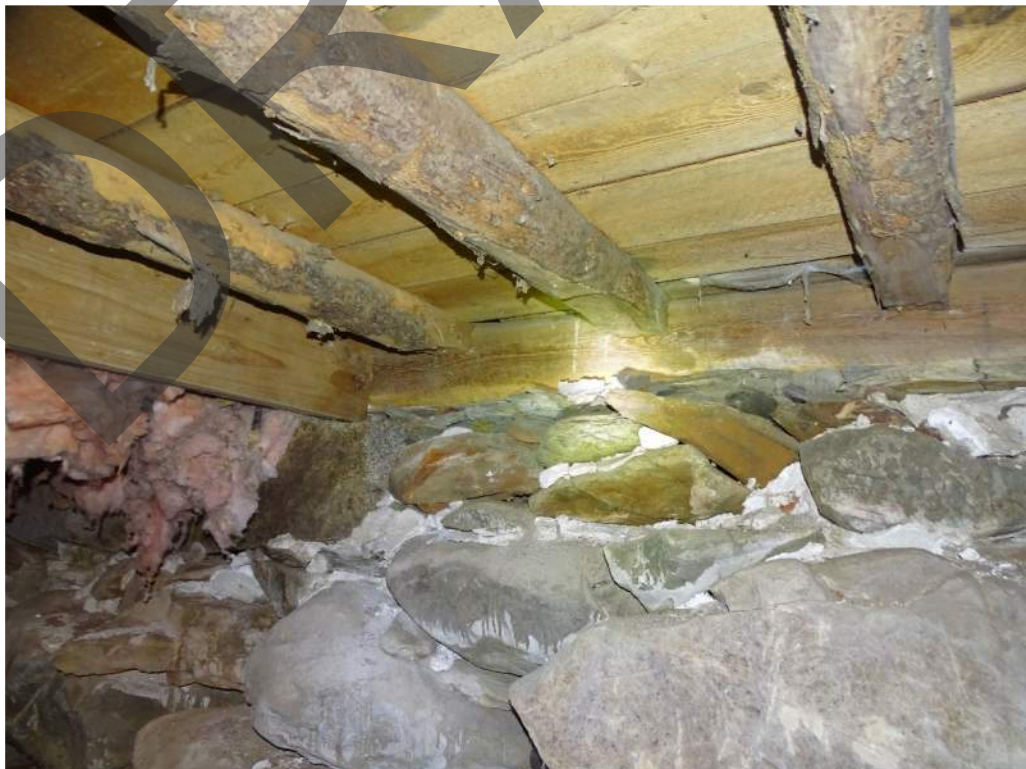
The foundation is mostly loose laid stone. The interior piers are loose rock piles. There is a dirt floor in a shallow crawl space. A loose-laid stone (no mortar) retaining wall at the road/north side holds back the soil and is in poor condition. This wall will require attention within the next 5 years.

- The north wall retaining soil is in poor condition and should be reinforced or replaced. Since the north section may be desirable as additional lower floor space, the foundation should be considered for replacement allowing the floor at the north lower level to be lowered to match the rest of the lower floor.

NORTH BASEMENT - SANCTUARY ENTRY FRAMING AND FAILING RETAINING WALL

- Repair or replace the north foundation wall within 5 years.
- Repair or replace basement piers & add vapor barrier or other moisture mitigation measures
- Regularly monitor roof framing and maintain.

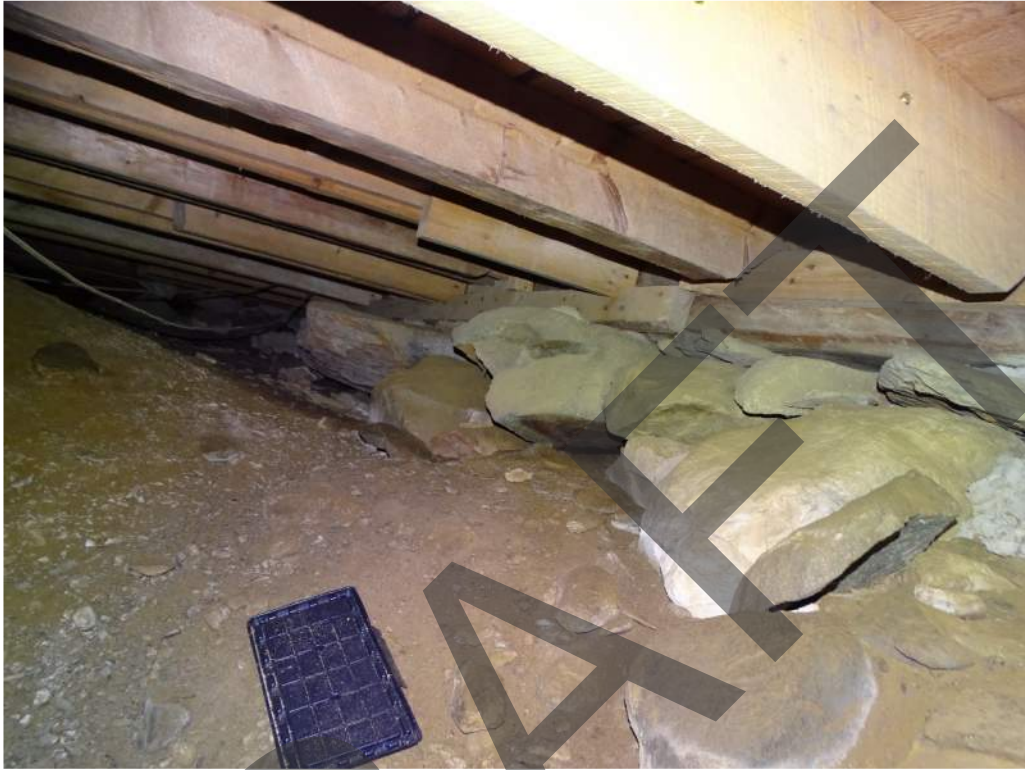
- The stone piers are in poor condition and are susceptible to collapse. These should be considered for replacement.
- The exterior foundation is loose laid stone in fair to poor condition and should be considered for substantial repair or replacement. This will facilitate long-term use and insulation/air sealing.

LOWER FLOOR FRAMING AND FAILING FOUNDATIONS

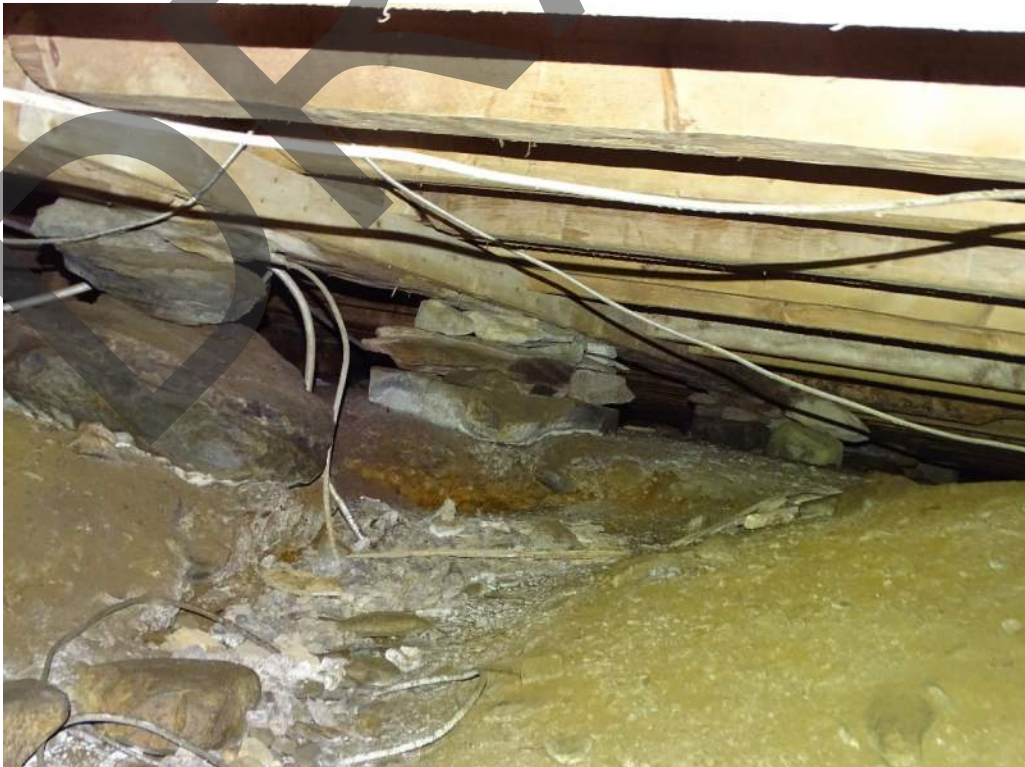
LOWER FLOOR FRAMING AND FAILING PIERS

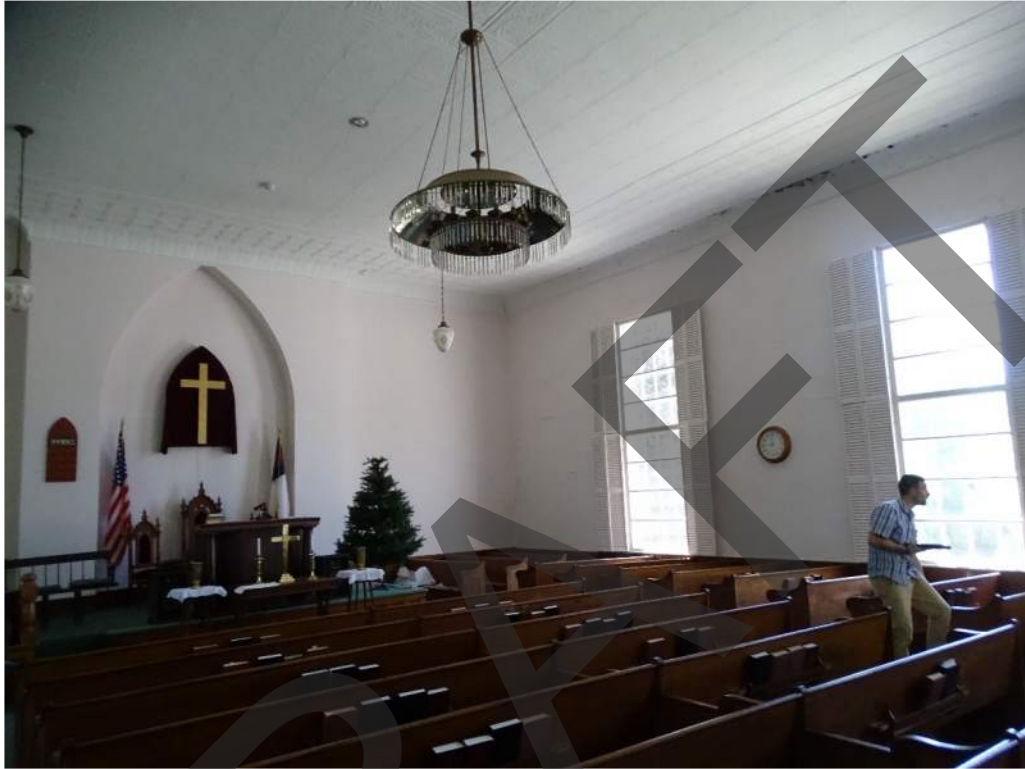
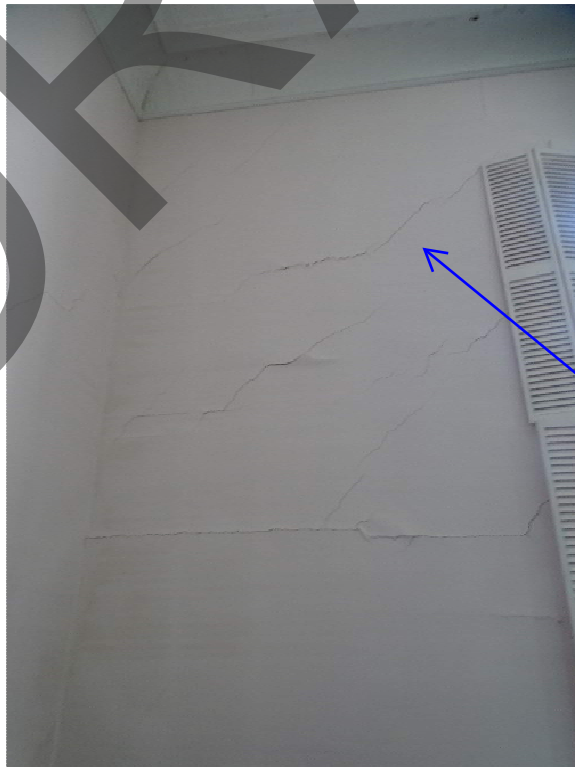
CRACKING OF PLASTER
LIKELY DUE TO
SETTLEMENT OF
FOUNDATIONS

- d) Repair cracked/damaged plaster and paint all existing walls and trim to remain.
 - e) Provide hollow metal frames and solid core doors at new interior door locations and insulated metal frame and door at new exit door location.
