**Wood Condition Assessment of the
Petaluma Trestle, Petaluma, California**

GHD, Inc.
2300 Clayton Road, Suite 920
Concord, CA 94520

Porter & Associates
P.O. Box 3002
Burlington, VT 05408

July 14, 2023

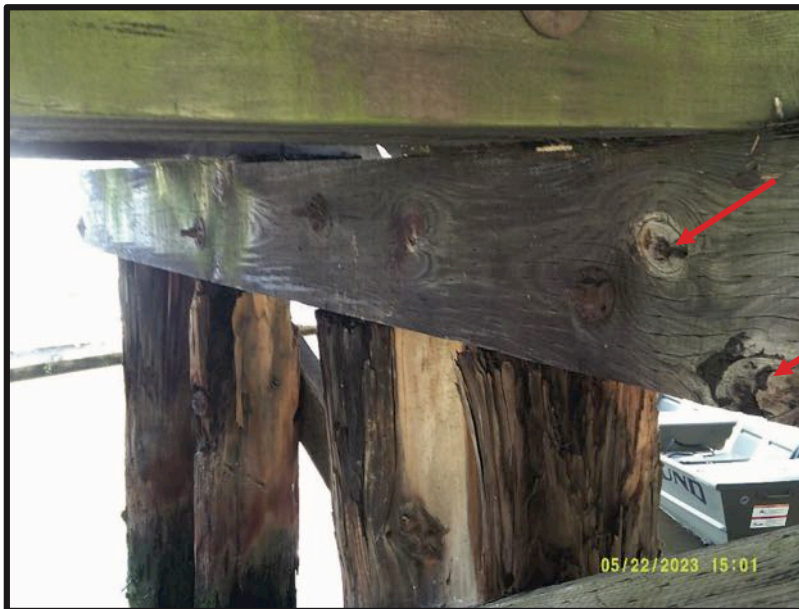
Figure 6. The size and location of the knots on the timber (shown by the arrows) were used to determine the structural grade of this pile cap.

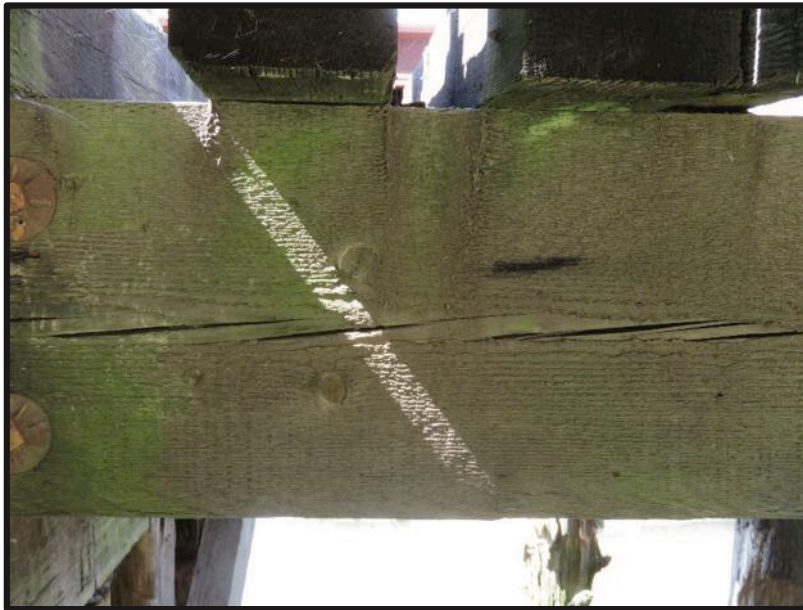
Figure 7. Slope of grain, as indicated by the angle of the seasoning checks, was used to determine the structural grade of this stringer. Seasoning checks are a natural characteristic of lumber and timber and do not affect the strength of the member.

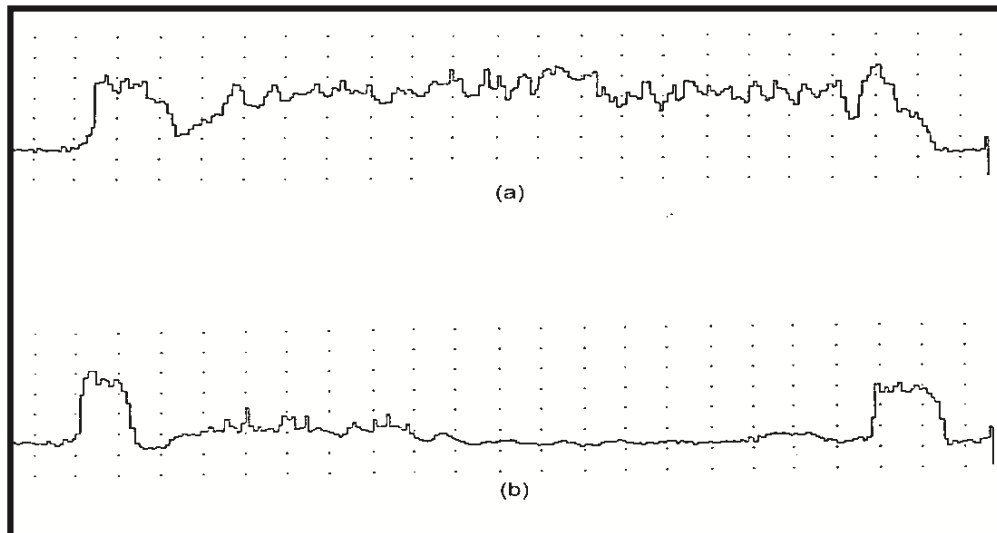
Figure 10. Typical resistance drilling results showing (a) solid wood and b) wood with solid shells on the exterior with internal decay (but not a void) that reduces the effective cross section.

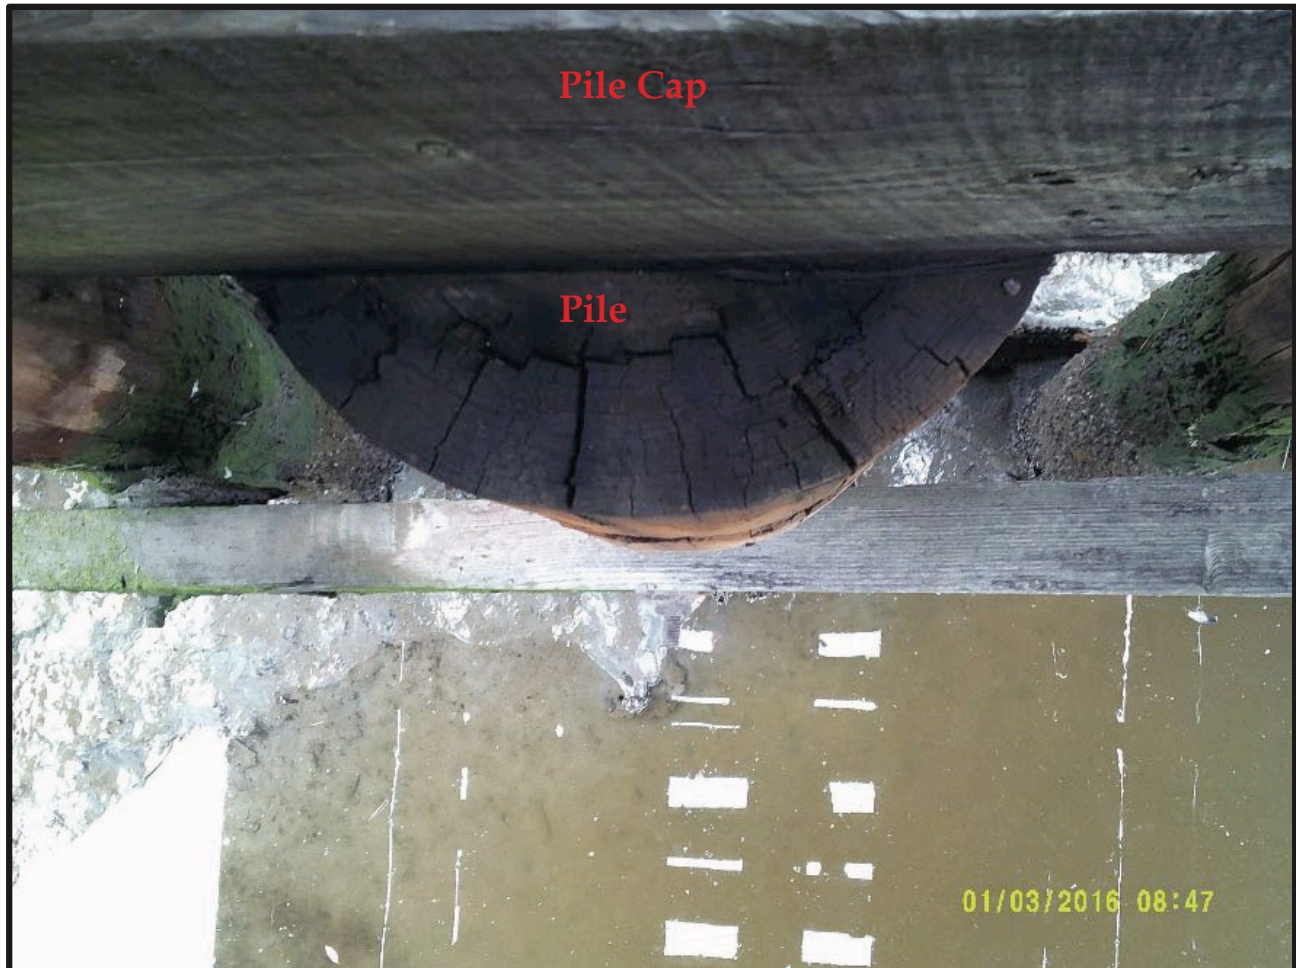
Figure 11. Where the tops of piles are not completely protected by the pile caps, they are susceptible to weather and subsequent wood decay, as viewed from above. The inspection included resistance drilling of a representative sample across the diameter within a few inches of the top surface to detect decay voids.

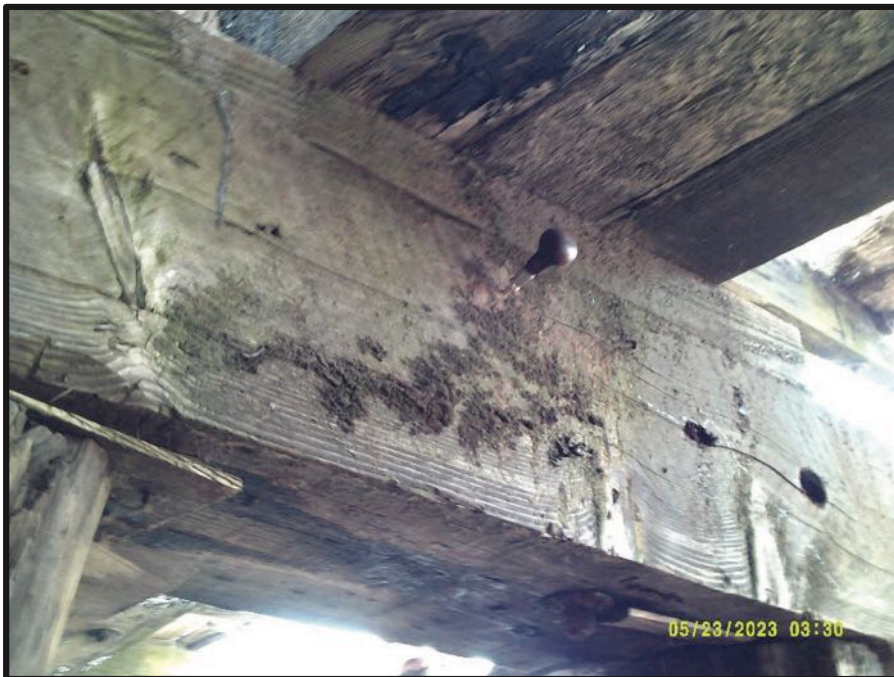
Figure 13. Of the 35 pile caps we were able to inspect, we found nine that effectively have no surviving cross section in at least one location along the length and likely require replacement in kind, pending engineering review of wood assessment findings.

7. The condition of the pile caps is, generally, poor-to-excellent, with deterioration due to wood decay, with the most severe loss of section generally below a stringer, sometimes resulting in a shell and no sound wood on the interior. Of the 35 pile caps we were able to inspect, we found nine that effectively have no surviving cross section in at least one location along the length and possibly require replacement in kind, pending engineering review of wood assessment findings.

1. Subject to engineering requirements, most of the pile caps can likely remain in service. Some reinforcement or replacement of those with large voids may be necessary.

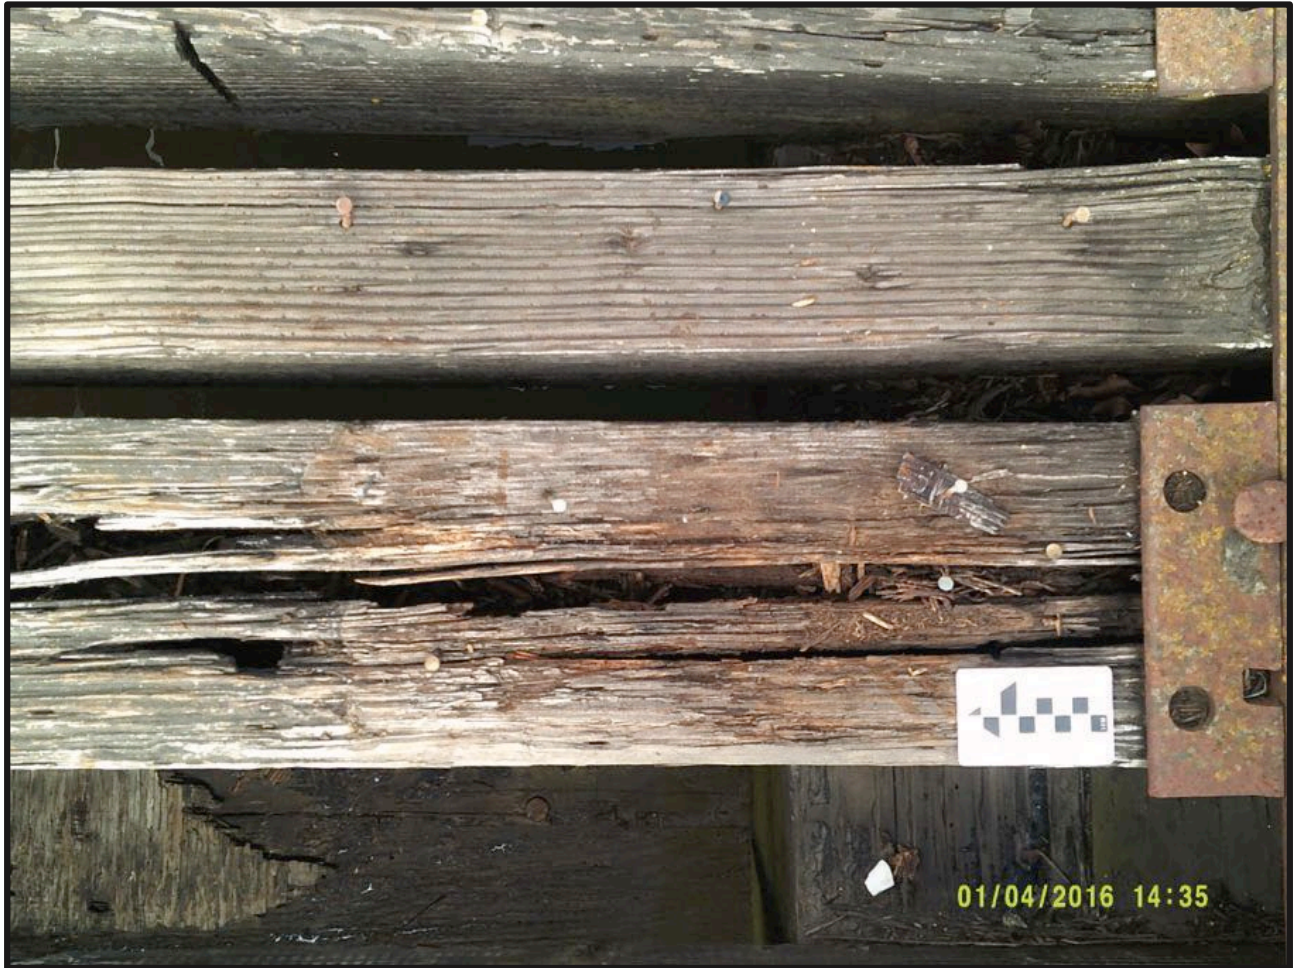
Figure 14. Approximately 23% of the ties have large internal decay voids, many of them accompanied by prominent drying checks on the top surface, along with holes left by spikes that seem to have accompanied an old switch. If left exposed to the elements, the large checks and holes provide a means of water ingress that can lead to additional decay.

9. The condition of the ties making up the decking is, generally, poor-to-good, meaning that some deterioration due to wood decay is present in some areas of the Trestle. Approximately 23% of the ties have large internal decay voids, many of them accompanied by prominent drying checks on the top surface, along with holes left by spikes that seem to have accompanied an old switch. If left exposed to the elements, these large checks and holes can fill with debris and provide a means of water ingress that can lead to additional decay.

4. Because of the close spacing of the ties, individual ties with minor deterioration can either be replaced or remain in service so long as remedial preservative treatment (such as borate rods⁴) is applied and the deck is covered with a

continuous wearing service. Individual ties with more severe deterioration could be replaced and groups of consecutive ties with severe deterioration should be replaced.

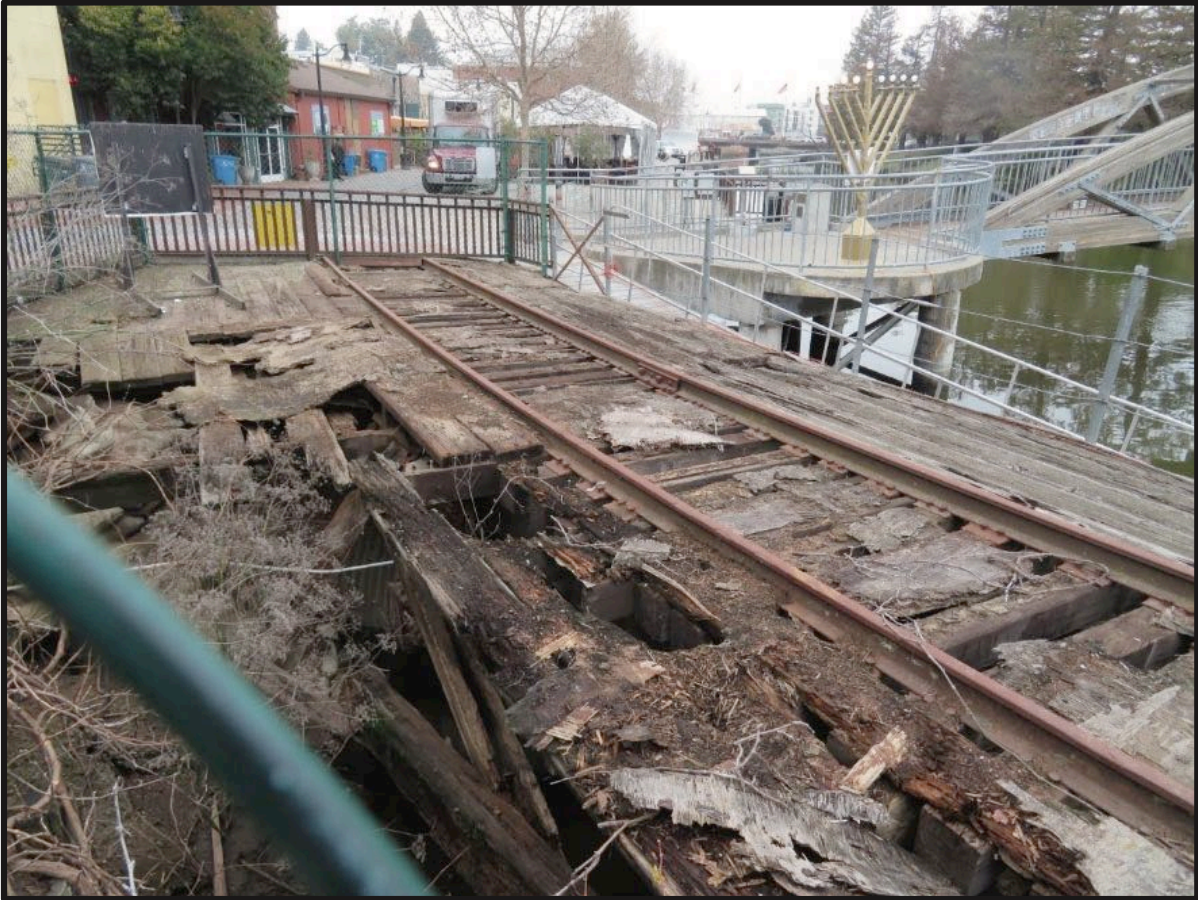
Figure 15. Much of the framing south of the rails is unsalvageable and will require replacement in any repair scenario.

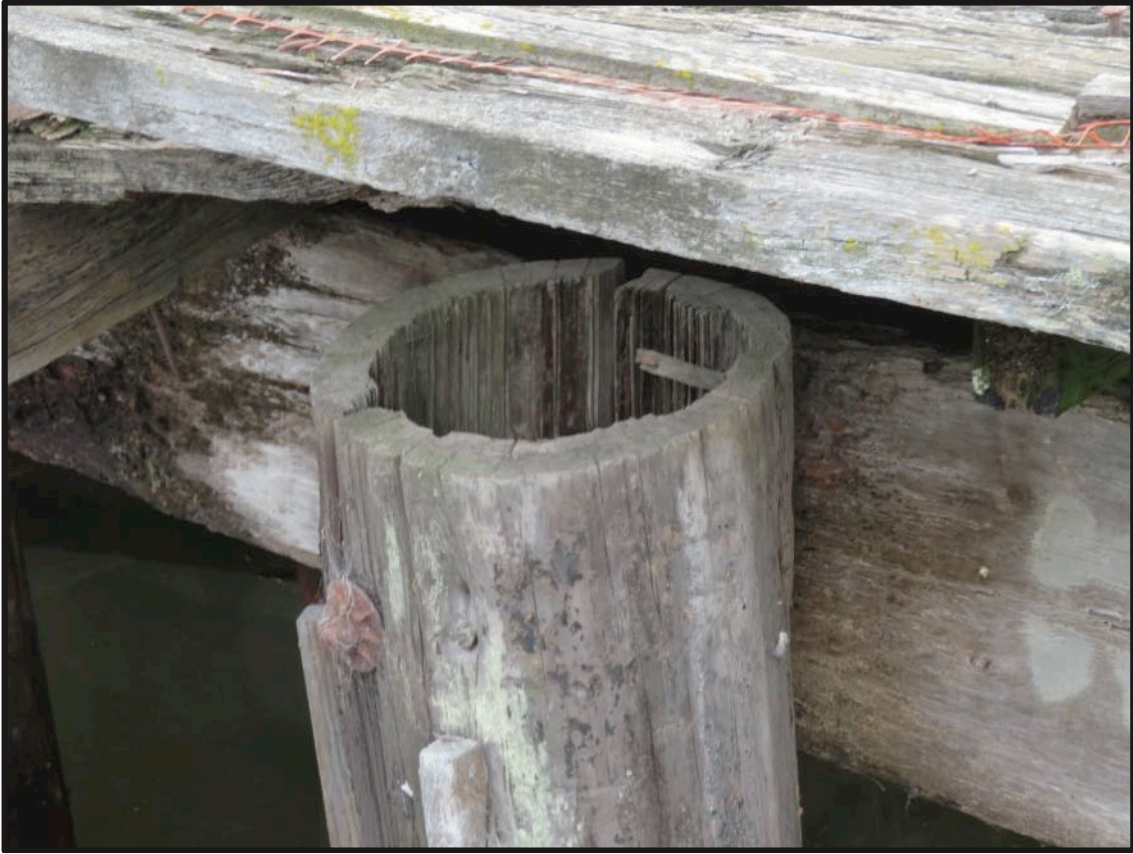
Figure 16. 'Stovepipe' condition in a fender pile; a condition where the wood on the pile interior has decayed, leaving only a shell, typically at the top of the pile. We encountered this condition in the piles that were subjected to resistance drilling in a single instance only.

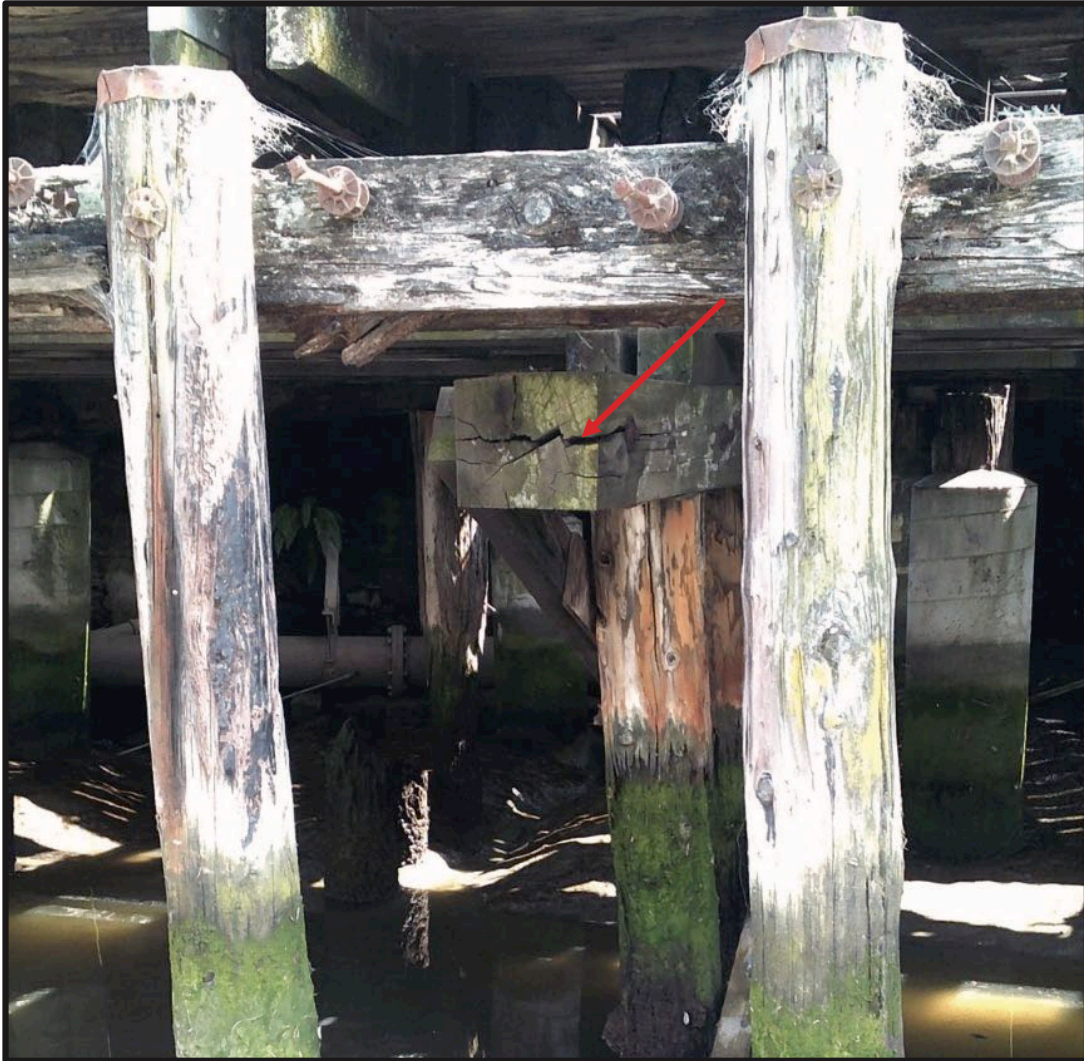
Figure 17. Arrow points to an end split in a pile cap focused on a bolted sway brace – pile cap connection (on the left, or east side, of the cap). The split effectively reduces connection capacity.

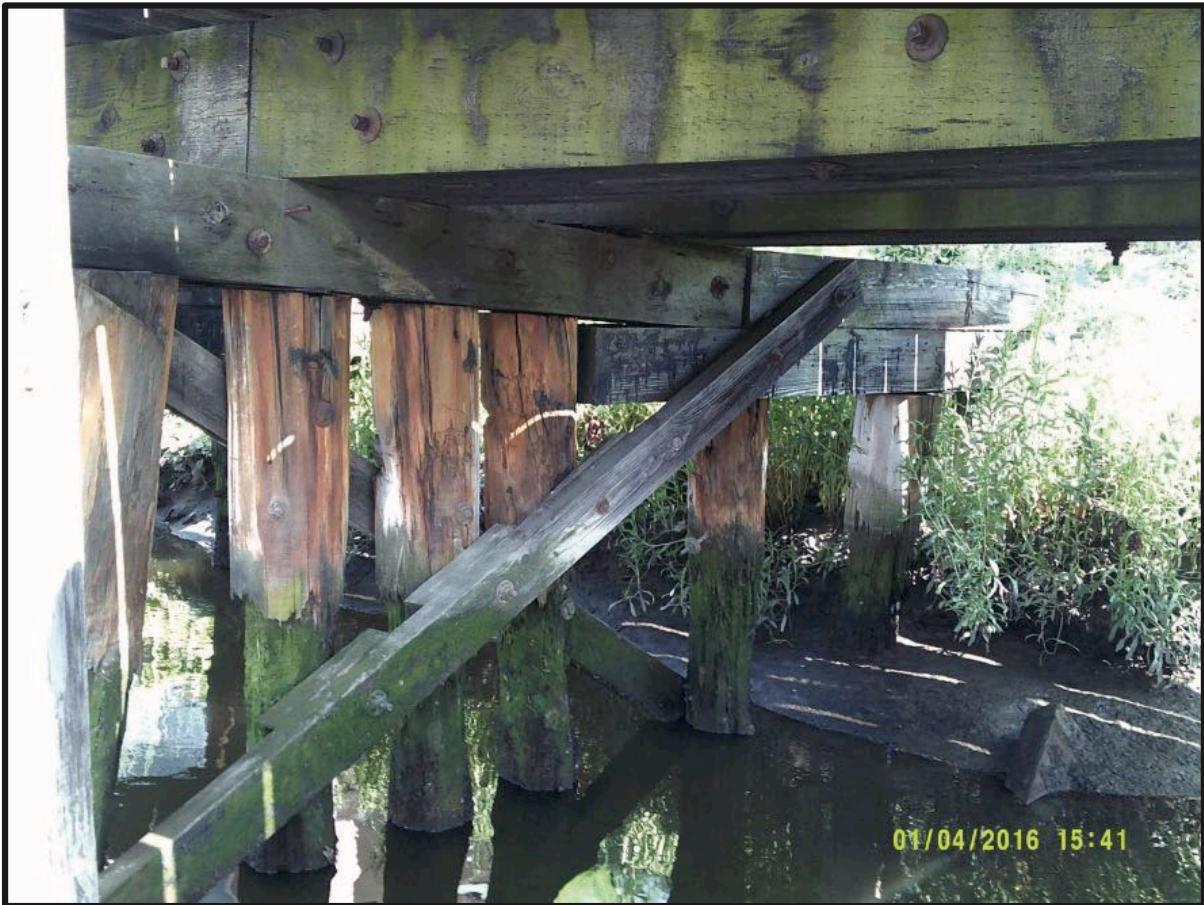
Figure 18. Many of the sway braces are of high-quality wood and are in serviceable condition as is. Should there be a need to repair or replace the piles, the sway braces should be replaced in-kind. Note the extension of the bent, perhaps to carry a switch and second set of rails.

11. Many of the sway braces are of high-quality wood and are in serviceable condition as is. Should there be a need to repair or replace the piles, the sway braces should be replaced in-kind.
12. Although not within the scope of the wood assessment, the outriggers and planks outboard of the rails are, generally, in poor condition, meaning that severe deterioration due to wood decay fungi and/or weathering has occurred in most of the members.
13. Moisture content readings taken primarily on the stringers and ties indicate that conditions at the time of the assessment were not favorable for active wood decay.

3. The sway braces will need to be replaced if the piles are repaired, in which case the replacement braces should be of Select Structural Douglas Fir – Larch Visually Graded Dimension Lumber.

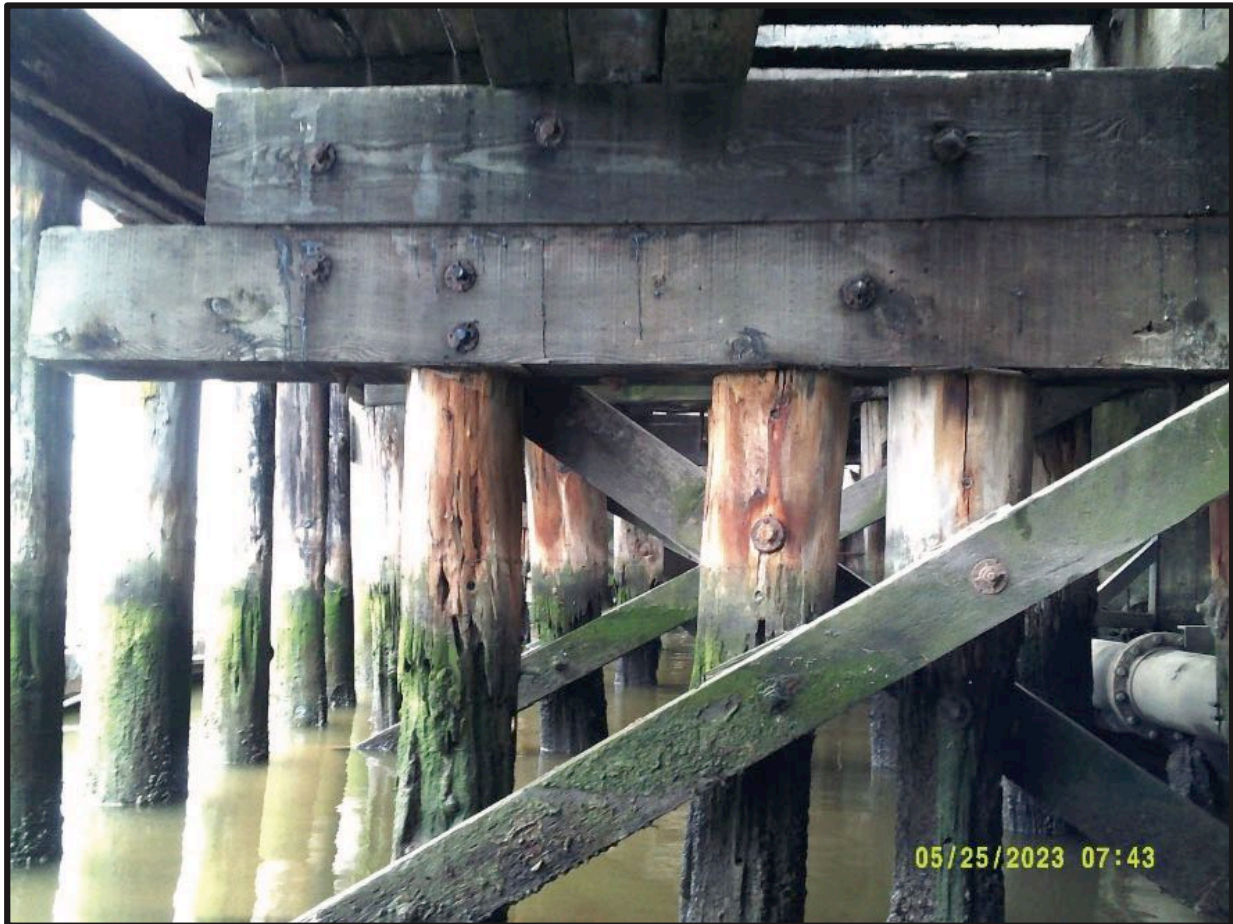
Figure 19. Some of the pile caps are doubled; note the necking down of some piles.
