December 14, 2021

**Re: Arborist Peer Review of the Head Royce School project, Oakland**

This report comprises an independent arborist opinion regarding the proposed Head Royce School (HRS) South Campus project at 4368 Lincoln Avenue. My scope of work involves reviewing the relevant tree-related documents to provide my opinion regarding their content and conclusions. I focused on the latest arborist report by H.T. Harvey & Associates, but also reviewed other documents where relevant. I was also asked to determine how many trees could be saved if a proposed amphitheater and a portion of the loop road were eliminated.

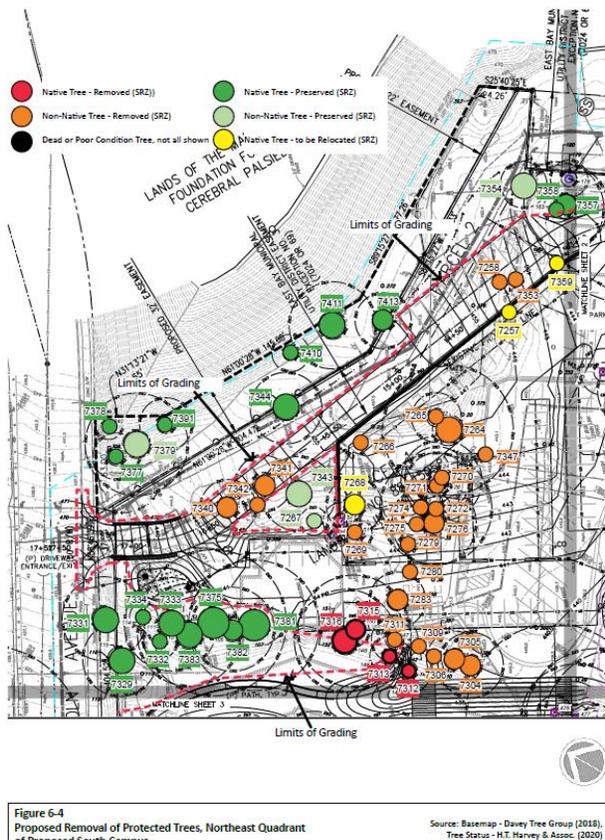
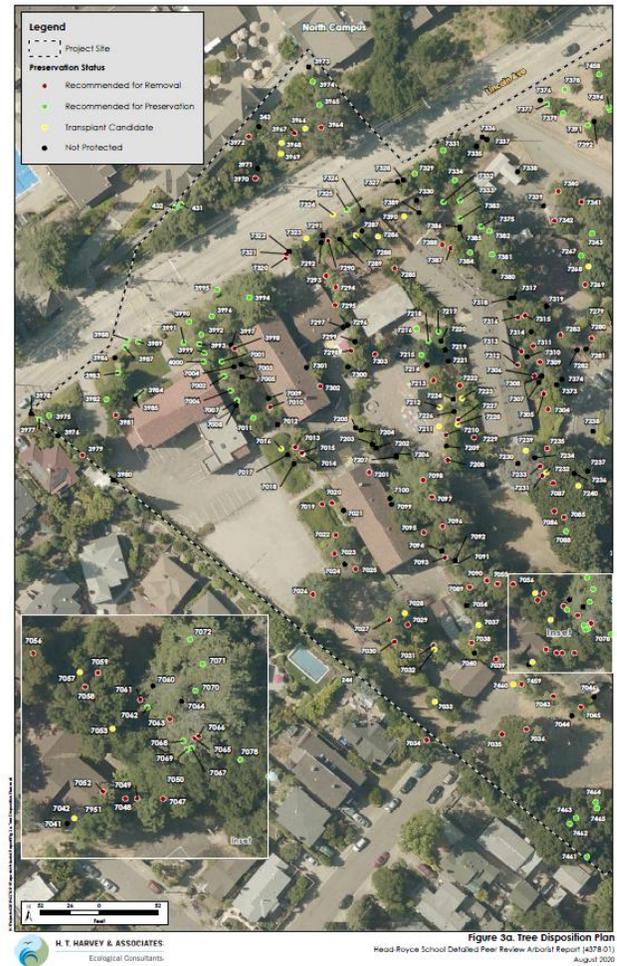
Figure 1. The Tree Disposition Plans in the DEIR Biological Resources chapter (left) display tree locations and recommendations on the proposed site plan, while the Tree Disposition Plans in the H.T. Harvey report only show existing conditions (right).

The DEIR BR chapter discusses the impact of the proposed project on protected trees, in accordance with the City of Oakland's Protected Trees Ordinance Chapter 12.36. Figures 6-4 to 6-8 in the chapter consist of tree disposition plans drawn over the proposed site plan (Figure 1, left); the site plan is based on a 2018 base map by DRG. These tree disposition plans are much more detailed – I was able to easily compare the locations of the trees to the proposed construction. By contrast, the H.T. Harvey tree disposition plans only show the tree locations on existing satellite imagery (Figure 1, right).

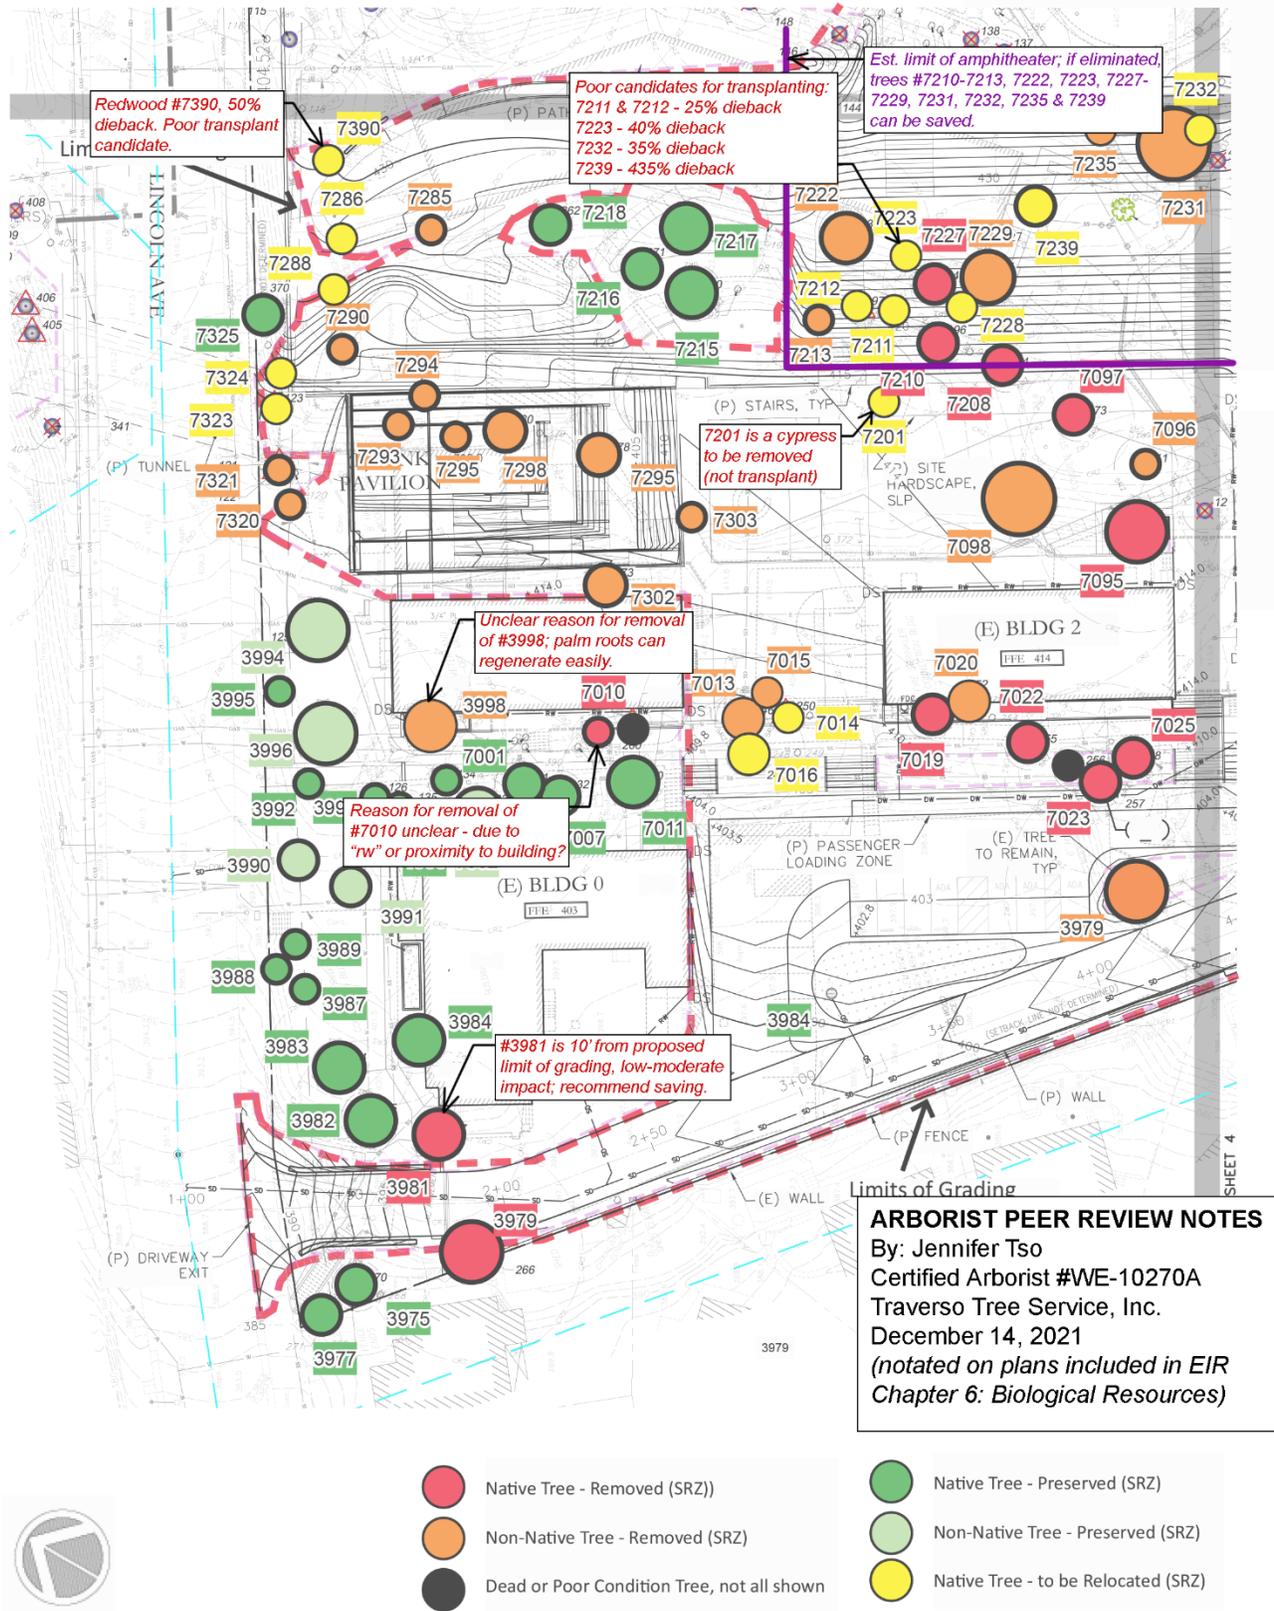
**Figure 6-6**  
**Disposition of Protected Trees, Northwest Quadrant of Proposed South Campus**  
 Source: Basemap - Davey Tree Group (2018), Tree Status - H.T. Harvey & Assoc. (2020)

Five plans are attached, which consist of my review notes drawn on the BR tree disposition plans. The limits of the amphitheater and loop road discussed above are also shown on the plans.
