**POLYMER CONCRETE MICRO-OVERLAY  
FOR FUEL AND ABRASION RESISTANT SURFACING:  
LABORATORY RESULTS AND FIELD DEMONSTRATIONS**

**By  
Kent Newman, PhD  
and  
James E. Shoenberger, PhD**

**US Army Engineer Research and Development Center  
Vicksburg, Mississippi, USA**

**PRESENTED FOR THE FEDERAL AVIATION ADMINISTRATION  
AIRPORT TECHNOLOGY TRANSFER CONFERENCE**

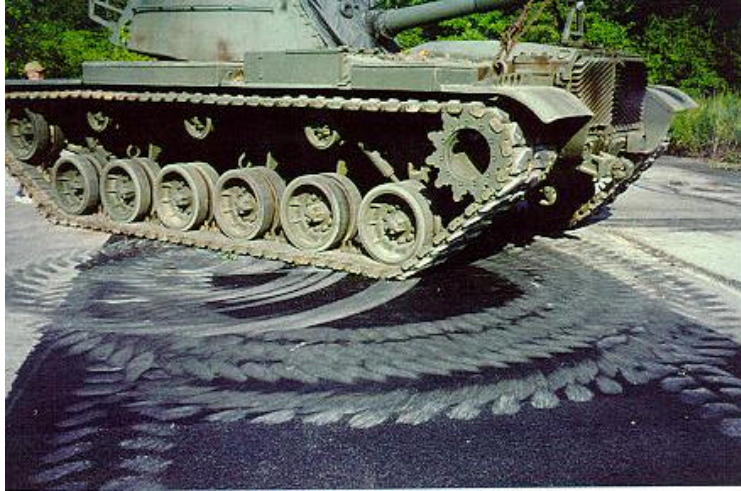
**Figure 2. 106,000 lb M-60 tank conducting pivot steers on PCMO surface at US Army ERDC.**

On Friday, August 28, 2008 an M-60 tank (approximately 106,000 lbs gross weight or 53 tons) was employed as a test vehicle (Figure 2). Tracked vehicles (with rubber pads) cause

significant raveling of aggregate particles from the surface of asphalt pavements while conducting “pivot steers”, in which the vehicle spins while remaining in one location.

Ten total pivot steers were conducted on the E-Krete PCMO surfaces with no delamination from the underlying asphalt. The damage to the PCMO surface was some scuffing of the surface in areas with a surface layer of broadcast sand. The sand had sheared loose from the surface and caused scuffing under the tank treads. No delamination of the PCMO was noted. The tank testing ended prematurely with the rupture of a fuel line on the tank spilling 2-3 gallons of diesel onto the PCMO surface. After 2 days, no residue of the fuel or staining of the E-Krete PCMO was apparent.

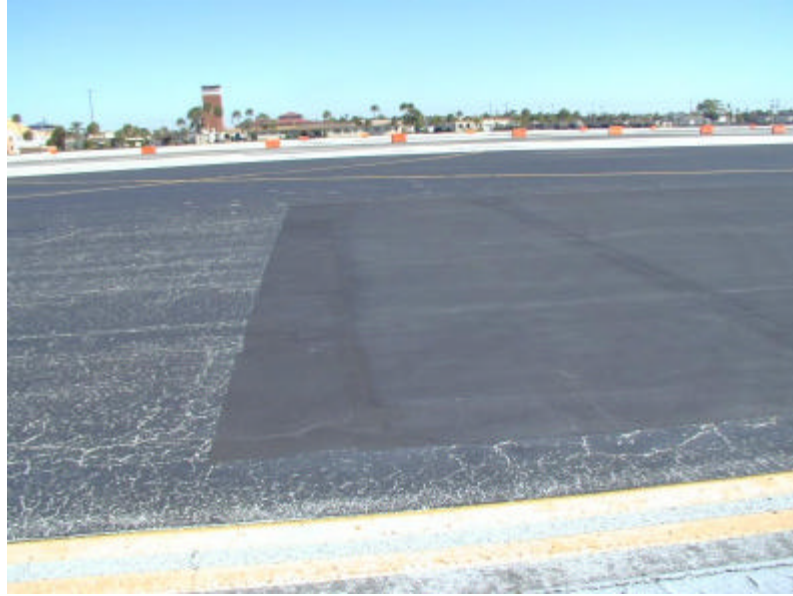
**Figure 4. PCMO surface in October 2012 at MacDill AFB. The adjacent pavement is coal tar that is approximately 14 years old and is severely deteriorated.**

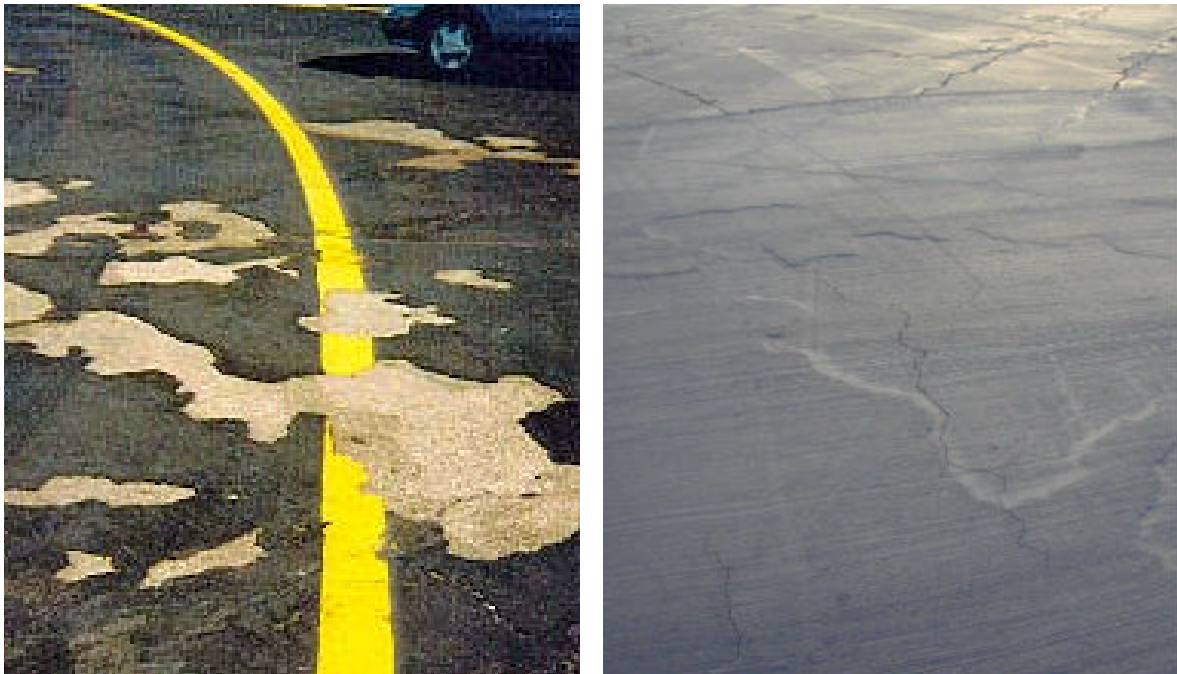
**Figure 7. “Delaminated coal tar area before (2008) and after sealing with PCMO (2012) at Forbes Field, Topeka, KS.**

Section 2 was a small area placed over severely delaminating coal tar. The purpose was to determine if the PCMO was able to encapsulate the existing coal tar. It appears to have accomplished this by preventing further adhesion loss of the coal tar from the asphalt (Figure 7).
