# Wetland Health Evaluation Program

# 2022 Wetland Health Evaluation Program Report

## Dakota County, MN

**January 2023**

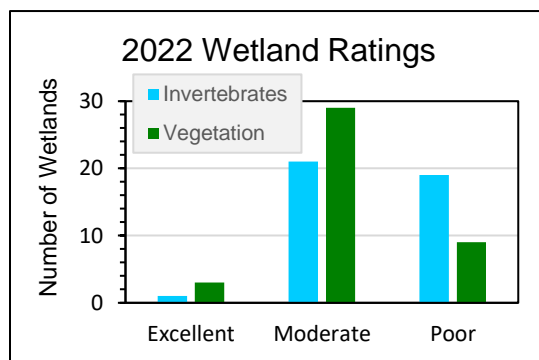
FIGURE 3.1.1 WETLAND RATINGS

Figure 3.1.1 and Table 3.1.1 show the invertebrate and vegetation ratings for all the wetlands assessed during the 2022 sampling season. Based on invertebrate scores, one of the wetlands rated excellent, 21 rated moderate and 19 rated poor. Invertebrate scores ranged from 8 to 24 out of a maximum of 30 points. Based on vegetation scores, 3 wetlands rated excellent, 29 rated moderate, and 9 rated poor. Vegetation scores ranged from 11 to 29 out of a maximum of 35 points.

Several of the sites showed different ratings for vegetation versus invertebrates. Eighteen of the wetlands showed agreeing ratings for vegetation versus invertebrates. Differing ratings per wetland may be the result of varying factors influencing the plant and invertebrate communities in each wetland. Possible factors affecting wetland quality are described in the next section. Each metric can achieve a score of 1, 3, or 5. Metric scores per wetland for the current year can be found at [www.mnwhep.org](http://www.mnwhep.org).

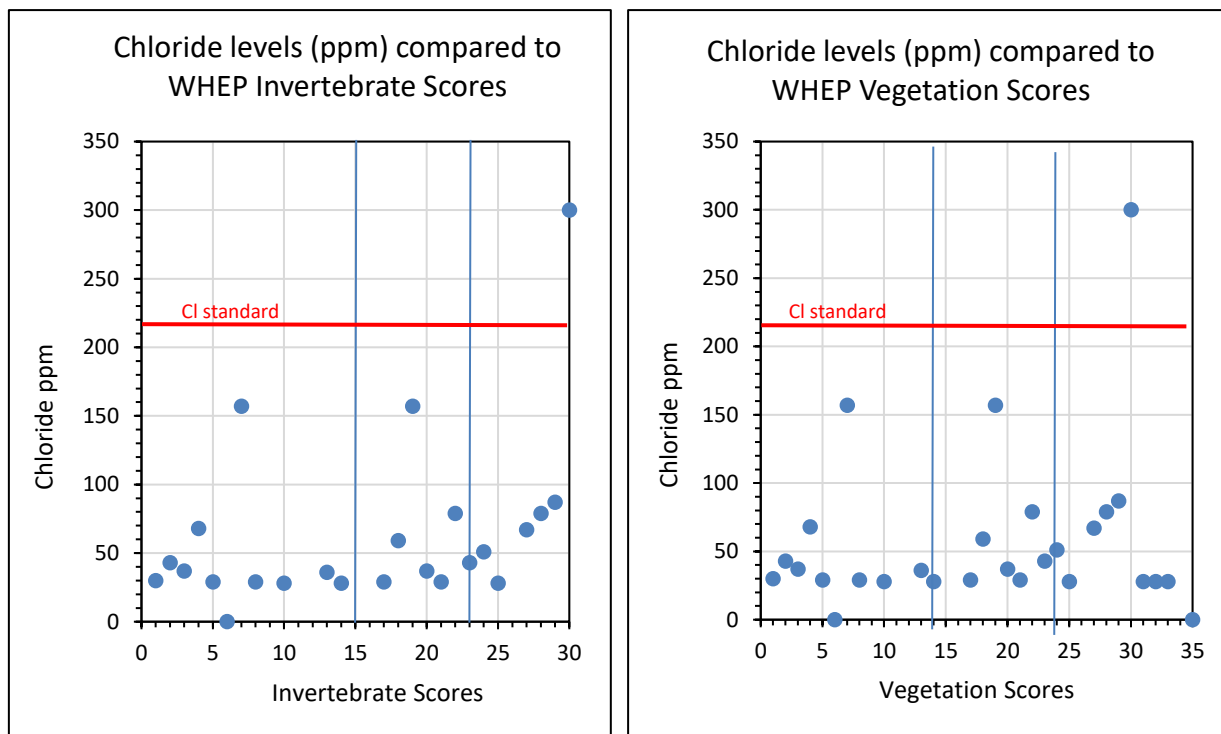
**Figure 3.1.5 Chloride Levels Compared to WHEP Invertebrate and Vegetation Scores**

Thirty-five of the 41 wetlands were tested for chloride. Winter Salt Watch results for the current year can be seen at [www.mnwhep.org](http://www.mnwhep.org). A wide-range of chloride concentrations were observed. The majority of the wetlands measured less than 30 ppm. Only one wetland measured chloride levels exceeding the chronic standard, MH-20, which also exceeded levels in 2021. Figure 3.1.5 shows the comparison of chloride levels to the invertebrate and vegetation scores calculated in 2022. Only one sample was collected from each wetland. There is not enough data to analyze a trend or complete statistical analysis.

Chloride concentrations in the wetlands are likely to be higher during the winter and in the spring than what is found in May or June. Chloride will also be higher in the bottom of the wetland rather than at the surface where the samples were collected per the procedures of the test kit. A study on a shallow wetland in Madison, Wisconsin showed that ice thickening over the winter can increase chloride concentrations that are above natural background beyond the toxicity threshold for much of the winter.<sup>4</sup> Additional monitoring of the wetlands with elevated chloride concentrations would be helpful to determine if and for how long they are exceeding the chloride standard.

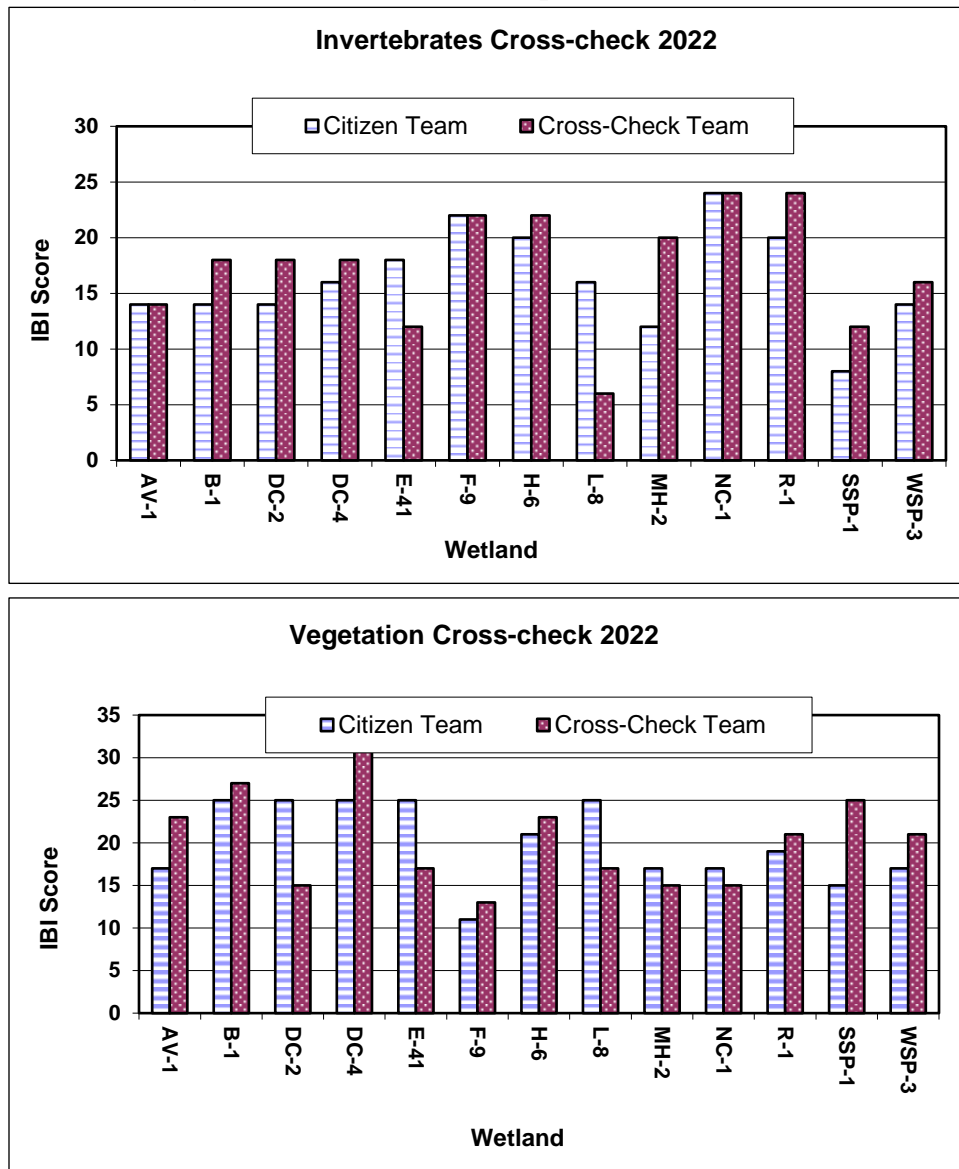
**Figure 3.2.1 Cross-check Comparisons of IBI Scores**

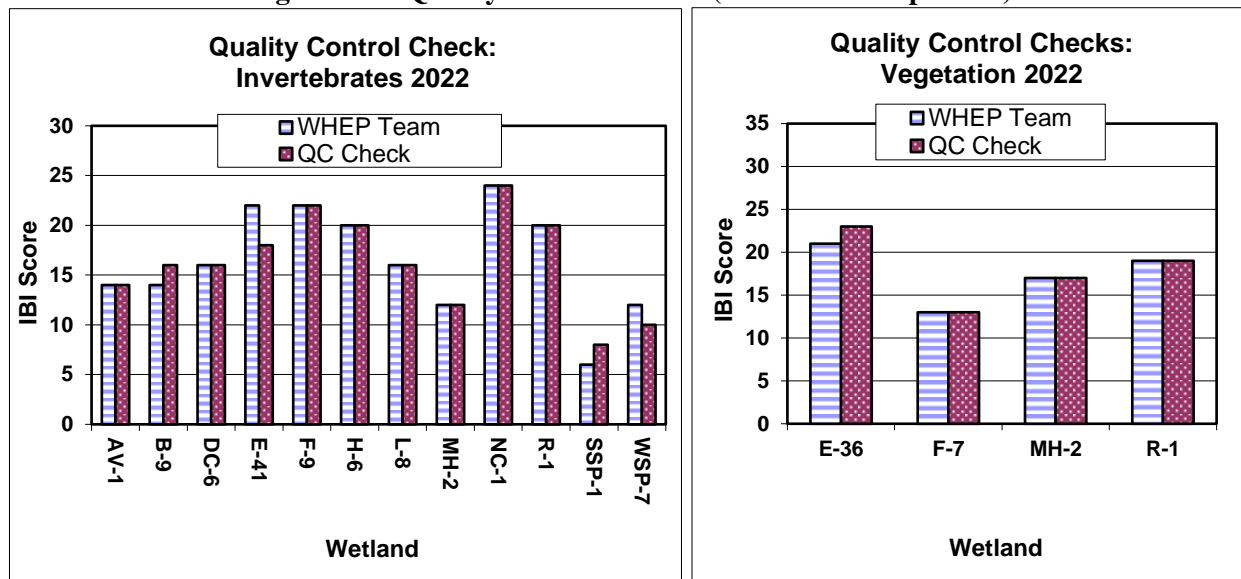
**Figure 3.2.2 Quality Control Checks (IBI Score Comparison)**

Quality control checks were conducted at four sites for vegetation and thirteen sites for invertebrates in 2022 (Figure 3.3.2) by Bolton & Menk, Inc. The invertebrate check was conducted by reviewing one identified and preserved invertebrate sample per team. The vegetation check was conducted by re-sampling the area marked off by the citizen team using the WHEP procedures and comparing results. The quality

control review was done independently of the citizen team. The following sites were checked as a measure of quality control: AV-1, B-9, DC-6, E-41, F-9, H-6, L-8, MH-2, NC-1, R-1, SSP-1, and WSP-7 were reviewed for invertebrate identification accuracy; E-36, F-7, MH-2, and R-1 were reviewed for vegetation identification accuracy.

All team invertebrate and vegetation scores were found to be consistent with the quality control checks. Each WHEP team did very well in both their invertebrate identification and vegetation surveys. This shows that with a high-quality program that provides good training and oversight, citizen volunteers can collect good usable data.

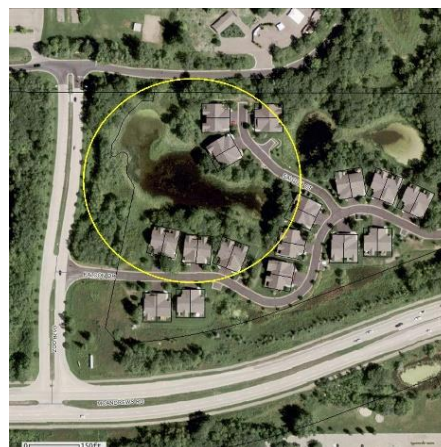
Hidden Valley (AV-1), also known as EVR-P53, is a 2.0- acre, type 4 wetland within the Vermillion River Watershed. It drains locally to a wetland known as EVR-53, and then through a series of wetlands and lakes. The wetland watershed is 21 acres with 15 acres of direct drainage, and it is 35 percent impervious. It has two inlets along the southern border, one equalizer pipe along the eastern border, and one outlet along the western border. Shallow sumps have been placed at the inlets. This wetland is part of the City's stormwater management plan, and it is designated as a Manage 2 wetland with a goal to continue monitoring over time as a reference wetland. Wetlands assigned to this category are characterized by high or exceptional restoration potential but are not located in public or open space.

The wetland is located within a privately-owned residential development and is surrounded by homes. A vegetation buffer exists between the wetland and homes/roads. Historic aerial photos show an increase in open water/ponding depth. An adjacent County trail (North Creek Greenway) was constructed in 2016. Infiltration BMPs were included during the trail construction and native seed was used to establish any areas that were disturbed adjacent to the wetland.

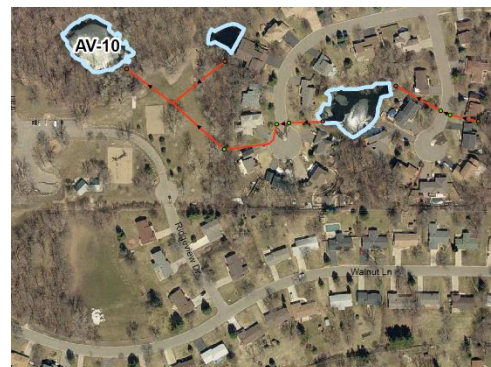
Alimagnet Park Ridgeview Drive Parking Lot Wetland (AV-10), also known as AL-P9.6, is a 0.5-acre, type 5 wetland within the Alimagnet Lake subwatershed of the Vermillion River Watershed, and lies just southeast of Alimagnet Lake. The wetland watershed is 25 acres with 5 acres of direct drainage, and it is 20 percent impervious. There is one inlet in the southeast corner of the wetland and one outlet along the western border. It is designated as a Manage 2 wetland with a goal to continue to monitor over time. It is within the Alimagnet TMDL drainage. With grants received from the County, the City will establish a Natural Resource Management Plan in Alimagnet Park and establish baseline data for future improvements under the plan.

The wetland is located within an active park that features a frisbee golf course. The surrounding area includes wooded parkland and residential neighborhoods. Some minor disturbances to the understory have occurred within the parkland from installation of the frisbee golf course; however, disturbances within this watershed are limited. A raingarden was installed upstream of the wetland, by the parking lot, in 2008. It will treat some of the stormwater that flows to this wetland. One stormwater pond and one upstream wetland also serve as BMPs.

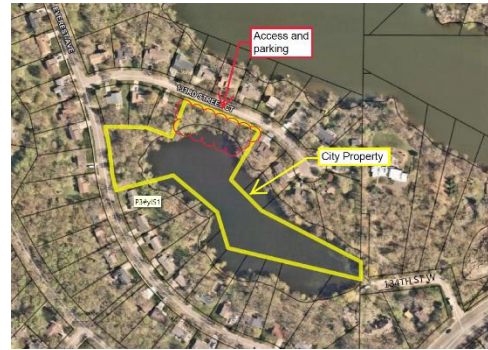
Everest Pond (AV-12), also known as EVR-P12 and Public Water 19-225W, is a 5.7-acre, type 5 wetland within the EVR-P12 subwatershed within the Vermillion River Watershed. The watershed has approximately 527 acres of total drainage in which 61 acres drain directly. There is one inlet in the northwest corner of the wetland, and one inlet along the southwestern shoreline. There is one outlet in the northwest corner of the wetland, and one outlet along the northeastern shoreline. Everest Pond is part of the City's stormwater management plan and is designated as a Manage 1 wetland. Wetlands in this classification have medium floral diversity/integrity, but also have direct stormwater input. The wetland must have high or exceptional restoration potential and be located in public or open space in order to meet the restoration classification.

This wetland is a key drainage area to Long Lake and Farquar lake, both of which are impaired for phosphorus. Approximately 68 percent of the external phosphorus load entering Long Lake comes from this pond. Several projects have been completed in the pond and the overall drainage as part of addressing the TMDL, including an iron-enhanced sand filter and raingardens upstream. The area surrounding this wetland is primarily residential. More than half of the wetland is surrounded by a wooded buffer, and the rest by manicured lawn. There are algal blooms in the summer, and the presence of goldfish has been noted.

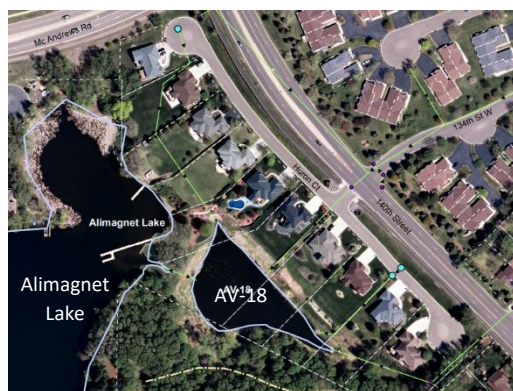
Sunset Park Pond (AV-18), also known as AL-P8, is a 1.0-acre, type 4 wetland within the Vermillion River Watershed. The wetland watershed includes approximately 252 acres, of which 43 acres drains directly. The watershed has 30 percent impervious surface. There are four inlets along the northeast side of the wetland. There are also two outlets; one large pipe at the west corner of the wetland and one drain tile pipe in the southwestern area of the wetland, as part of the City's iron-enhanced sand filters (IESF) project. In 2019, a new IESF was installed. The project was identified in a subwatershed assessment for Alimagnet Lake. The goal is to reduce the pollutants, such as phosphorous, from entering into Alimagnet Lake. When water levels rise in the wetland, the water seeps through the gabion wall into the sand filter areas. The iron-enhanced sand combines with dissolved phosphorous to remove it from the water column, then discharges via a drain tile into the lake, cleaner than before. This wetland is part of the

City's stormwater management plan, and is designated as a Manage 2 wetland with a goal to continue to monitor wetland health following IESF project.

The area surrounding the wetland is residential and parkland. The buffer around the pond was impacted by the IESF project, and is being actively managed. A fountain operates at this site.

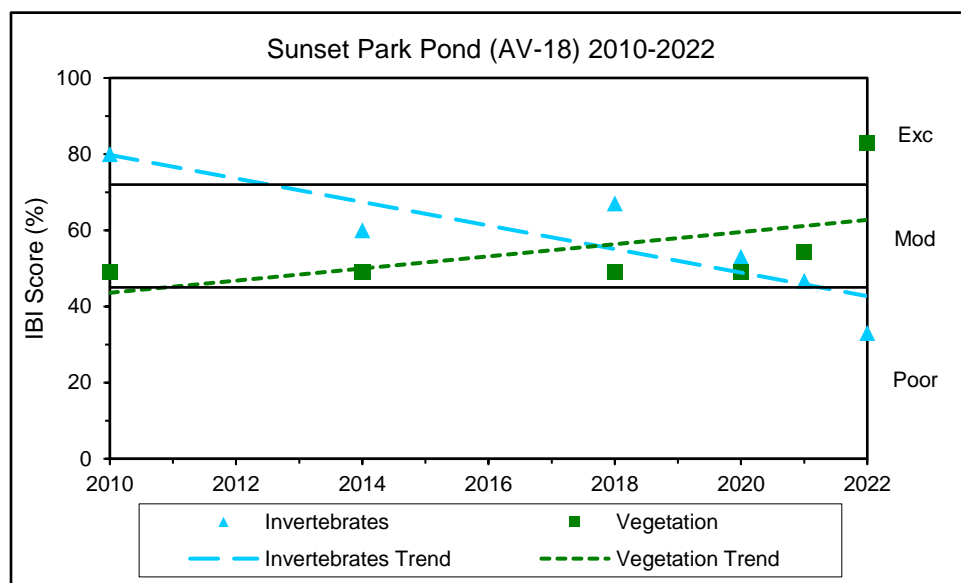
**Figure 4.1.4 Invertebrate and vegetation trends for Sunset Park Pond (AV-18)**

**Site summary:** This is the sixth time that AV-18 has been monitored since the initial survey in 2010. The invertebrate and vegetation scores are very inconsistent, differing by 50 percent. The vegetation score indicates excellent wetland health while the invertebrates score indicates poor wetland health. There was high vegetation diversity in 2022, but low invertebrate diversity. Fish, crayfish, and tadpoles were reported and may be preying on the invertebrates impairing the invertebrates score. The vegetation trend has remained stable until a steep spike in 2022. The vegetation trend appears to be declining since 2010.

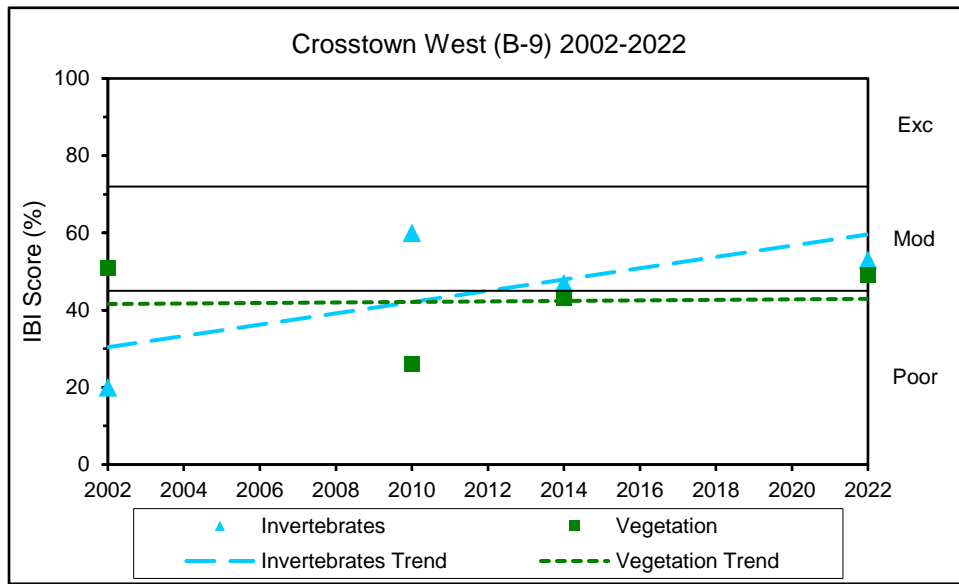
**Figure 4.2.3 Invertebrate and vegetation trends for Crosstown West (B-9)**

**Site summary:** This is the fourth time that Crosstown West has been monitored since 2002. The invertebrate and vegetation scores are consistent, and both indicate moderate wetland health. The vegetation health trend appears stable, while the invertebrate health trend has shown improvement. More data would help determine a more reliable health trend.

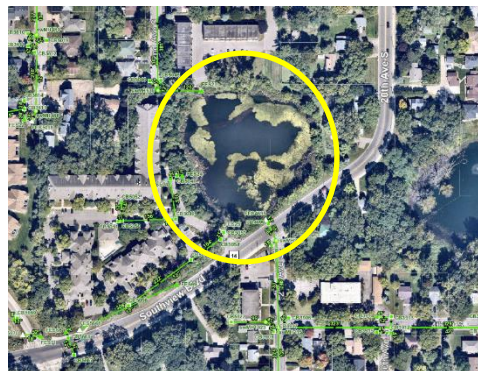
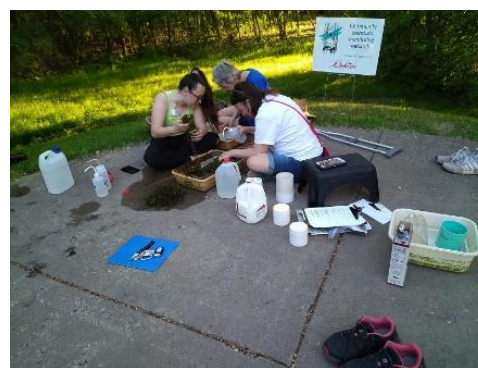
**Site Observations:** The wetland has a gentle entrance, but water deepens quickly. The wetland substrate is mucky. A thick band of cattails (*Typha* sp.) surrounds about 75 percent of the wetland shoreline. The area without the cattails has large overhanging trees. Coontail (*Ceratophyllum* sp.) filled the water column. Waterweed (*Elodea* sp.), pondweed (*Potamogeton* sp.), duckweed (*Lemna* sp.) were the only other plant species in the vegetation releve. Mayflies, snails, trueflies, and crustaceans were the only invertebrates collected. Fish, crayfish, tadpoles, and mystery snails (*Cipangopaludina chinensis*) were abundantly present.

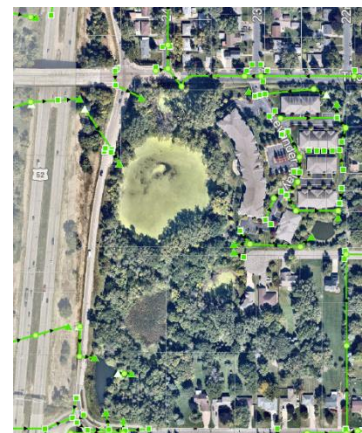
**Site Observations:** The wetland slope is gentle. The substrate is mucky. The wetland surface is covered in duckweed (*Lemna* sp. and *Spirodela* sp.) and water-meal (*Wolffia* sp.). Coontail (*Ceratophyllum* sp.) filled the water column. Pondweed (*Potamogeton* sp.) cattails (*Typha* sp.), willow trees (*Salix* sp.), and cottonwood trees (*Populus* sp.) were also present in the vegetation releve. No other emergent grasses or forbs present. Leeches, dragonflies, mayflies, snails, trueflies, crustaceans, and bugs and beetles were collected. Fairy shrimp (*Strtocyphalus sealii*) have been found in this wetland consistently since 2012.

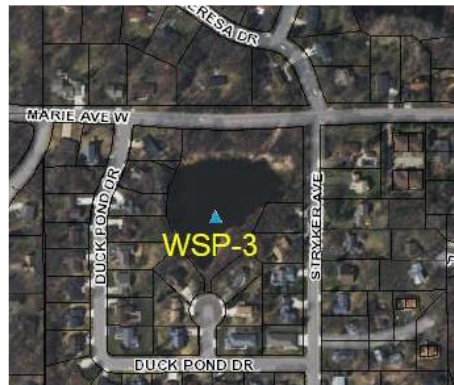
**Site Observations:** The wetland slope is gentle. The wetland substrate is very mucky. The water level appeared low in 2022. The wetland is surrounded by trees. Pondweed (*Potamogeton* sp.) filled the water column. Duckweed (*Lemna* sp.) and water-meal (*Wolffia* sp.) covered the surface of the water. Water plantain (*Alisma* sp.), beggar-tick (*Bidens* sp.), purple loosestrife (*Lythrum salicaria*), and reed canary grass (*Phalaris arundinacea*), were also present. Leeches, dragonflies, damselflies, mayflies, snails, fingernail clams, trueflies, crustaceans, and bugs and beetles were collected.

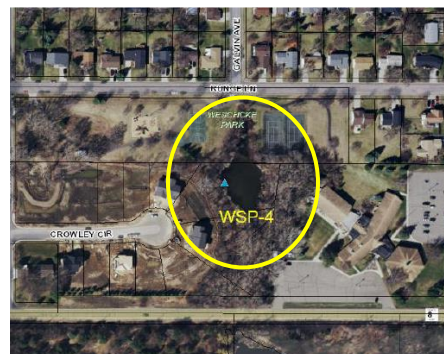
**Site Observations:** The wetland slope is gentle. The wetland substrate is mucky. The water level dropped in mid-July, during the vegetation survey compared to the invertebrate survey in early June. Cattails (*Typha* sp.) are prominent, but the soil mostly dry. There was no submergent vegetation. Duckweed (*Lemna* sp.) and water-meal (*Wolffia* sp.) are present. Several emergent forbs and grasses were also observed in the vegetation releve, including sedges (*Carex* sp.), spike-rush (*Eleocharis* sp.), bulrush (*Scirpus* sp.), reed canary grass (*Phalaris arundinacea*), water plantain (*Alisma* sp.), arrowhead (*Sagittaria* sp.), and smartweed (*Polygonum* sp.). Leeches, snails, trueflies, crustaceans, and beetles and bugs were collected.

**Site Summary:** This is the fifth time that Weschcke Pond has been surveyed by WHEP volunteers, since 2000. The invertebrate and vegetation scores were consistent, and both scores indicate moderate wetland health. Low water levels impeded the growth of submergent and floating vegetation. Despite these conditions, high numbers of leeches, snails, and bugs and beetles supported moderate wetland health rating. Inclusion of several emergent forbs and grasses present in the vegetation releve also supported the moderate wetland health rating. Few years of data display stable health trends, and the data remains similar through the years of monitoring. More years of monitoring will help determine a more reliable health trend.

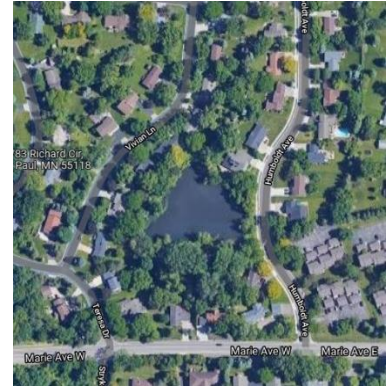
**Site Observations:** The wetland slope is gentle. The wetland substrate is solid and there are many submerged sticks and branches. Water levels were low in 2022. There was no submergent vegetation present. Duckweeds (*Lemna* sp. and *Spirodela* sp.) only sparsely floated on the surface of the water. Trees surround the pond, but no other emergent forbs or grasses were within the vegetation releve. Leeches, caddisflies, trueflies, crustaceans, and bugs and beetles were collected.
