Dakota County, Minnesota

Coordinated By:
Dakota County
14955 Galaxie Avenue
Apple Valley, MN 55124-8579

Report
Prepared by:

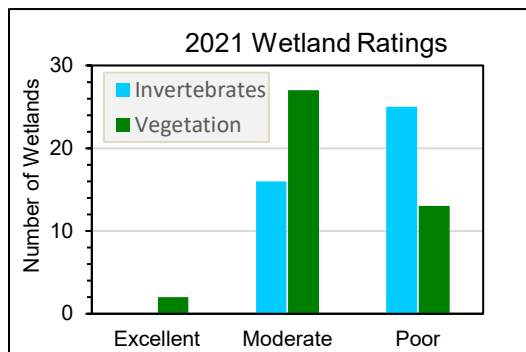
FIGURE 3.1.1 DAKOTA COUNTY WETLAND RATINGS

During the 2021 sampling season, thirteen citizen teams (Apple Valley, Burnsville, Dakota County Parks Team 1, Dakota County Parks Team 2, Eagan, Farmington, Hastings, Lakeville, Mendota Heights, North Cannon River Watershed Management Organization, Rosemount, South St. Paul, and West St. Paul) monitored 42 wetlands in ten cities in Dakota County, one watershed management organization, and Dakota County Parks. Thirteen of these wetlands were sampled twice through citizen cross-checks. Four wetland vegetation samples and thirteen invertebrate samples were checked for accuracy through the quality control check performed by Fortin Consulting, now Bolton & Menk, Inc.

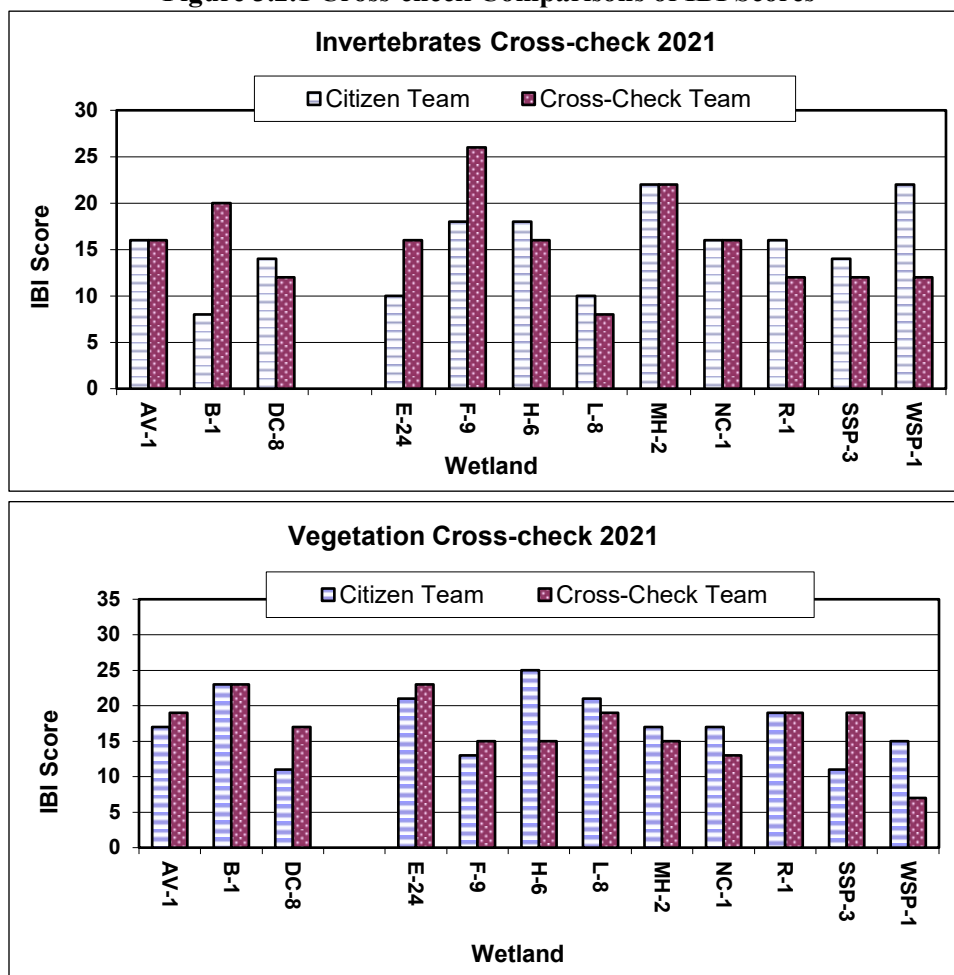
Figure 3.2.1 Cross-check Comparisons of IBI Scores

differences in identification accuracy, or some other cause. Below lists the obvious differences in scoring for those wetlands that were inconsistent. Data collected by the original citizen team is used for the individual wetland analysis in Section 4.0 of this report. Invertebrate scores between citizen team and cross-check team for site AV-1, MH-2, and NC-1 were identical. Vegetation scores between City team and cross-check team for sites B-1 and R-1 were identical. Many scores were close in comparison. A general explanation of differences between inconsistent scores are as follows:

Citizen Team	Cross-Check Team	Wetland Evaluated	Invertebrate Score Comparison		Vegetation Score Comparison	
			Citizen	x-check	Citizen	x-check
Apple Valley	Lakeville	AV-1	16	16	17	19
Burnsville	Mendota Heights	B-1	8	20	23	23
Dakota County Parks Team 1	Dakota County Parks Team 2	DC-8	14	12	11	17
Dakota County Parks Team 2	NA	NA	NA	NA	NA	NA
Eagan	Rosemount	E-24	10	16	21	23
Farmington	West St. Paul	F-9	18	26	13	15
Hastings	South St. Paul	H-6	18	16	25	15
Lakeville	North Cannon River WMO	L-8	10	8	21	19
Mendota Heights	Burnsville	MH-2	22	22	17	15
North Cannon River WMO	Apple Valley	NC-1	16	16	17	13
Rosemount	Eagan	R-1	16	12	19	19
South St. Paul	Hastings	SSP-3	14	12	11	19
West St. Paul	Farmington	WSP-1	22	12	15	7

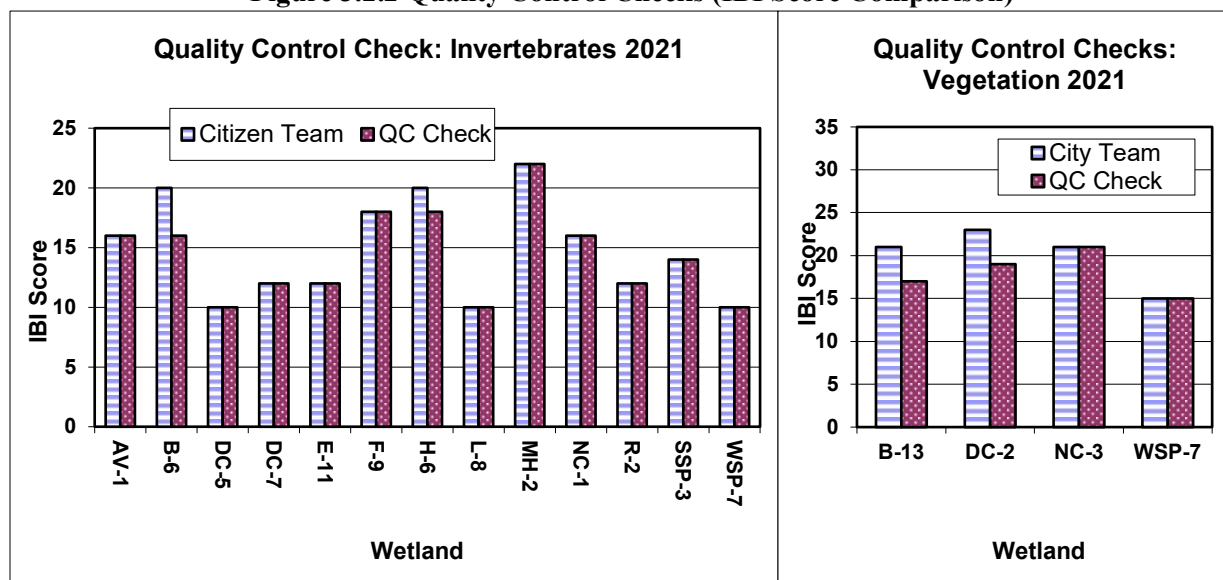
Figure 3.2.2 Quality Control Checks (IBI Score Comparison)

All team invertebrate and vegetation scores were found to be consistent with the quality control checks. Each WHEP team did very well in both their invertebrate identification and vegetation surveys. This shows that with a high-quality program that provides good training and oversight, citizen volunteers can collect good usable data.

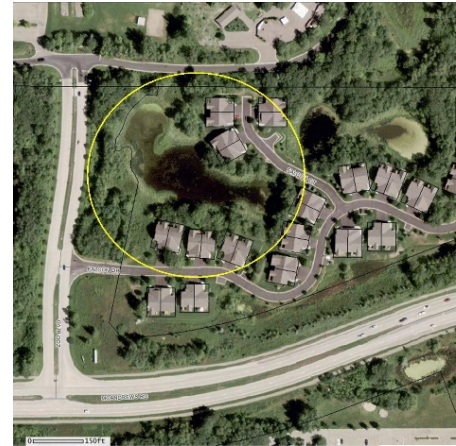
Site Observations: The wetland slope is steep from the road to the wetland, but gentle at the water's edge. The wetland substrate is mucky with a solid bottom. There is a large vegetative buffer between the homes and the wetland. Drought conditions resulted in very low water levels and exposed wetland bottoms in 2021. Cattails (*Typha* sp.), reed canary grass (*Phalaris arundinacea*), and other emergent forbs near the shoreline were excluded from the vegetation releve in order to reach open water. Duckweed (*Lemna* sp. and *Spirodela* sp.), water-meal (*Wolffia* sp.) covered the surface of the water. Dense populations of pondweed (*Potamogeton* sp.) and coontail (*Ceratophyllum* sp.) dominated the water column. Smartweed (*Polygonum* sp.) and arrowhead (*Sagittaria* sp.) were also present. Species of leeches, dragonflies, damselflies, caddisflies, snails, trueflies, crustaceans, and beetles and bugs were collected.

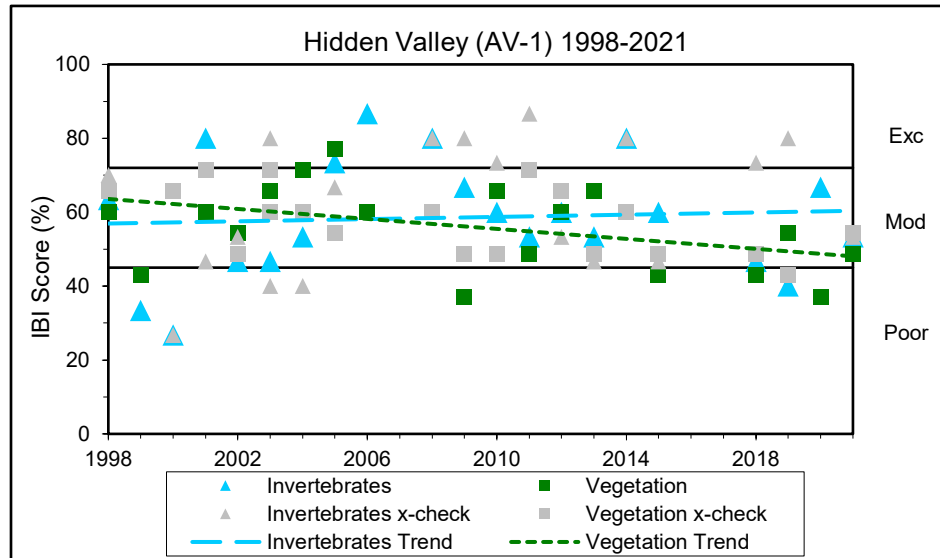
Figure 4.1.1 Invertebrate and vegetation trends for Hidden Valley (AV-1)

Site Summary: Hidden Valley has been surveyed 21 times since 1998. The invertebrate and vegetation health scores were consistent in 2021, and indicated moderate wetland health. Both the invertebrate and vegetation scores have been variable over the years fluctuating between excellent and poor. The extreme fluctuations may be due to factors such as changes in water level and plot placement. In 2021, drought conditions resulted in very low water levels exposing much of the wetland bottom. AV-1 was cross-checked by another team in 2021. Though wetland scores between the teams were very consistent, the plot placement during vegetation survey resulted in very different vegetation species representation, with the City team identifying more submergent and floating species and the cross-check team including more emergent grasses and forbs. Overall, the invertebrates trend appears to be stable, if not improving slightly, while the vegetation trend appears to be declining.

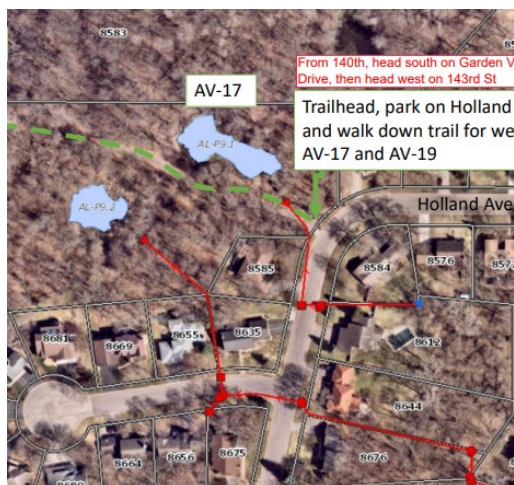
Site Observations: The wetland is near a park path surrounded by trees and shrubs. The wetland slope is gentle and the substrate is very mucky. There are many dead fallen trees in the water. The surface of the water is covered with duckweed (*Lemna* sp.). Pondweed (*Potamogeton* sp.) was the only submergent vegetation observed. Spike-rush (*Eleocharis* sp.), bulrush (*Scirpus* sp.), cut grass (*Leersia* sp.), arrowhead (*Sagittaria* sp.), Joe-pye weed (*Eupatorium* sp.) were represented in the releve. Species of leeches, snails, and fingernail clams, and beetles and bugs were collected.

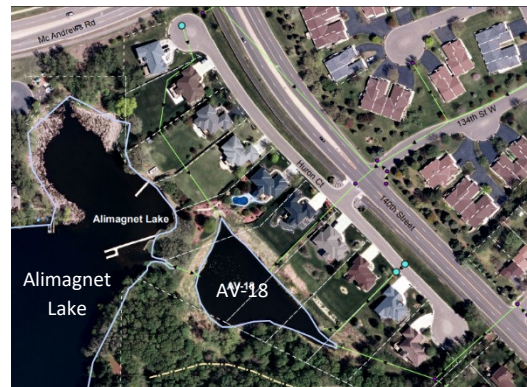
The area surrounding the wetland is residential and parkland. In 2019, a new iron-enhanced sand filter was installed. The project was identified in a subwatershed assessment for Alimagnet Lake. The goal is to reduce the pollutants, such as phosphorous, from entering into Alimagnet Lake. When water levels rise in the wetland, the water seeps through the gabion wall into the sand filter areas. The iron-enhanced sand combines with dissolved phosphorous to remove it from the water column, then discharges via a drain tile into the lake, cleaner than before. The buffer around the pond was impacted by the IESF project, and is establishing nicely.

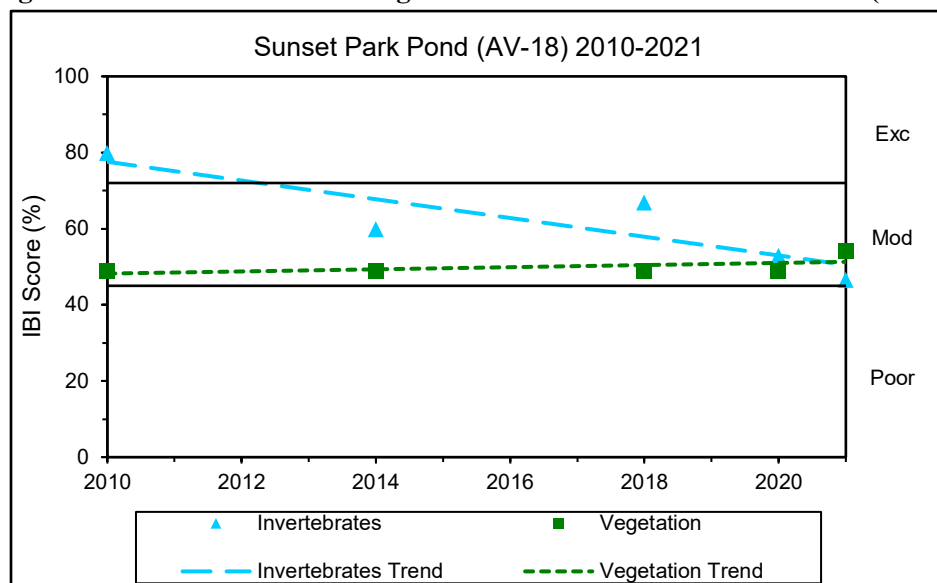
Figure 4.1.3 Invertebrate and vegetation trends for Sunset Park Pond (AV-18)

Site summary: This is the fifth time that AV-18 has been monitored since the initial survey in 2010. The invertebrate and vegetation scores are consistent, even though the invertebrates score indicates poor wetland health and the vegetation score indicates moderate wetland health. The vegetation health trend is already displaying stable health scores; however more data would help assess a more reliable health trend. Water

levels were very low in 2021 and could have impaired invertebrate collection. Tadpoles and fish were found in the bottle traps which could have impacted the invertebrate collection, as well.

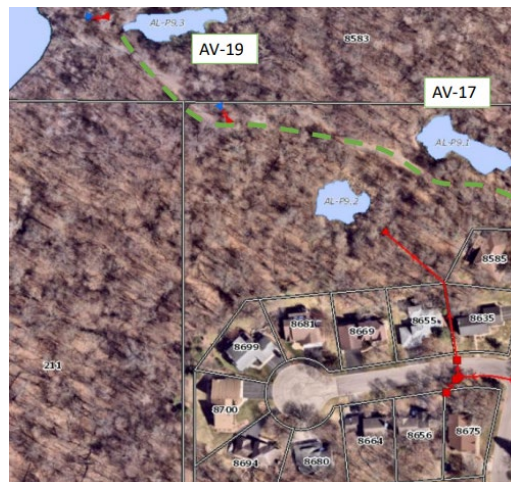
Site Observations: The wetland slope is gentle, and the substrate is mucky. Duckweed (*Lemna* sp. and *Spirodela* sp.) and water-meal (*Wolffia* sp.) cover the surface of the wetland. A dense population of pondweed (*Potamogeton* sp.) made up the submergent vegetation. Arrowhead (*Sagittaria* sp.), bur-reed (*Sparganium* sp.), spike-rush (*Eleocharis* sp.), bulrush (*Scirpus* sp.), and several grasses and emergent forbs were also present. Leeches, damselflies, snails, trueflies, crustaceans, and bugs and beetles were collected.

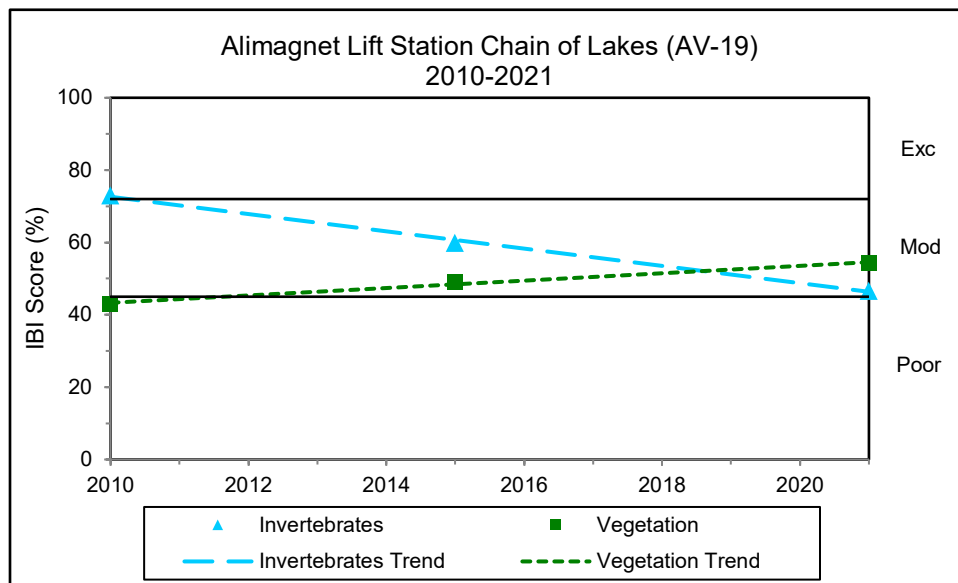
Figure 4.1.4 Invertebrate and vegetation trends for Alimagnet Lift Station Chain (AV-19)

Site summary: This is the third time that AV-19 has been monitored through WHEP. The invertebrate and vegetation scores were consistent; however, the invertebrate score indicates poor health while the vegetation score indicates moderate health. Low water levels and the presence of tadpoles, fish, and crayfish in the bottle traps may have impacted the invertebrate score in 2021. More years of monitoring will help determine a more reliable health trend.

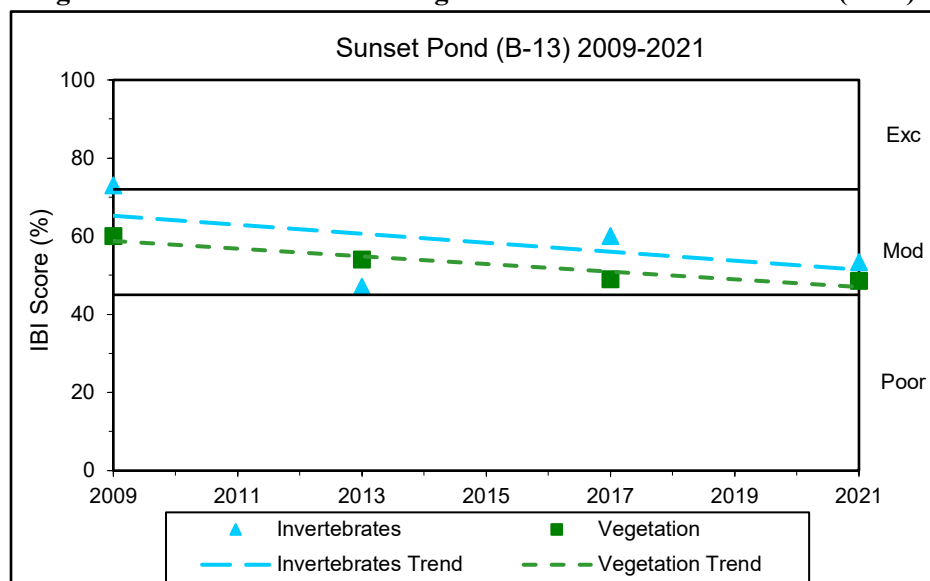
Figure 4.2.3 Invertebrate and vegetation trends for Sunset Pond (B-13)

Site summary: This is the fourth time that Sunset Pond has been monitored since the initial survey in 2009. The invertebrate and vegetation scores are consistent, and indicate moderate wetland health. The health trends appear fairly stable, though the initial surveys in 2009 indicated better wetland health. More data would help determine a more reliable health trend. This wetland was cross-checked by Fortin Consulting in 2021, and confirmed the vegetation observed by the team.

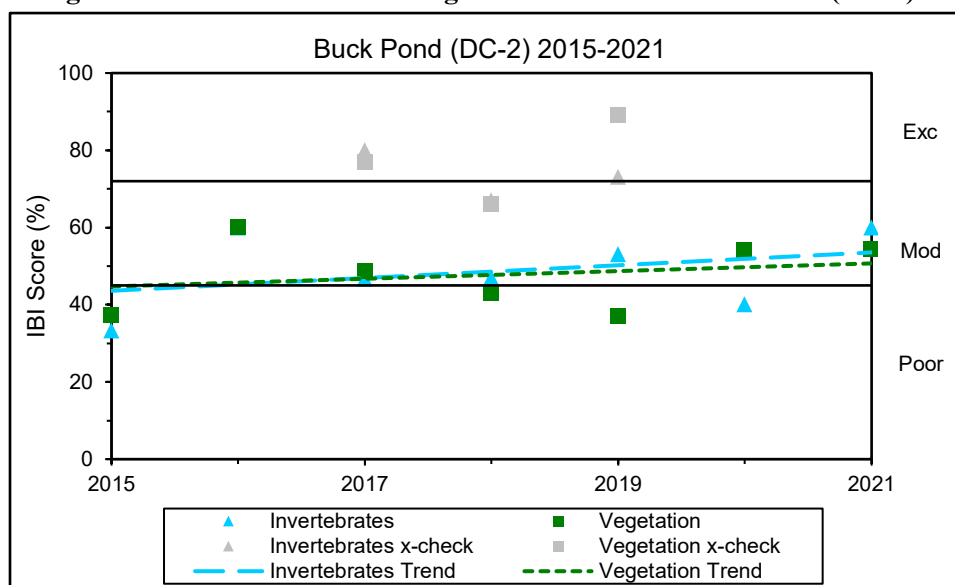
Figure 4.3.2 Invertebrate and vegetation trends for Buck Pond (DC-2)

Site summary: This is the seventh consecutive year that Buck Pond has been monitored by WHEP. The invertebrate and vegetation scores were consistent, both scoring moderate wetland health. Both health trends appear stable. This wetland was cross-checked by Fortin Consulting in 2021, and confirmed the vegetation observed by the team.

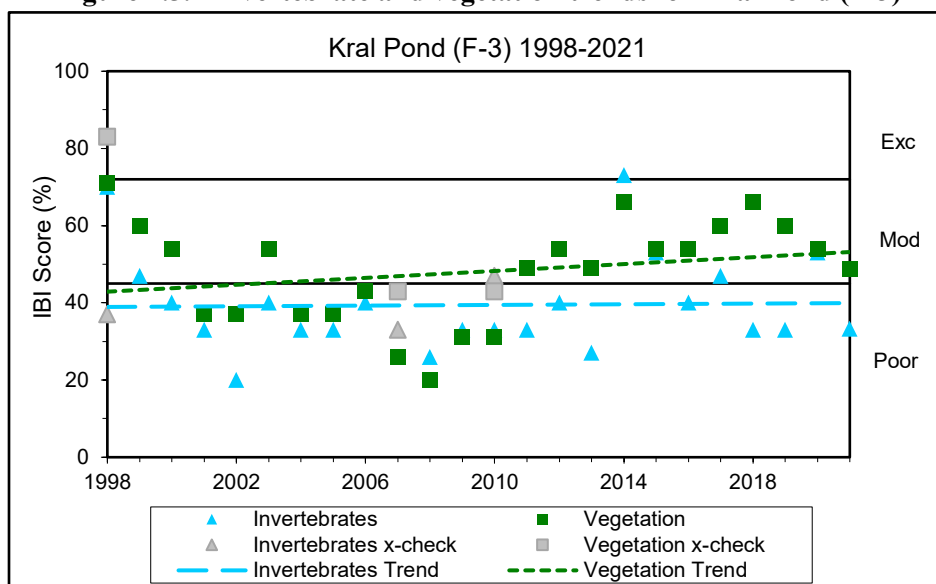
Figure 4.5.1 Invertebrate and vegetation trends for Kral Pond (F-3)

Site summary: Kral Pond has been monitored for 24 consecutive years. The invertebrate and vegetation scores were inconsistent in 2021, differing by 16 percent. The invertebrates score indicates poor wetland health while the vegetation score indicates moderate wetland health. The team commented that the water level was the lowest they've observed, and in July was partially dry. The data throughout the years has been variable. The vegetation scores were gradually decreasing from 1998 to 2008 and then rebounding. The invertebrate scores are consistently poor with exception to a few years of data. Vegetation scores are more often higher than invertebrate scores. The long-term health trends are variable but stable. The area was historically agricultural. Development surrounding the wetland may have impacted the wetland. In some cases, conversion from agriculture to residential development can improve water quality since stormwater treatment is added.

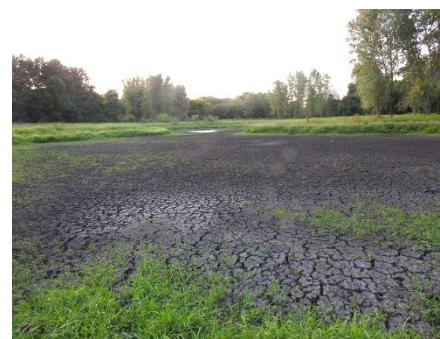
Site Observations: The wetland slope is gentle and the substrate is very mucky. The water levels were almost too low to set bottle traps in 2021. A bicycle path runs along the south side of the wetland. A meadow of reed canary grass (*Phalaris arundinacea*) surrounds the wetland. Water-meal (*Wolffia* sp.) is the only plant found in the vegetation releve. Spike-rush (*Eleocharis* sp.), bulrush (*Scirpus* sp.), and smartweed (*Polygonum* sp.) were observed in the dry mudflats. There were very few plants in deeper portions of the wetland. Leeches, damselflies, mayflies, snails, trueflies, crustaceans, and bugs and beetles were collected.

AUTUMN GLEN IN AUGUST 2021

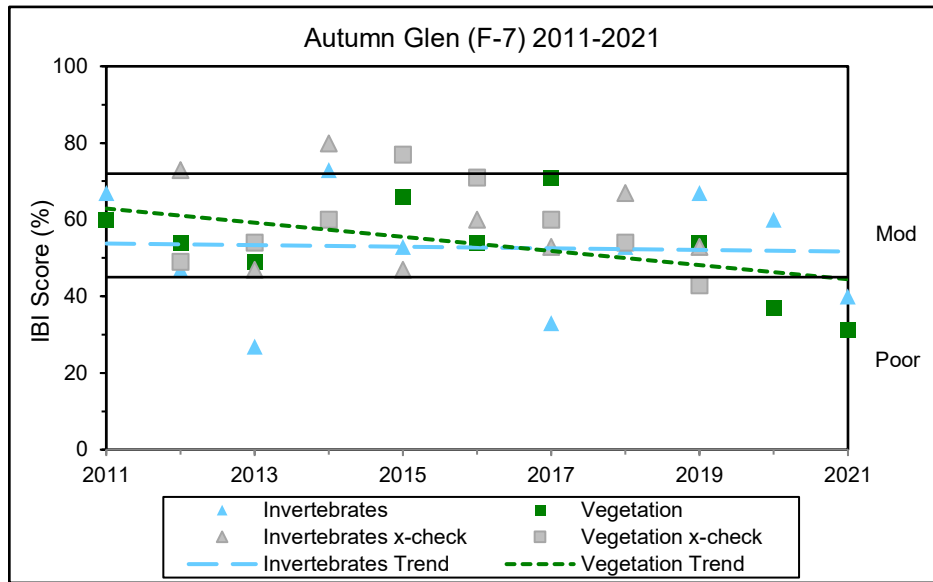
Site Summary: This is the eleventh consecutive year that Autumn Glen has been monitored. The invertebrate and vegetation scores are consistent with each other. The invertebrate and vegetation scores indicate poor wetland health. Vegetation diversity declined in 2019 and 2020, and in 2021 drought conditions drastically reduced the vegetation representation to one taxa (water-meal). Macroinvertebrate diversity also declined. Water levels were almost too low to set bottle traps. Dry conditions seem to have impacted wetland health scores. Long term health trends for invertebrates appear stable, though data is variable. The vegetation health trend are starting to show signs of decline. The large invasion of reed canary grass encroaching on this wetland may be impacting the vegetation diversity.

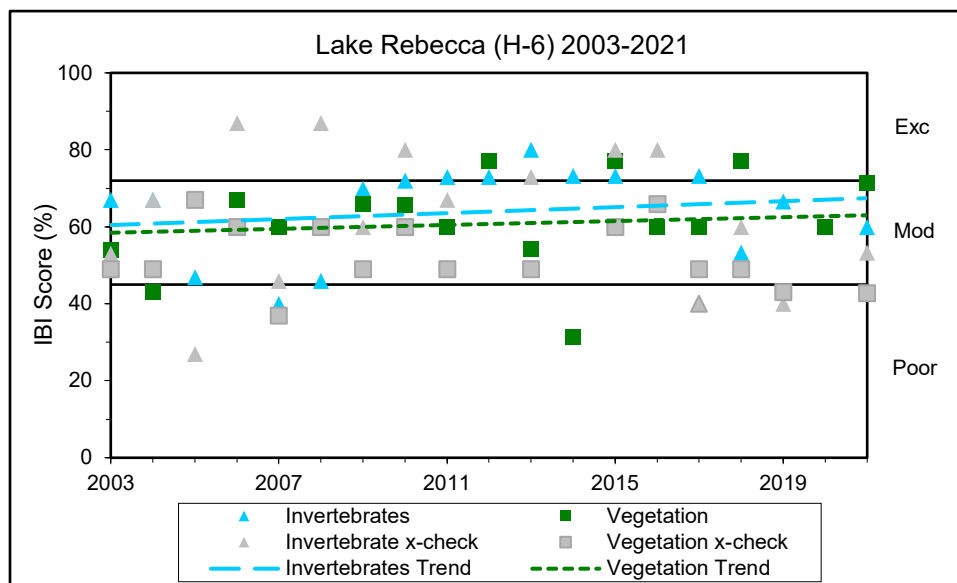
Site summary: This is the nineteenth consecutive year of monitoring for Lake Rebecca. Invertebrate and vegetation scores are considered inconsistent, differing by 11 percent. With the exception of a few variable years, the invertebrates and vegetation scores have fallen near a long-term stable health trend. A new location for sampling was set in 2020, which was repeated in 2021. This vegetation plot at this site was cross-checked by another team in 2021. The invertebrates scores between the two teams were consistent; however, the vegetation scores were inconsistent, differing by 28 percent. The teams placed their

vegetation plots in different areas of the wetland. The City team found a larger diversity of woody, emergent, and submergent plant species.

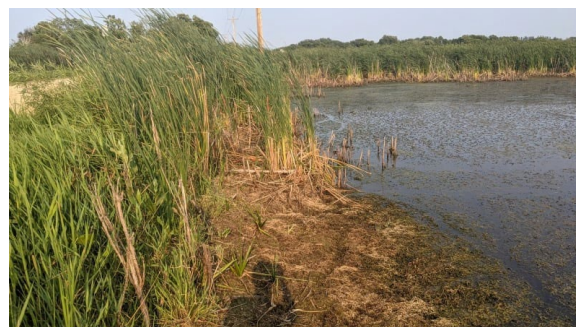
Site Observations: The wetland slope is moderate. The wetland substrate is sand and gravel beneath a layer of mucky organic matter. Water levels dropped between the macroinvertebrate and vegetation surveys, receding by two meters. This affected the ability to capture emergent and submergent plants together in the vegetation releve. Dense populations of coontail (*Ceratophyllum* sp.) and pondweed (*Potamogeton* sp.) dominated the water column. Duckweed (*Lemna* sp. and *Spirodela* sp.) and water-meal (*Wolffia* sp.) floated on the water. Cattail (*Typha* sp.), water plantain (*Alisma* sp.), and smartweed (*Polygonum* sp.) were also present. Vegetation outside of the plot included willow trees (*Salix* sp.), spike-rush (*Eleocharis* sp.), sedge (*Carex* sp.), burreed (*Scirpus* sp.), reed canary grass (*Phalaris arundinacea*), arrowhead (*Sagittaria* sp.), and bugle weed (*Lycopus* sp.). Leeches, dragonflies, damselflies, caddisflies, snails, fingernail clams, crustaceans, and bugs and beetles were collected.

RETREATING SHORELINE AT 180TH ST MARSH

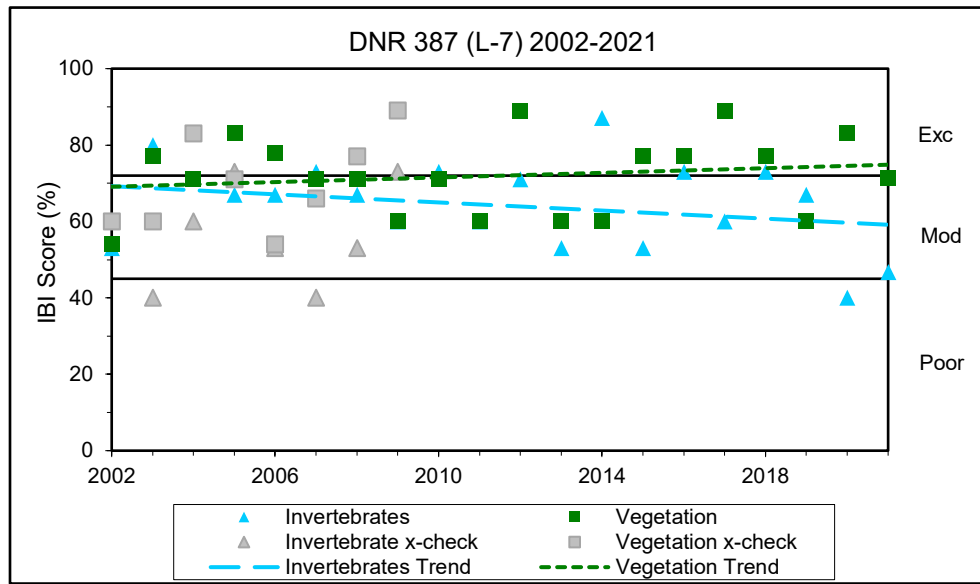
Site summary: This is the twentieth consecutive year that DNR 387 has been monitored for WHEP. The invertebrate and vegetation scores were inconsistent in 2021, differing by 24 percent. The invertebrates score indicates poor wetland health while the vegetation score indicates moderate wetland health. The invertebrate and vegetation both appear to have long-term stable health trends. Low water levels due to drought conditions proved poor habitat for invertebrates and submergent and floating plants. A large diversity of emergent woody, grass, and forb species enhanced the vegetation score.

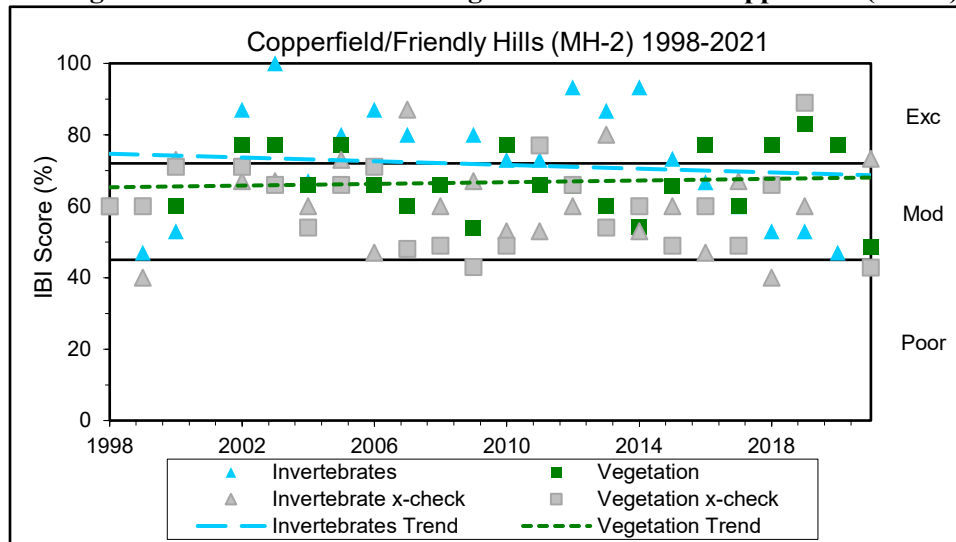
Site Summary: This is the 23rd year that MH-2 has been monitored since 1998. There is a lot of variability in the data throughout the years of monitoring. Both health data sets show steady long-term trends. Fluctuation in water levels from year to year may impact data results. The invertebrate and vegetation scores are inconsistent again, differing by 24 percent in 2021. MH-2 scores have showed this inconsistency several years. This wetland was cross-checked by another team. The invertebrate collections were very similar between teams. The City team found a large diversity of emergent vegetation represented in their vegetation plot, but the cross-check team observed none. However, the cross-check team did observe coontail (*Ceratophyllum* sp.), a submergent plant, while the City team found no submergent plants. Different vegetation plot placement likely affected these differences which caused a difference in scores.

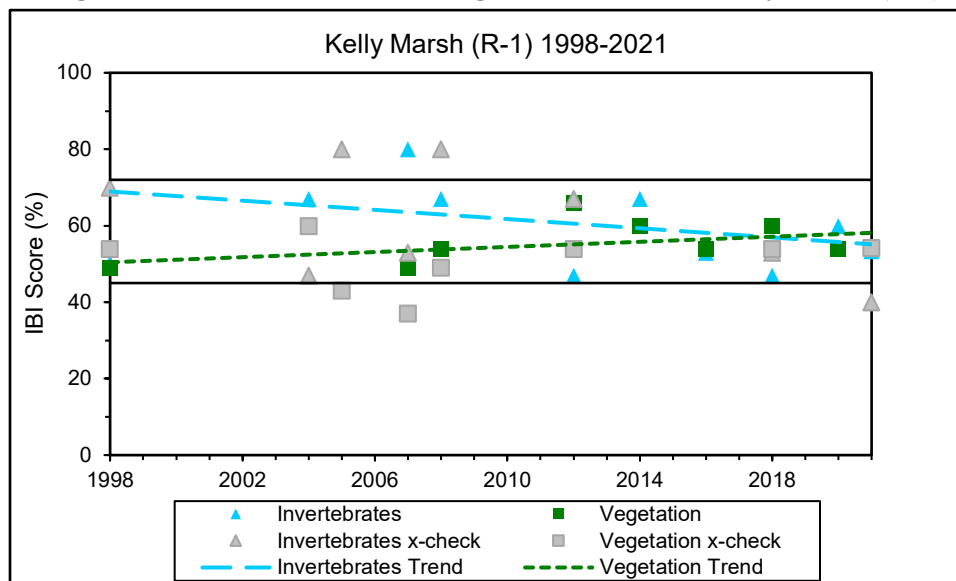
Site summary: This is the eleventh time Kelly Marsh has been monitored since 1998. The invertebrate and vegetation health scores are very consistent with each other in 2021, and indicate moderate wetland health. The low water levels don't appear to have impacted the data trends of the last several years of monitoring. This wetland was cross-checked by another team. The vegetation data findings for both teams was very similar. The invertebrates scores between teams are inconsistent, differing by 13 percent. The City team found a larger diversity of invertebrates including dragonflies, damselflies, and caddisflies.

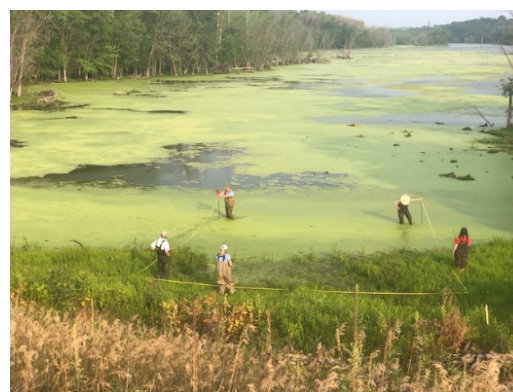
VEGETATION PLOT SET-UP BY SSP

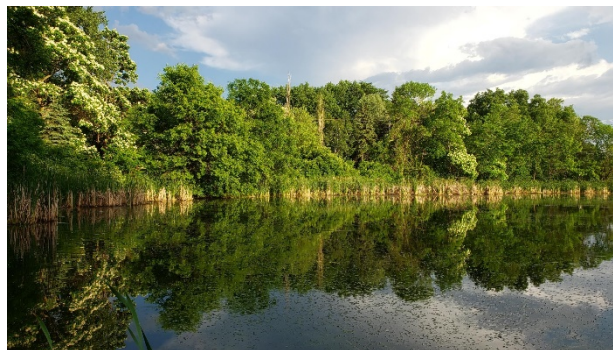
Site Observations: The wetland slope is gentle. The substrate is very mucky. The wetland surface is covered in duckweed (*Lemna* sp. and *Spirodela* sp.) and water-meal (*Wolffia* sp.). Coontail (*Ceratophyllum* sp.) was the only submergent vegetation observed. Cattails (*Typha* sp.), reed canary grass (*Phalaris arundinacea*), willow trees (*Salix* sp.), cottonwood trees (*Populus* sp.), and buckthorn (*Rhamnus cathartica*) surround the wetland. No other emergent grasses or forbs present. Leeches, snails, trueflies, crustaceans, and bugs and beetles were collected.

LEVANDER POND AFTER RAIN

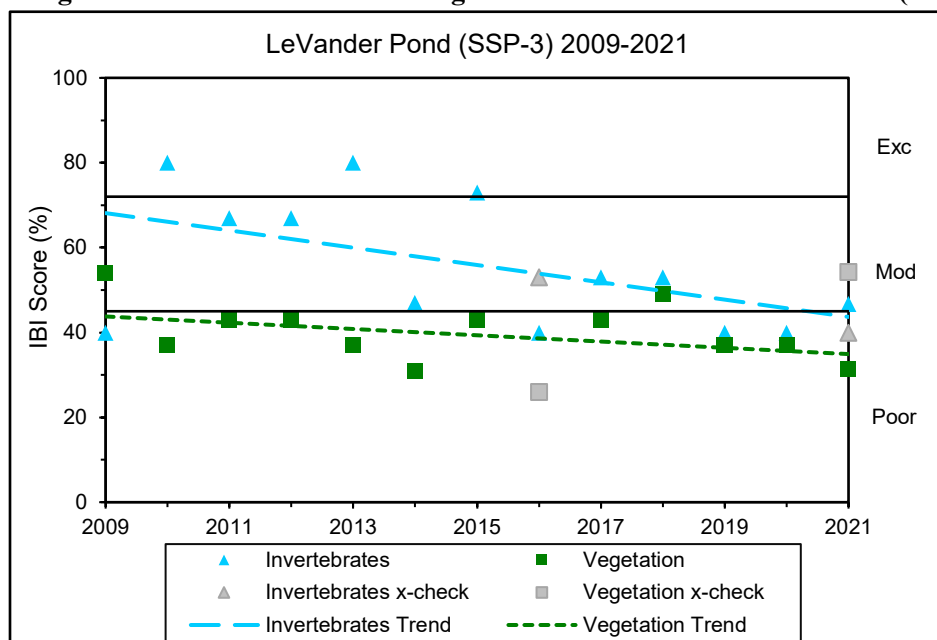
Site summary: This is the thirteenth consecutive year of monitoring LeVander Pond. The vegetation and invertebrates scores were inconsistent with each other in 2020, differing by 16 percent; however, both

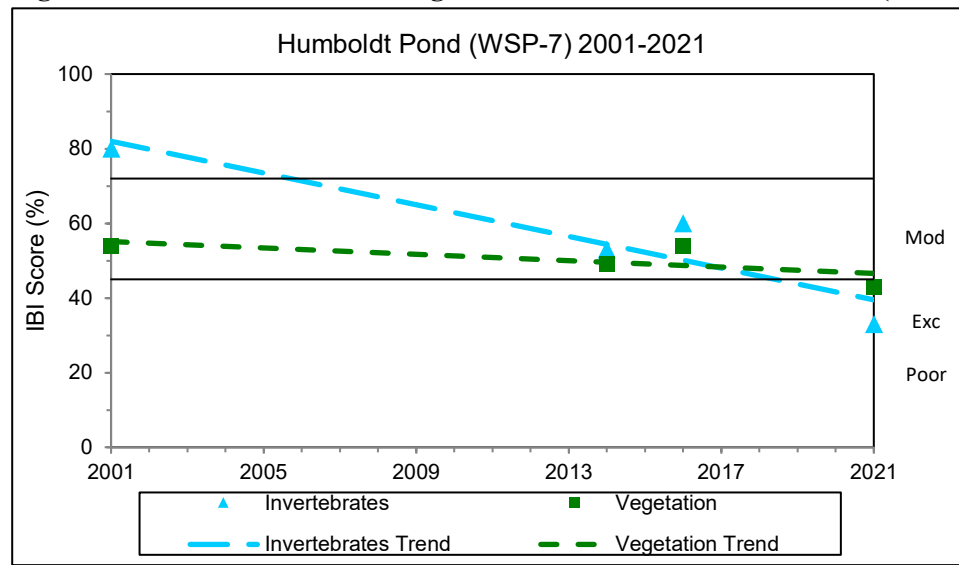
Site summary: This is the fourth time that Humboldt Pond has been monitored since 2001. The invertebrates and vegetation scores were consistent, both indicating poor wetland health. Vegetation abundance and diversity is very low in this wetland. This site was cross-checked by Fortin Consulting for quality assurance purposes. The teams found very similar species. More years of data may help determine a reliable health trend.
