**POLYMER CONCRETE MICRO-OVERLAY
FOR FUEL AND ABRASION RESISTANT SURFACING:
LABORATORY RESULTS AND FIELD DEMONSTRATIONS**

**By
Kent Newman, PhD
and
James E. Shoenberger, PhD**

**US Army Engineer Research and Development Center
Vicksburg, Mississippi, USA**

**PRESENTED FOR THE FEDERAL AVIATION ADMINISTRATION
AIRPORT TECHNOLOGY TRANSFER CONFERENCE**

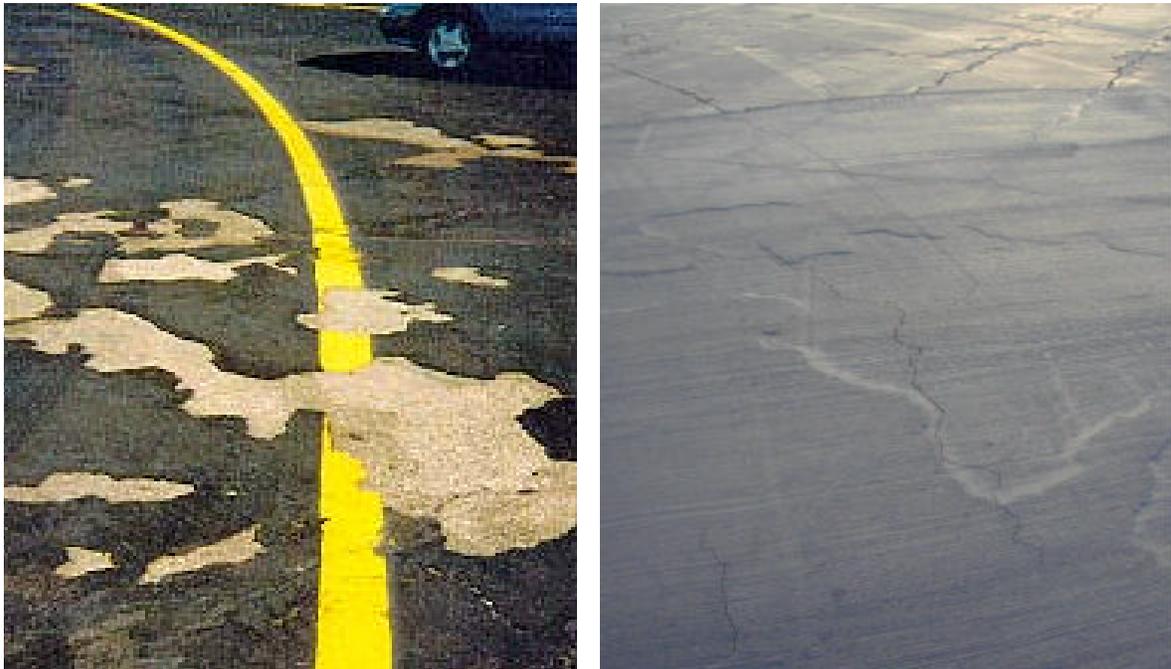
Figure 7. “Delaminated coal tar area before (2008) and after sealing with PCMO (2012) at Forbes Field, Topeka, KS.

Section 2 was a small area placed over severely delaminating coal tar. The purpose was to determine if the PCMO was able to encapsulate the existing coal tar. It appears to have accomplished this by preventing further adhesion loss of the coal tar from the asphalt (Figure 7).
