MILESTONE INSPECTION – PHASE I

SEAFARER CONDOMINIUMS
16401 PERDIDO KEY DRIVE
PENSACOLA, FLORIDA 32507

PREPARED BY: STEVEN W. RAY, P.E., R.S.
CARTER NELSON, E.I.T., R.S.

MAY 2024

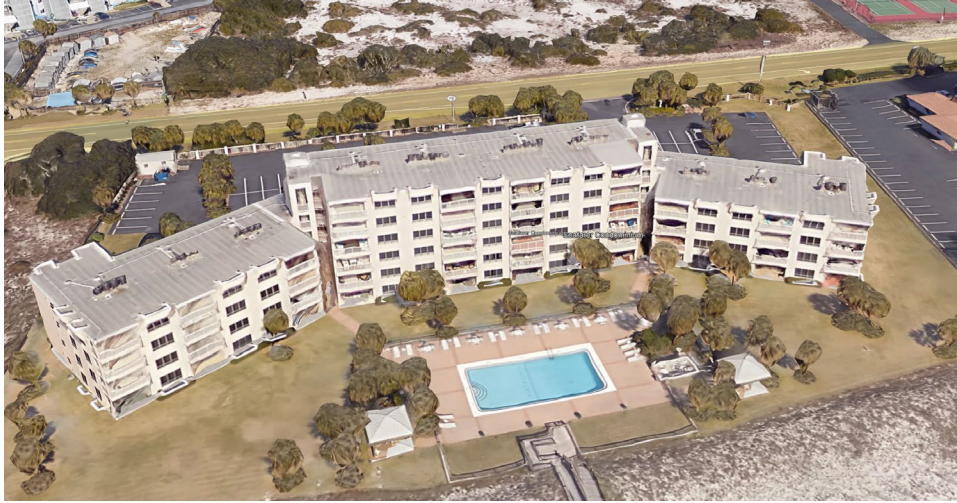
Seafarer is a condominium complex consisting of three buildings connected to each other, two, four-story, and a center six-story building (reference photograph 1). The complex was built in 1975 and consists of a total of 46 units. The building construction is consistent with a reinforced concrete frame, and post-tension slabs, all supported by a pile foundation system. The roofing system is primarily a modified bitumen membrane, with TPO roofing material along the penetration and parapet walls. The parapet walls appear to be capped with flashing; however, we cannot determine if the TPO wraps over the walls. Runoff is controlled by scuppers and roof drains. The exterior of the building is clad with a stucco system, with the corridors providing access to the units on the front elevation and balconies along the rear elevation. It is our understanding that the doors and windows are not the Association's responsibility, and the building has been grandfathered in; therefore, life safety systems and sprinklers are not present within the building and therefore are not included with the Milestone and SIRS.

1. View of the subject Association building on Google Earth.
