**Los Angeles County
Metropolitan Transportation Authority
Office of the Inspector General**

**Review of the Expo/Blue Line
Junction**

Case No. 2011-0040

December 18, 2012

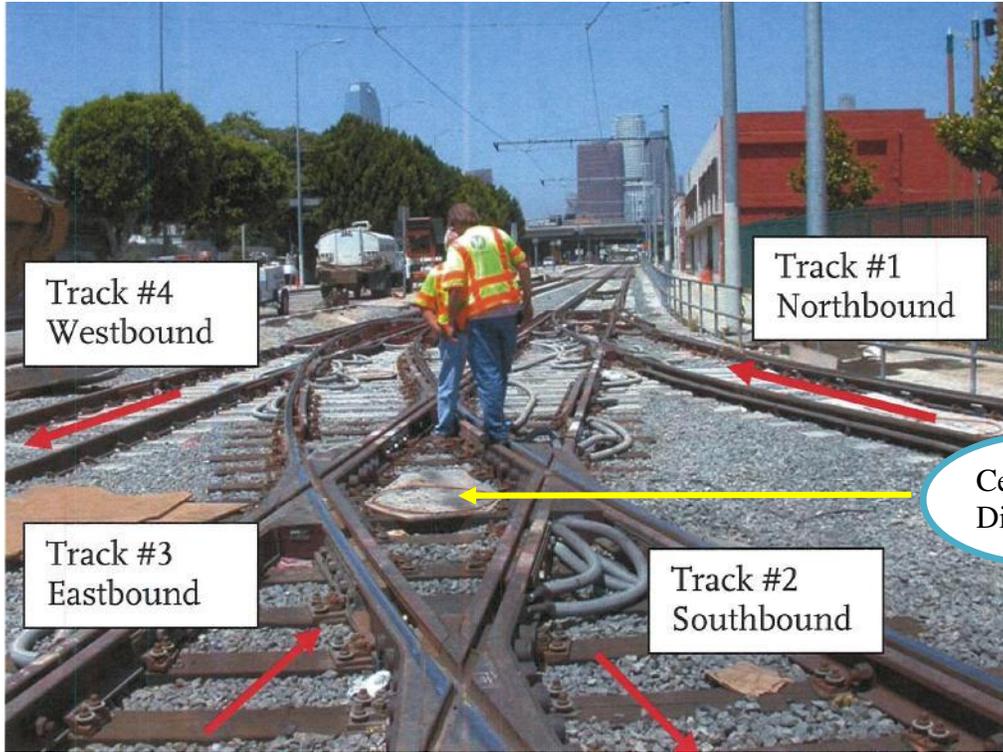
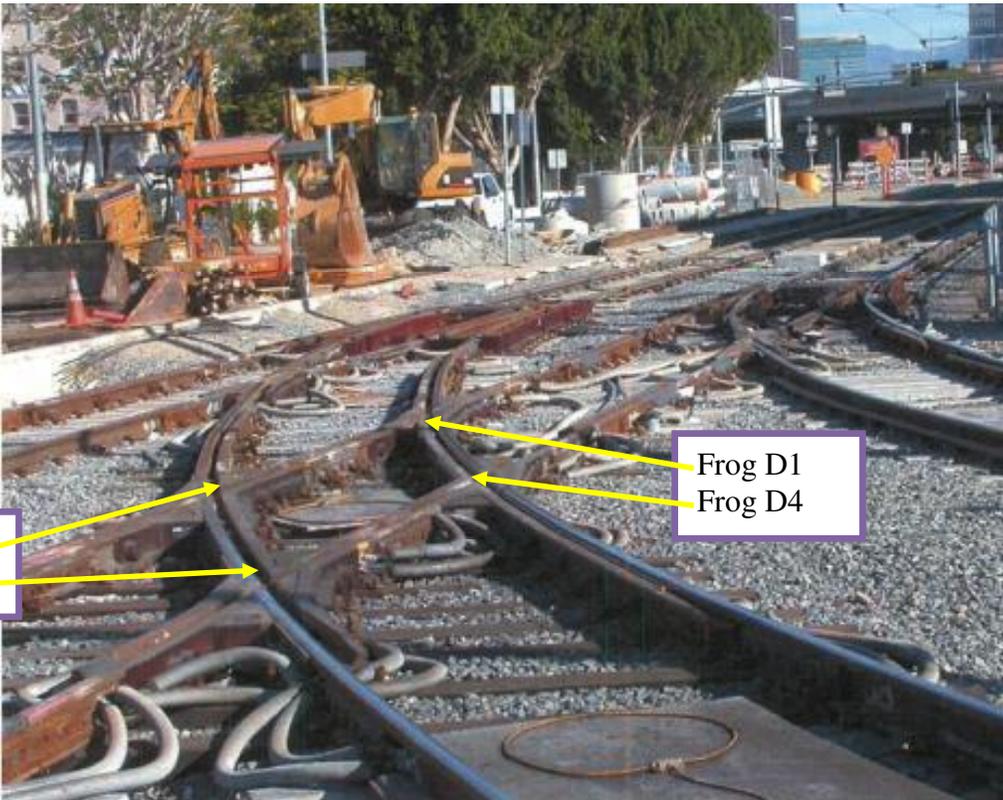
Pictures of Diamond/Frogs

2. **Identification of High Maintenance Area.** Soon after the special track work was installed in April 2010, Metro and CPUC personnel observed excessive wear and metal shavings and filings near one of the frogs at the Washington and Flower street junction, which indicated that the wheels of the LRVs were not traveling smoothly through the diamond area. Further inspections determined that the wheels were making hard contact with one of the frogs leaving metal shavings on the ground.

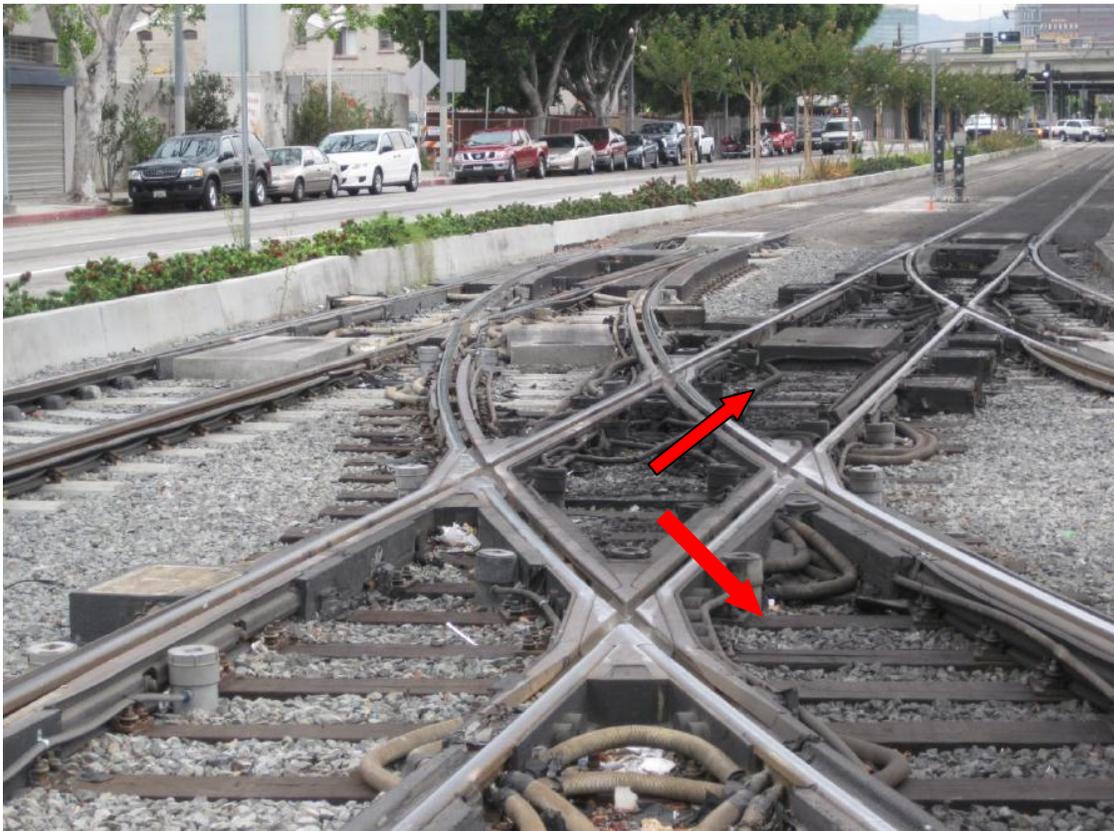
Figure 4: Junction Diamond. RED arrows indicate direction of normal travel.

Upon arrival at the Junction Diamond, several trains were observed travelling through the diamond on Track Blue #2 (small radius direction) as well as EXPO #3 (large radius direction). See Figure 4.

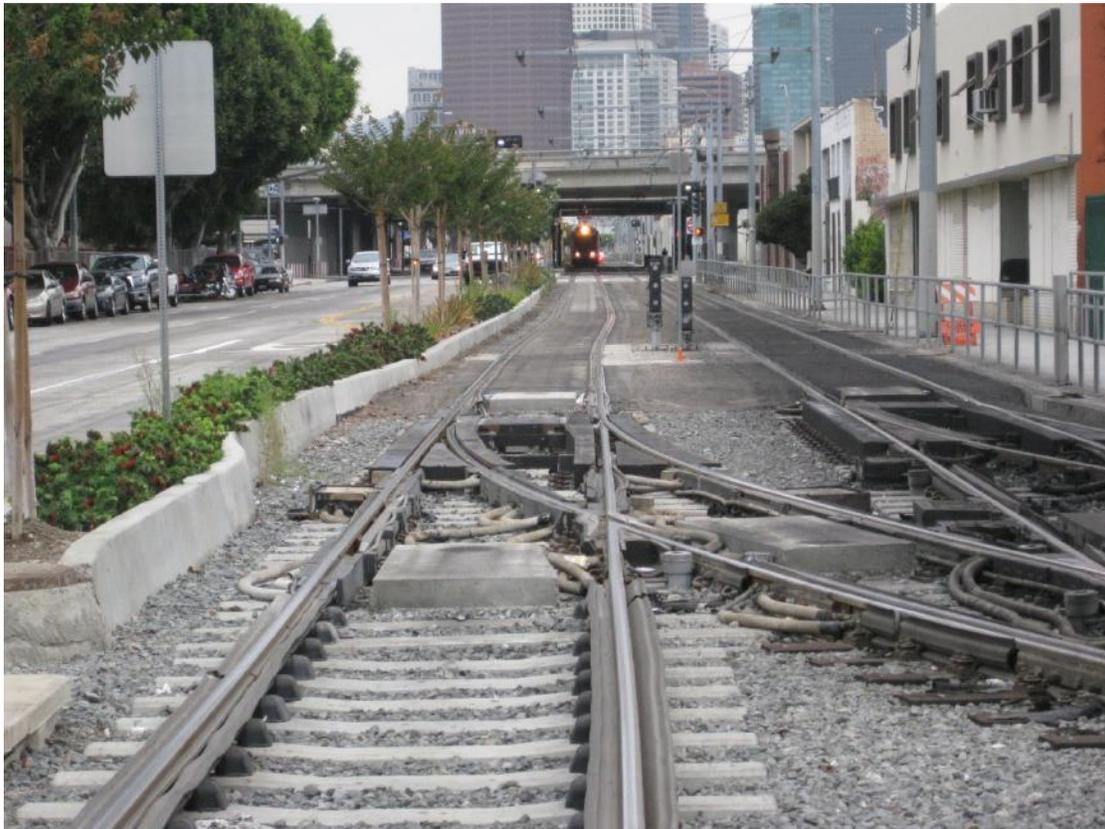
Figure 5: Straight move view of the Junction Diamond Looking North

The junction diamond is located between the Grand Station on one side (Figure 5) and Washington Blvd. and Flower Street on the opposite side (Figure 6).

The diamond junction is built on wood tie and ballast track where-as all other track and turnouts are built on concrete ties or embedded track (Figures 5 and 6).

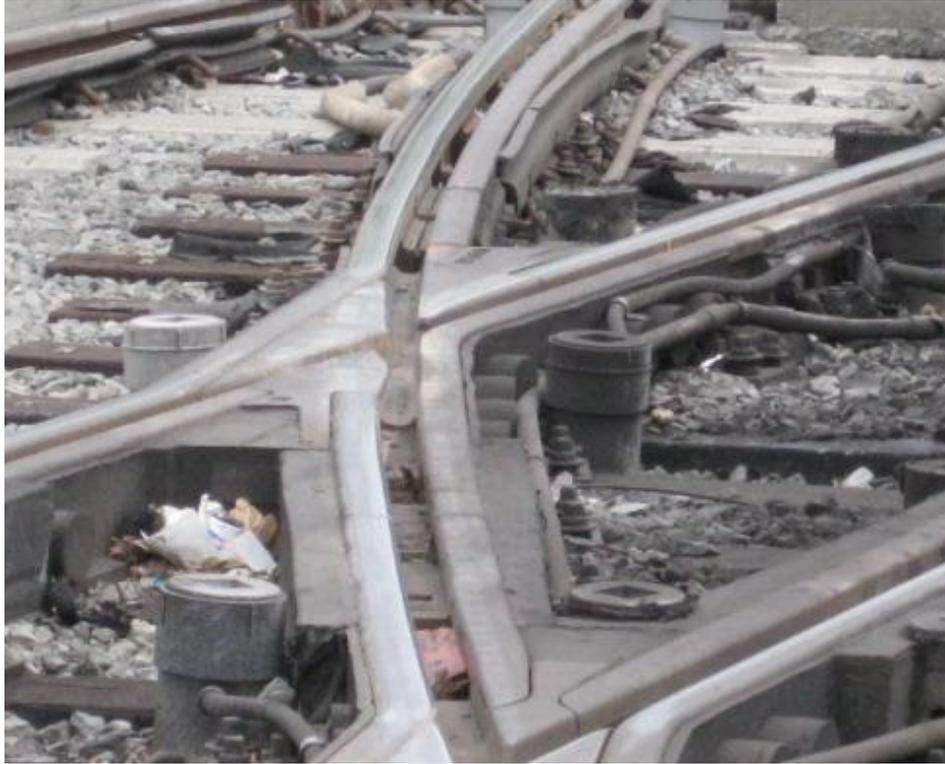
Figure 9:

As noted previously, there is a transition ramp welded onto the center frog of the diamond just ahead of the “Blip” that aids in moving the wheel flange onto the Blip without causing a large impact (see Figures 8 and 9). However, this is for Southbound movement of trains, there is no ramp for trains operating in the reverse (northbound) direction.
