Lower Waterford Congregational Church Adaptive Re-Use Study

September 22, 2020

Structural Conditions Assessment- Lower Waterford Church
September 1, 2020

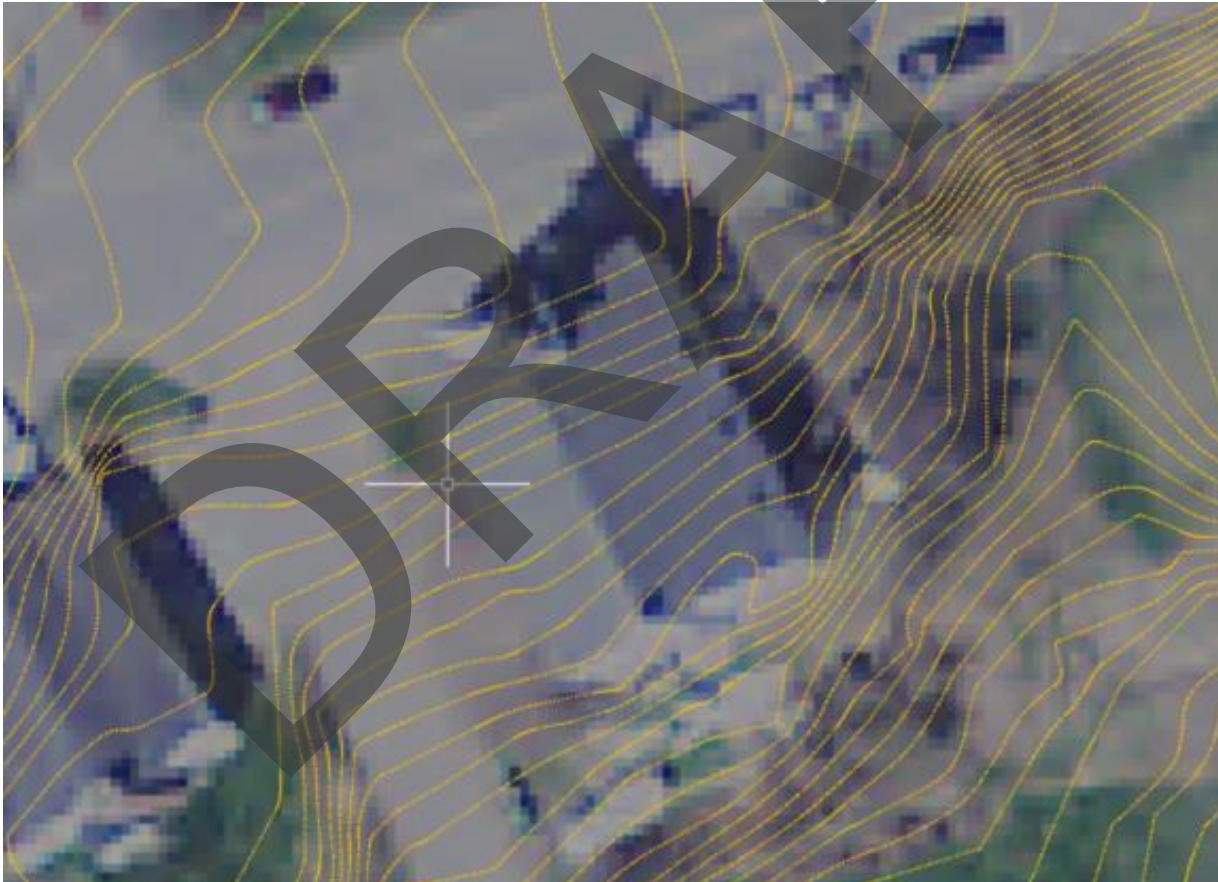
Church building with 1' contours shown in yellow (from LIDAR). Post office to left.

Parking for the site is currently provided by parallel parking on Lower Waterford Road (State Aid 2 Hwy). Nine spaces total are provided there including two ADA spaces. Based on LIDAR contours, Lower

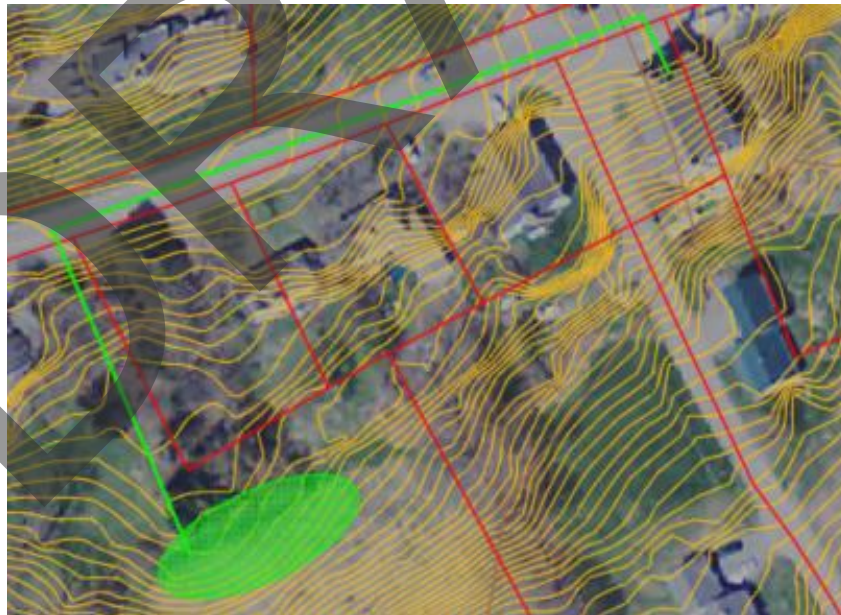
The greatest flexibility for building uses would be provided by construction of a new soil-based disposal system. Soils underlying the Church site and to the west are mapped as Vershire-Lombard Complex and should have reasonable potential for an on-site disposal field. Expansion of the Rabbit Hill system was suggested by a prior consultant and could be technically possible, but would require an agreement with the owner. Other off-site disposal locations are limited to a large degree by locations of nearby wells. One possible location would be to the west, if an agreement could be reached with the owners of 173 Lower Waterford Road (green ellipse below).

Potential disposal field location at lower left. Rabbit Hill WW system at upper right. Conceptual force main route shown in green along Lower Waterford Road.
