**Wood Condition Assessment of the
Petaluma Trestle, Petaluma, California**

GHD, Inc.
2300 Clayton Road, Suite 920
Concord, CA 94520

Porter & Associates
P.O. Box 3002
Burlington, VT 05408

July 14, 2023

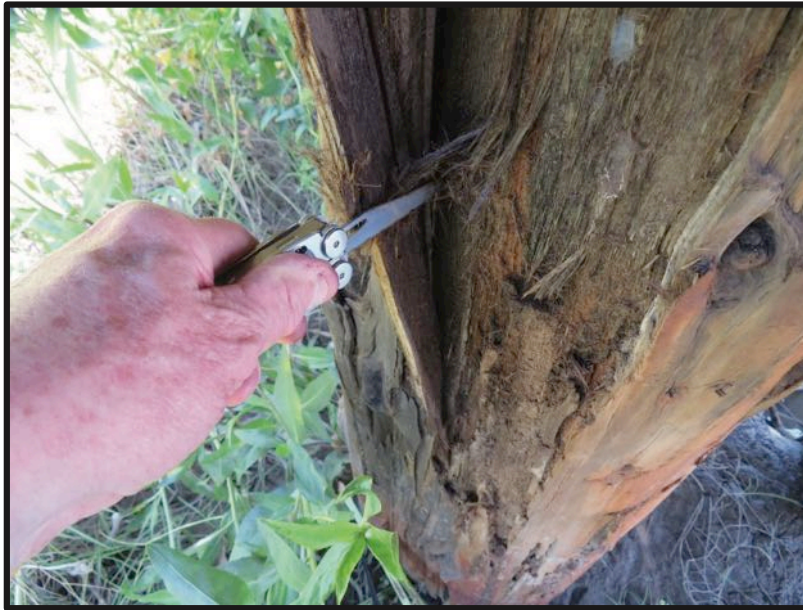
Figure 4. Using a knife to probe the shell of a pile with loose wood fibers to determine the extent of surface deterioration.

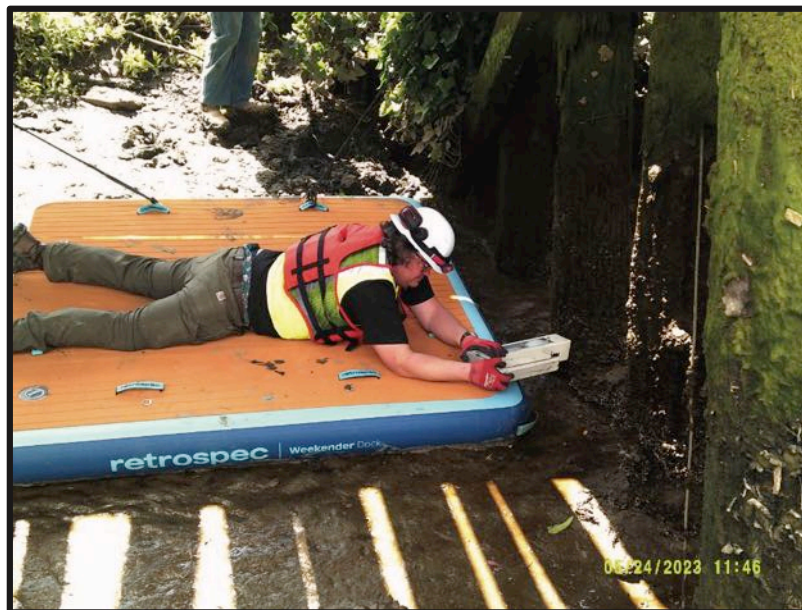
Figure 8. Resistance drilling of a timber pile near mudline at low tide.

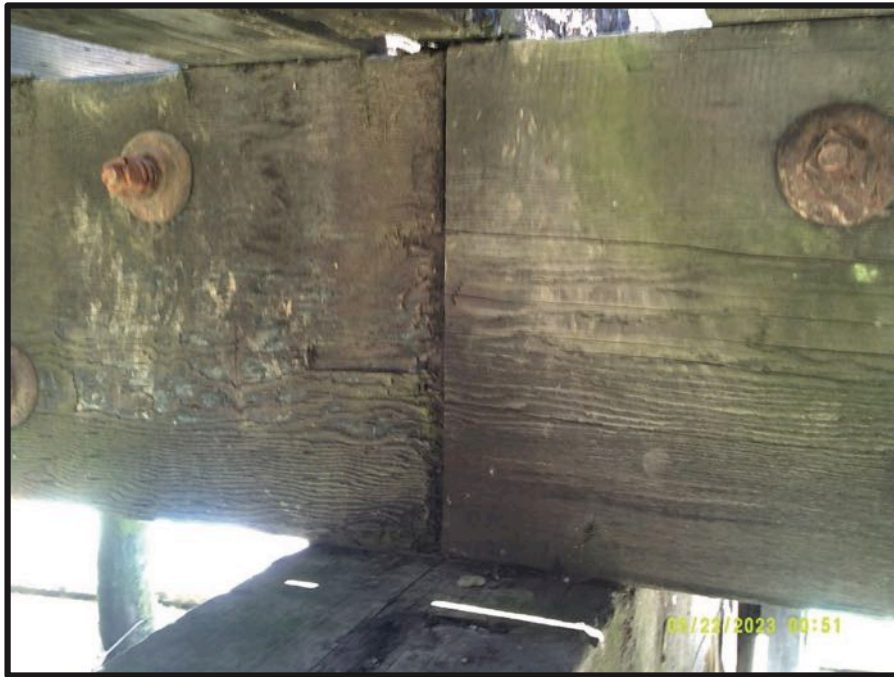
Figure 12. Stringers are nominally 8 x 18, are arranged in sets of three stringers under each rail, and meet over pile caps.

8. The condition of the stringers is, generally, fair-to-excellent with exceptions typically at the ends of stringers where they rest on the pile caps.
